EVALUATING CORROSIVE SITE PERFORMANCE AND POLICY WITH
CONCRETE ADMIXTURES

A thesis submitted to the faculty of
The University of North Carolina at Charlotte
in partial fulfillment of the requirements
for the degree of Master of Science in
Civil Engineering

2020

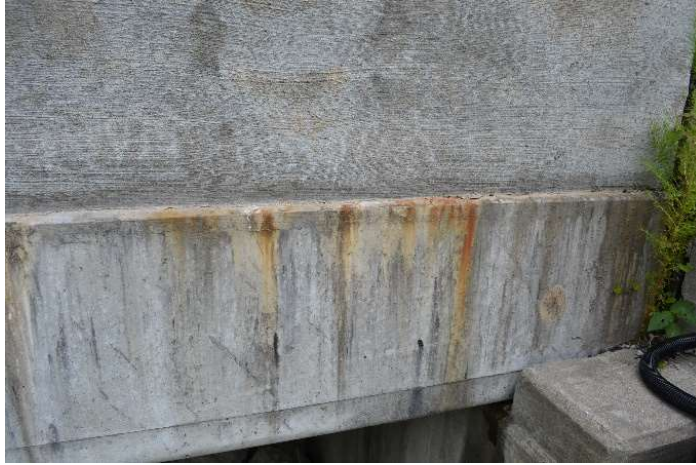
(a)

The visual inspection of SN 660091 identified many locations with significant efflorescence staining on the sides and underside of the cored slabs, a large section of honeycombing on the underside of a cored slab exposing a corroded prestressed strand, and large cracks that had been repaired (i.e. filled in) on the underside of multiple cored slabs. Photographs of these potential signs of corrosion can be seen below.

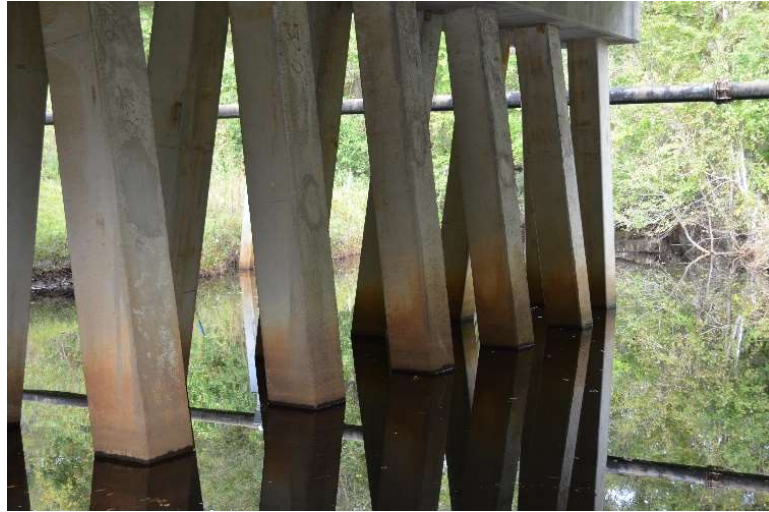
The visual inspection of SN 660019 revealed little to no sign of active corrosion. The only exception to this was efflorescence below the high tide line on all the piers. A photograph of this potential sign of corrosion can be seen below.

Figure 3.16. Efflorescence within Splash Zone of Piers.

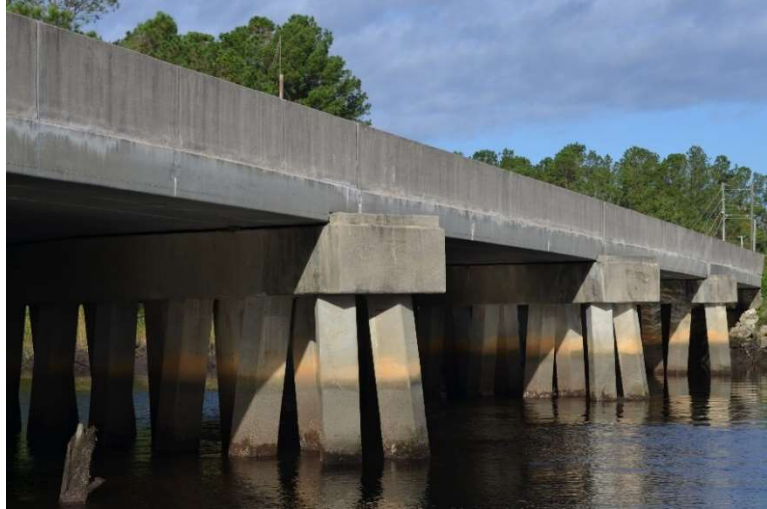
The visual inspection of SN 090061 revealed little to no sign of active corrosion. The only exception to this was efflorescence below the high tide line on all the piers. There was no efflorescence or honeycombing discovered on the cored slabs. A photograph of this potential sign of corrosion can be seen below.

Figure 3.18. Efflorescence at High Tide Line on all Piers.

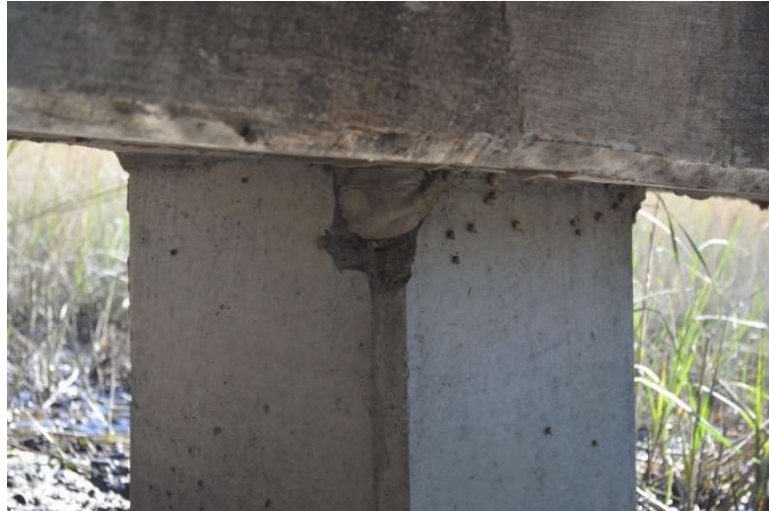
The visual inspection of SN 640010 revealed little to no sign of active corrosion. There was no evidence of efflorescence on the piers, caps, or cored slabs. Additionally, there were no signs of honeycombing on this structure. The only damage noted was a spalled section between a pier and interior bent cap connection that appeared to have been patched. It cannot be confirmed whether the origin of this spall is corrosion-related or is simply a construction defect, however, it was included here as a current defect that was identified during the visual inspection. This can be seen in Figure 3.21 below.

Figure 3.21. Spalled Section at Pier to Bent Cap Connection.

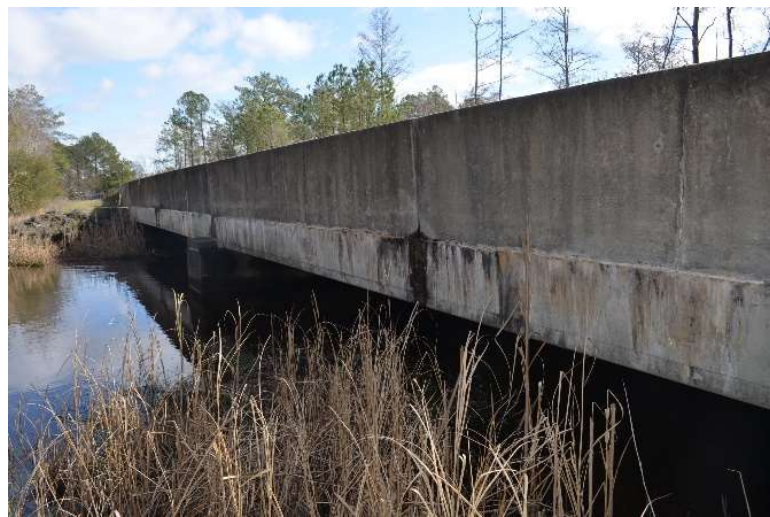
The visual inspection of SN 150026 revealed little to no sign of active corrosion. The only exception to this was efflorescence staining along the side of the exterior cored slabs. A photograph of this potential sign of corrosion can be seen below.

Figure 3.24. Efflorescence Staining on Side of Exterior Cored Slabs.

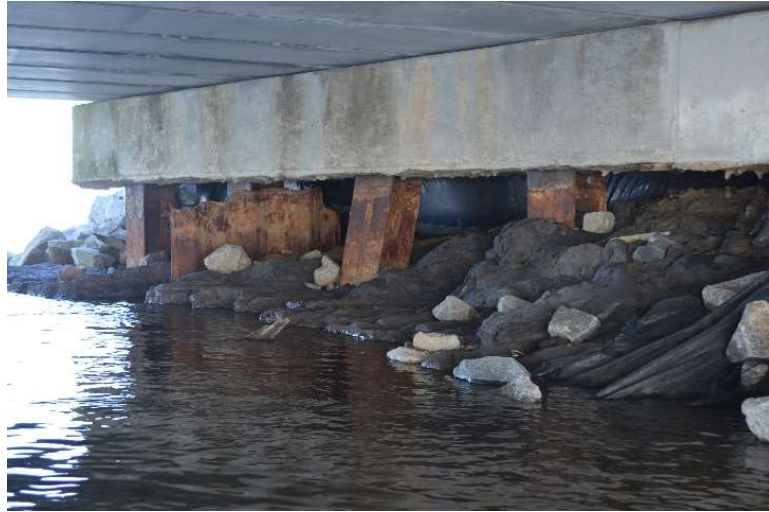
The visual inspection of SN 260007 revealed no active signs of corrosion on concrete elements, however, the steel sheet piles and steel bent piles appeared to be heavily corroded. The signs of corrosion can be seen in the photographs below.

Figure 3.27. Heavily Corroded Interior Bent Steel Piles.

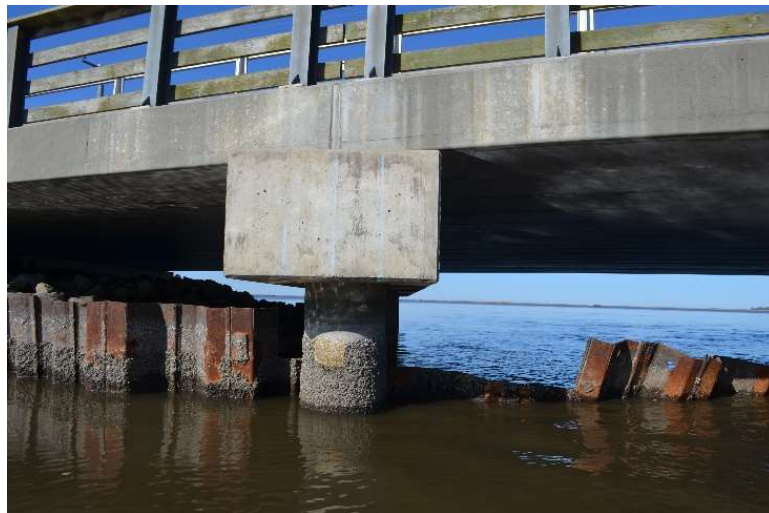
Figure 3.28. Heavily Corroded Steel Sheet Piles.

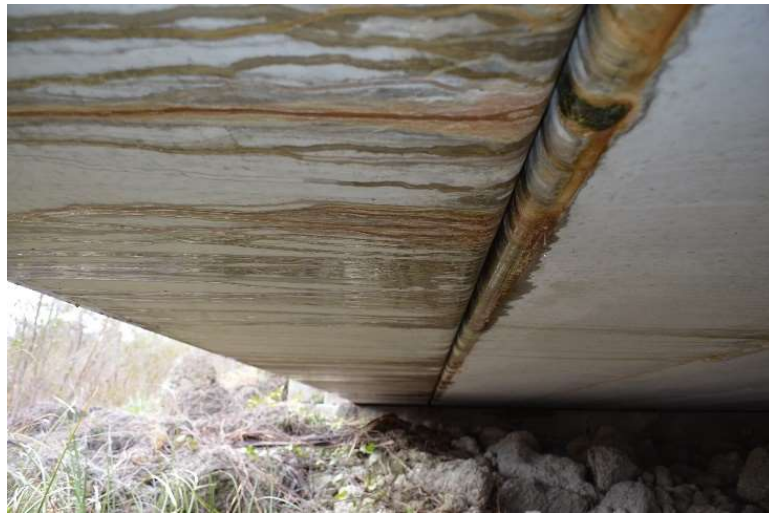
The visual investigation of SN 660021 revealed little to no sign of active corrosion. The only signs were efflorescence on the underside of the cored slabs and within the splash zone on the interior bent piles. Photographs of these potential signs of corrosion can be seen below.

Figure 3.30. Efflorescence on Underside of Cored Slab.
