POST-DISASTER INVESTIGATION OF STRUCTURES IN THE PHILIPPINES
(LEYTE AND EAST SAMAR) AFTER SUPER TYPHOON HAIYAN

A thesis submitted to the faculty of
The University of North Carolina at Charlotte
in partial fulfillment of the requirements
for the degree of Master of Science in
Engineering

2016

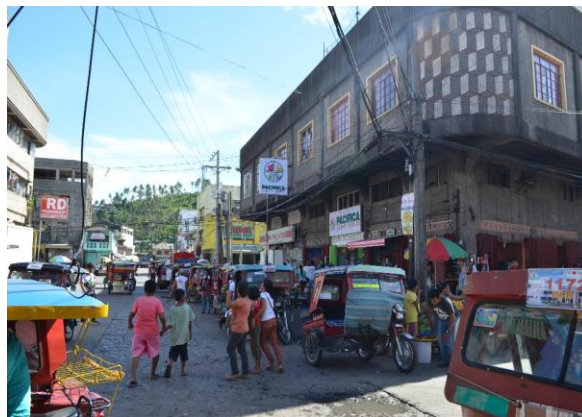
(2014) estimated maximum flow speed not more than 3 m/s. Figures 3 to 4 show downtown structures with minor wind and flood damages.

Figure 3: Shopping Mall Showing Structural Damages, Downtown Tacloban. (B38-007)

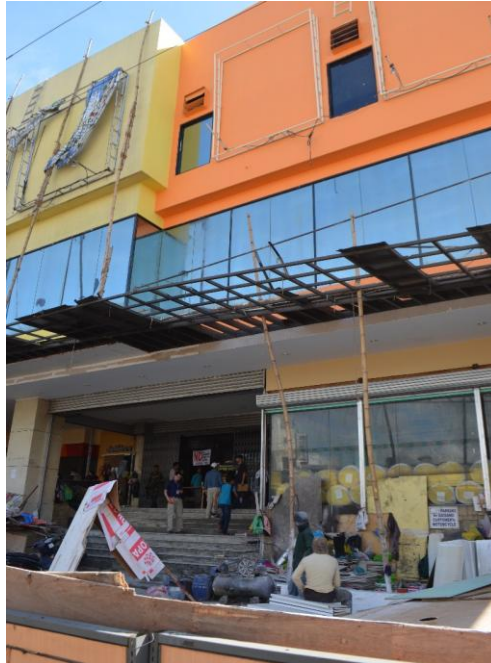
Figure 4: B13-001 Damaged Structure,
Downtown Tacloban. (B13-001)

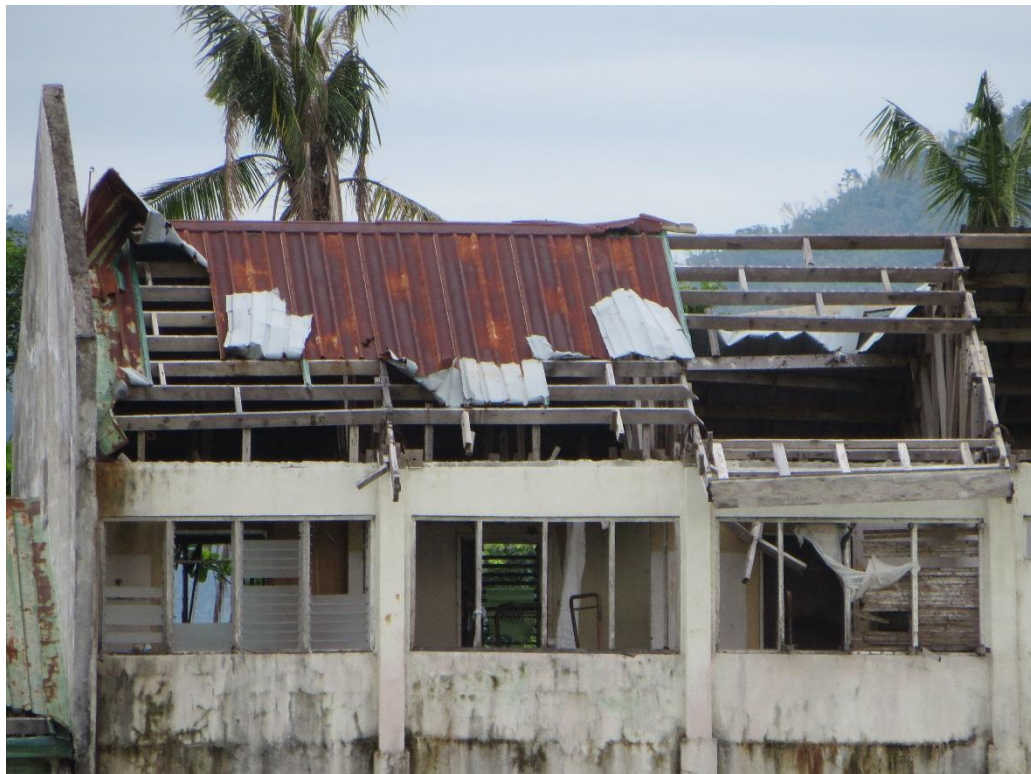
Figure 24: Damaged Two-story Structure (B88-030) near Tacloban Domestic Airport Depicting Metal Roof Panels, Wood Truss and Reinforced Concrete Walls

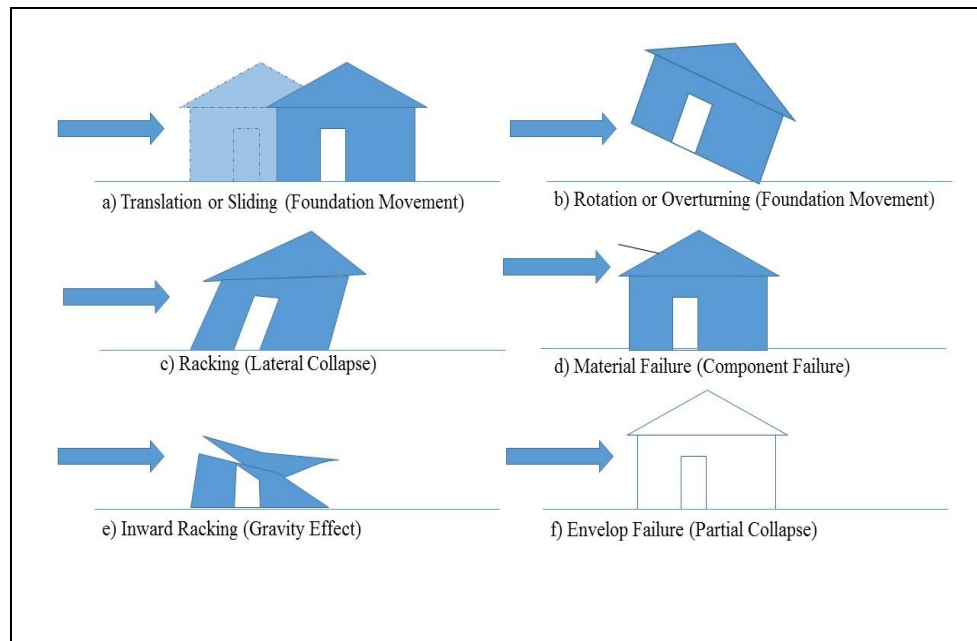
roof system may have applied excessive axial force on the vertical members (columns and walls). This may result in a combination of failure modes (Figures 25b and 25c). Figure 29 shows a typical completely destroyed commercial structure (Palo-008-D2, overall rating is 3). The structure is about 1,175 m away from the seashore and elevation is about 4 m above sea level. The failure mode started with the roofing sheet metals failing and wind load forced the metal roof trusses to fail. Due to the axial forces from the roof system results in the collapse of the structure as a whole. Figure 30 shows the damaged roof system indicating likely roof truss connected to concrete wall and sitting on a pedestal.

Figure 25: Global Failure Modes of Structures

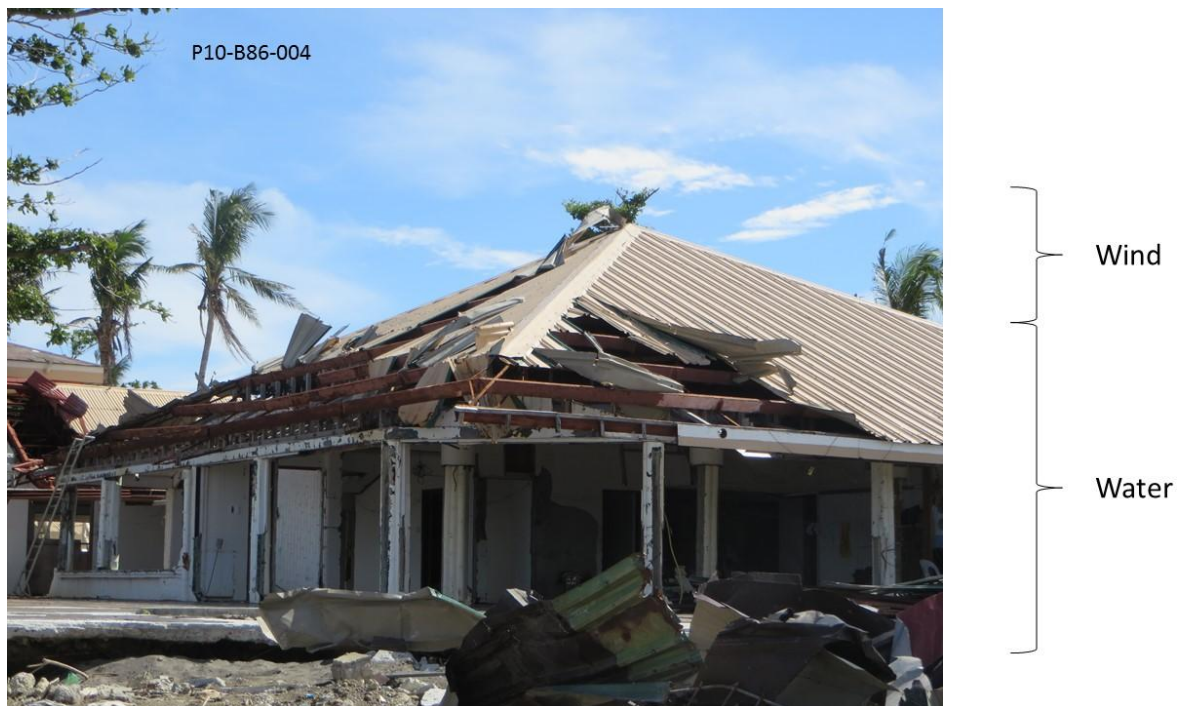
Figure 26: One-Story Residential Structure (P10-B86-004) with Wind and Water Damages

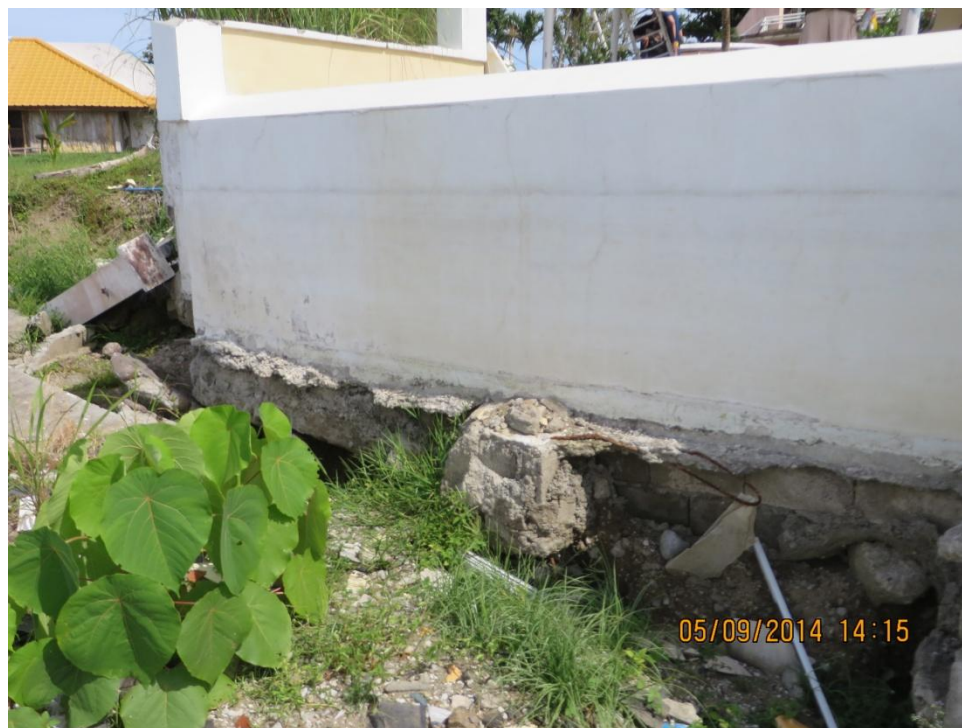
Figure 28: Severely Scoured Foundation (B01-003-013)

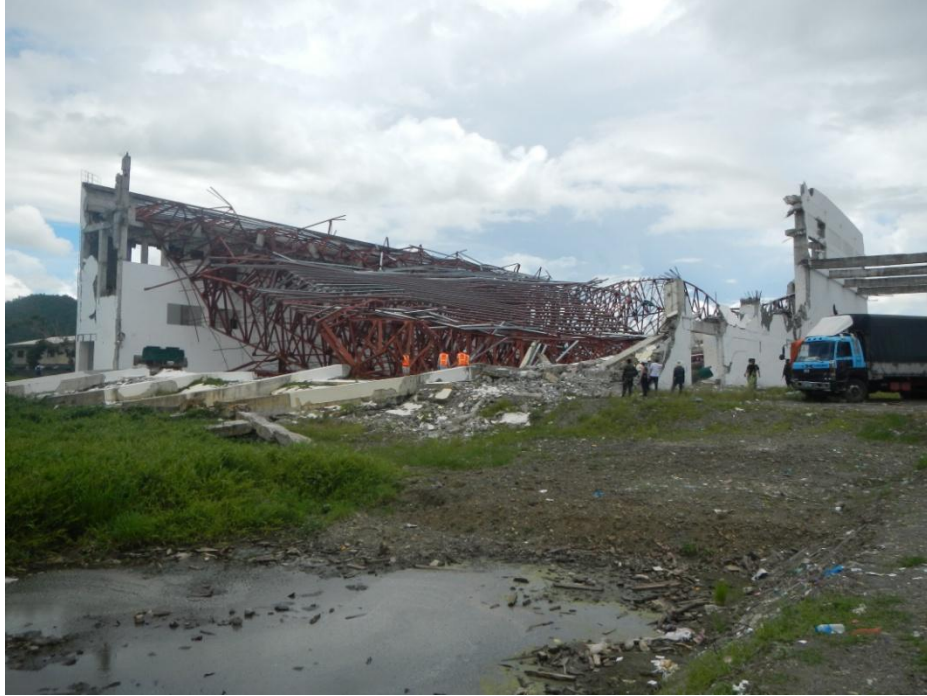
Figure 29: Collapsed Commercial Structure (Palo-008-D2)

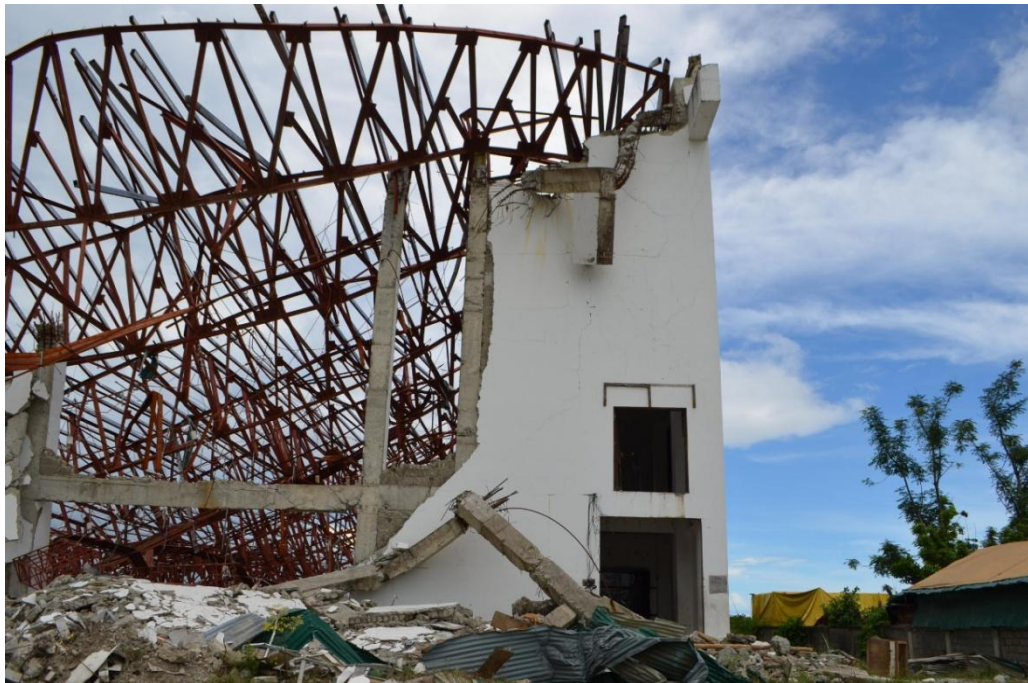
Figure 30: Roof Truss Connection for the Commercial Structure (Palo-008-D2)

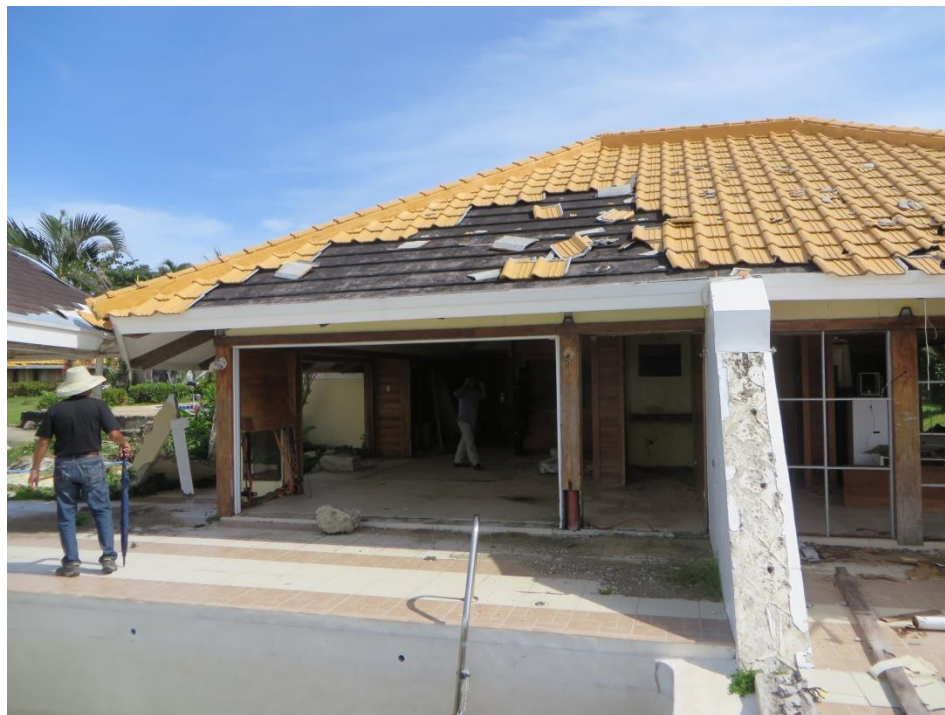
Figure 32: Storm Damaged Metal Roof (B01-003-013)

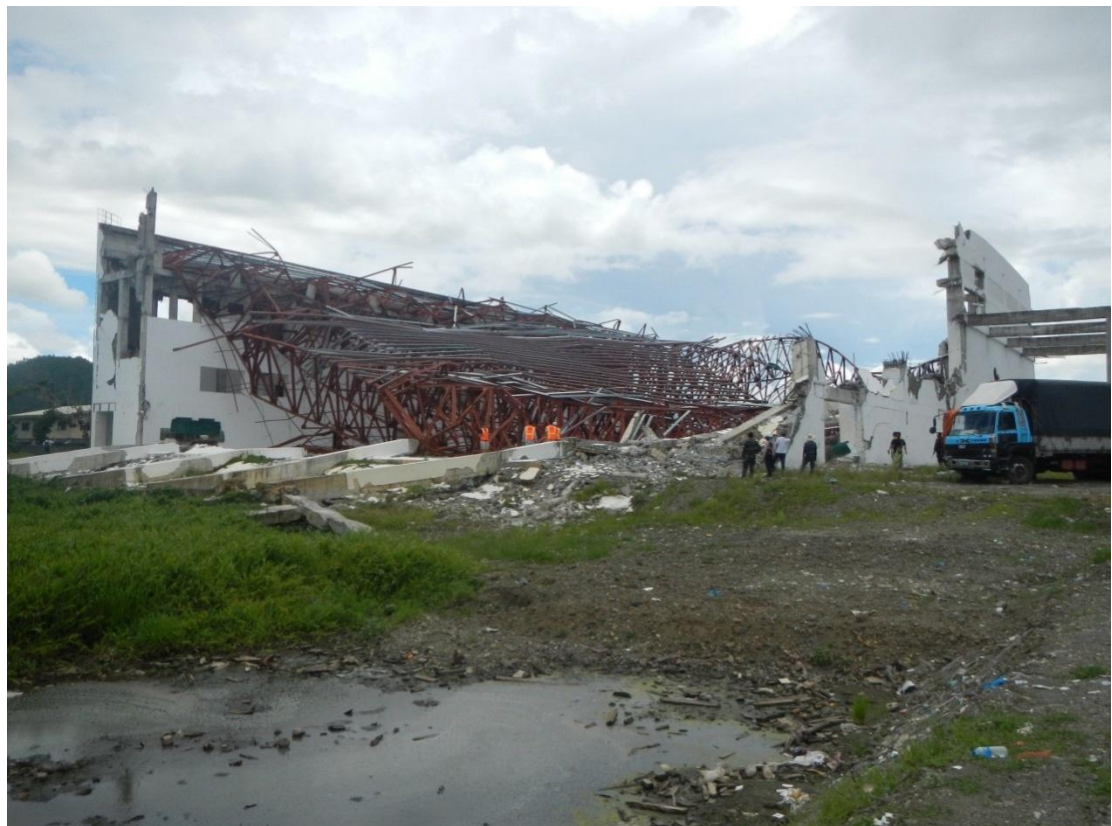
Figure 36: Collapsed Commercial Structure (Palo008-D2)
