PUERTO RICO GRID RESILIENCE ASSESSMENT USING BINOMIAL ANALYSIS
FOLLOWING HURRICANE MARIA CONSIDERING STORM EFFECTS

A thesis submitted to the faculty of
The University of North Carolina at Charlotte
in partial fulfillment of the requirements
for the degree of Master of Science in the
of Civil Engineering

YENKI NG. Puerto Rico grid resilience assessment using binomial analysis following hurricane Maria considering storm effects
(Under the direction of DR. SHEN-EN CHEN)

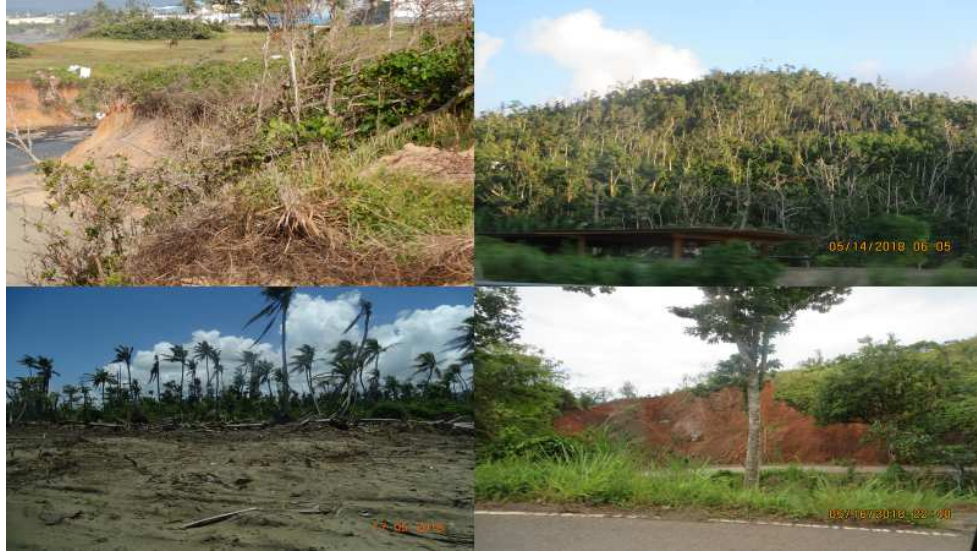
Figure 1.4: Images of storm events captured following hurricane Maria (NSF Rapid, 2018).

During and after the hurricane, Puerto Rico experienced various storm events as shown in Figure 1.4. In addition to the strong winds, storm events such as storm surge, rainfall and flooding, coastal and river erosion, deforestation, and landslides have occurred (Silva-Tulla et al. 2018). The topography of the island prior to the storm changed drastically following the storm, causing potential problems for the existing vegetation and wildlife. There were significant trees down due to the strong wind and torrential rain. These may be the causes of some or majority of the power grid to fail.

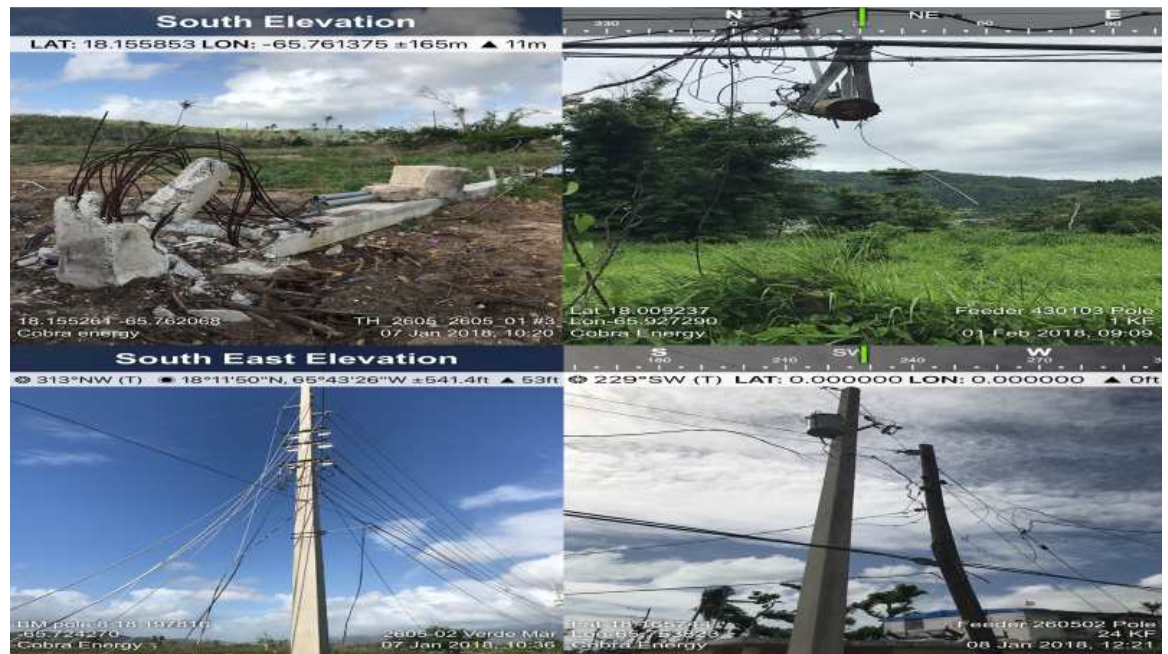
Entering from the southeastern corner of the island, hurricane Maria inflicted Puerto Rico's power infrastructure with severe physical structure damages. Figure 2.3 shows several power pole structures damaged by buckling, conductors down, and loss of equipment such as insulators, communications or transformers on pole. The damage

modes observed on the transmission poles also included foundation failures as a result of land movements (slides or debris flows).

Figure 2.3: Various modes of damages to transmission structures (PREPA, 2018).

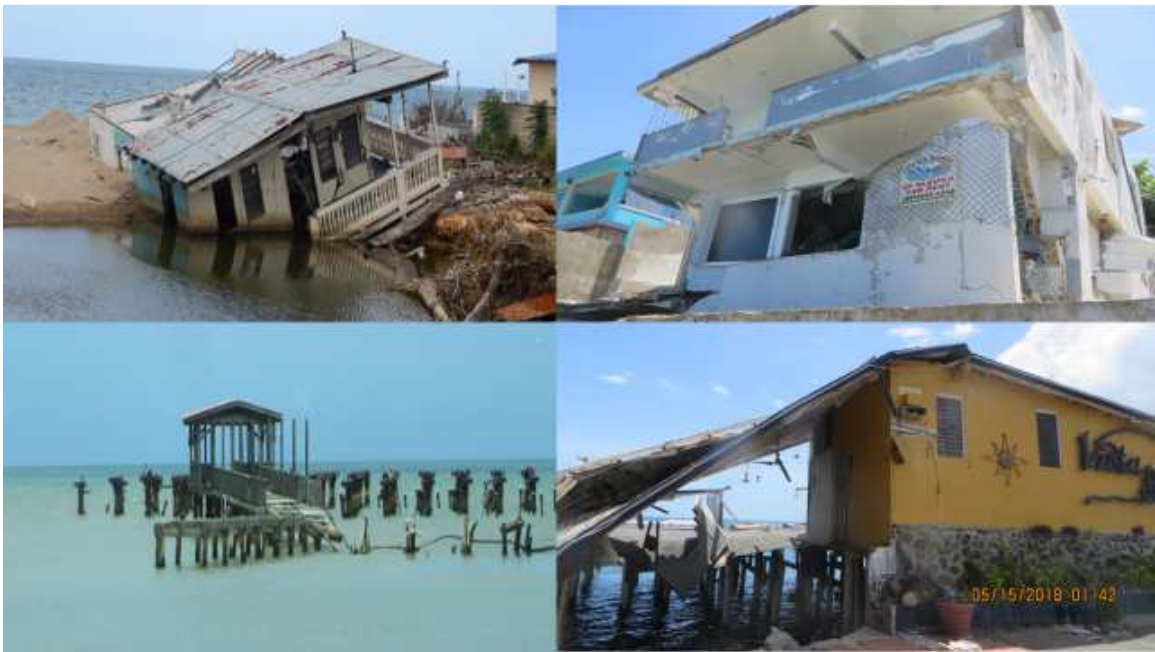
and characteristics of the hurricanes. These photographs were captured by a field/research team that was sent to Puerto Rico in early May 2018, eight months after the storm. The team consisted of both civil and electrical engineers. Within a seven-day travel span, the team captured photographs throughout most of the island starting from the west coast and making its way to the east coast. These photographs include a various range of the island's existing condition such as topography, roadways, and different types of infrastructures (transmission, residential, commercial, etc.). Figure 3.1 below shows some example of images that were captured during the field study.

Figure 3.1: Images of structural damages captured during the field study (NSF Rapid, 2018).

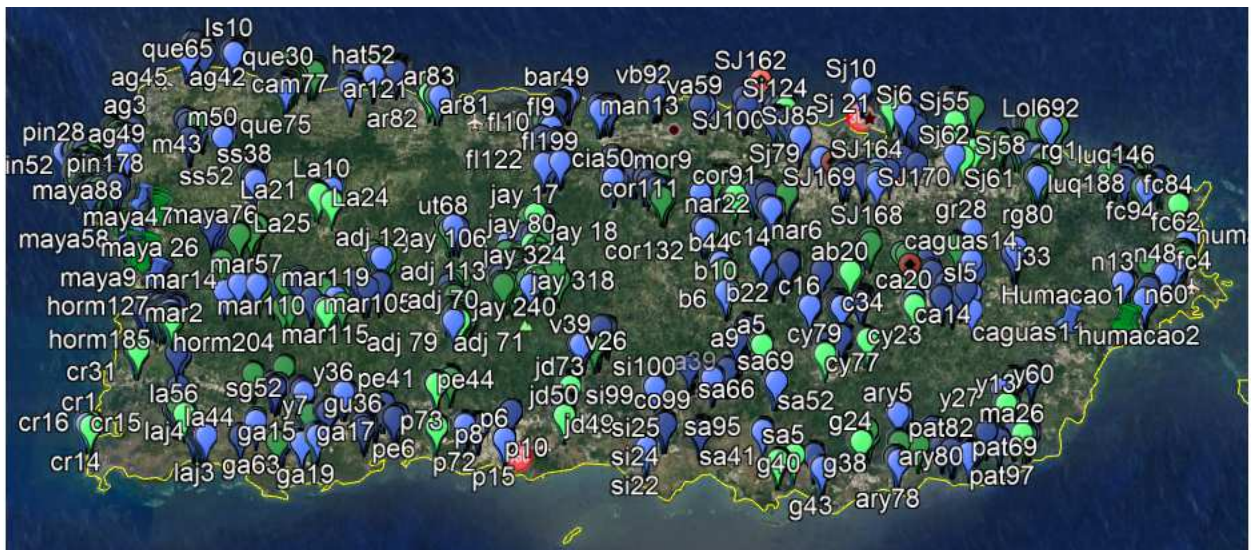
Figure 3.3: Complete structural assessment for Puerto Rico.

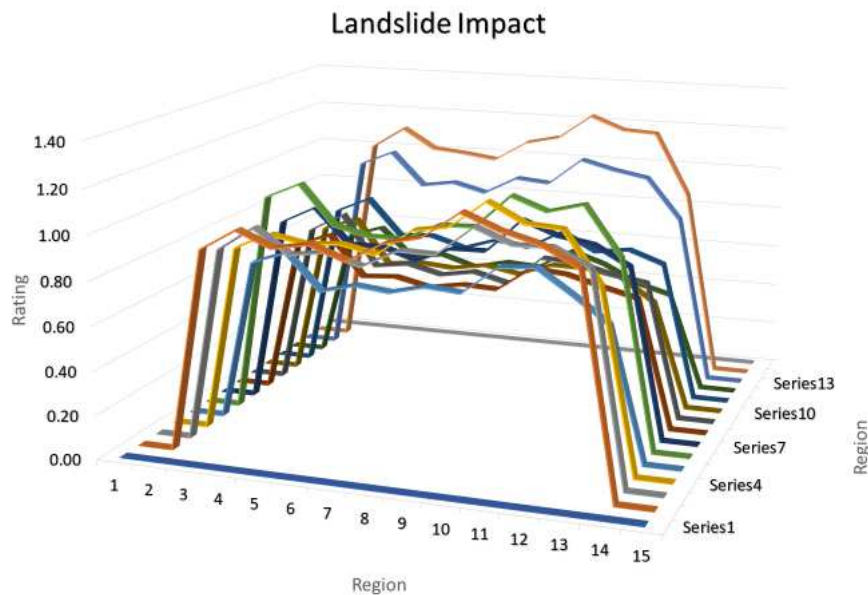
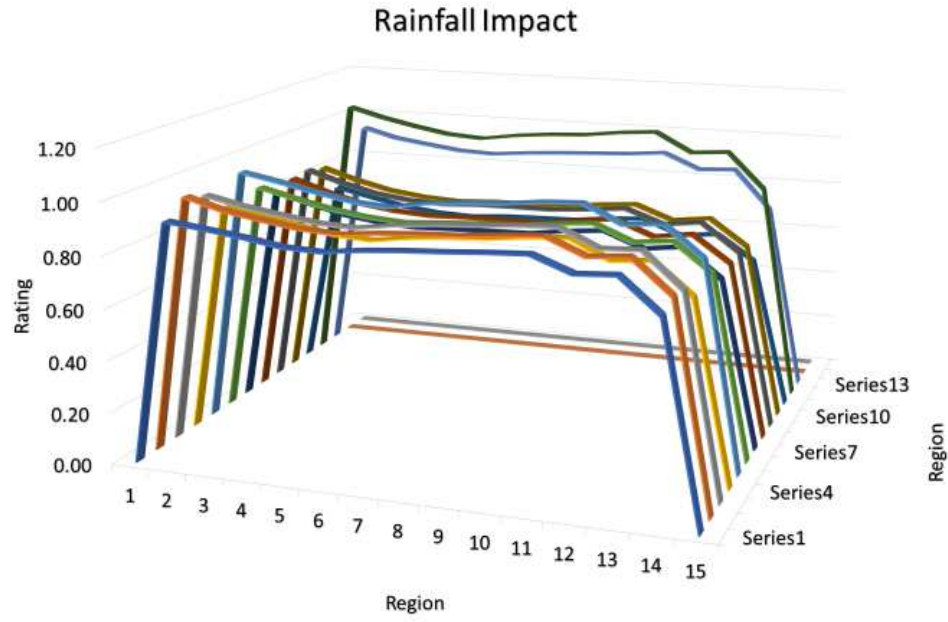
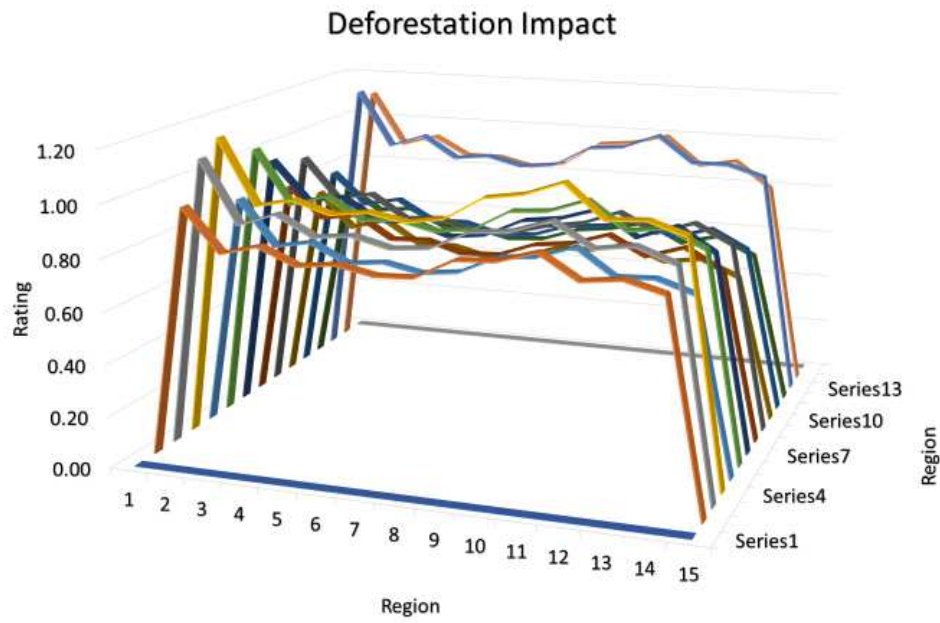
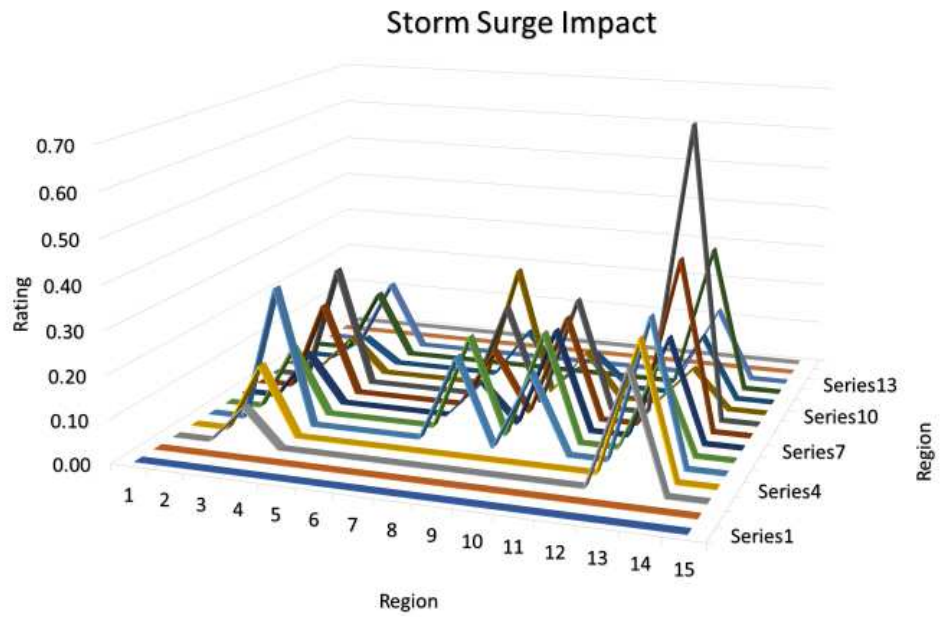
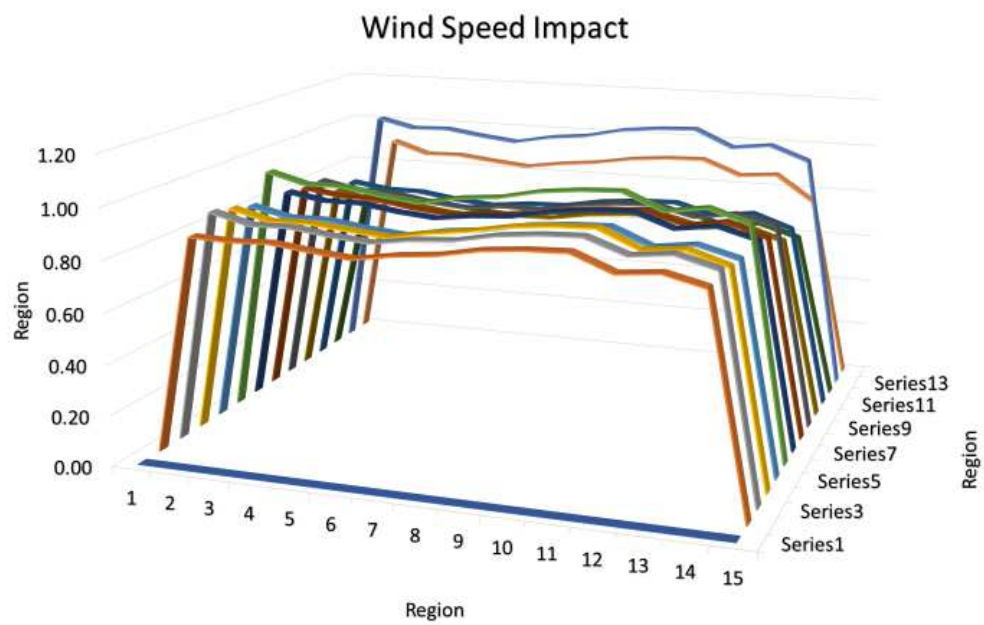
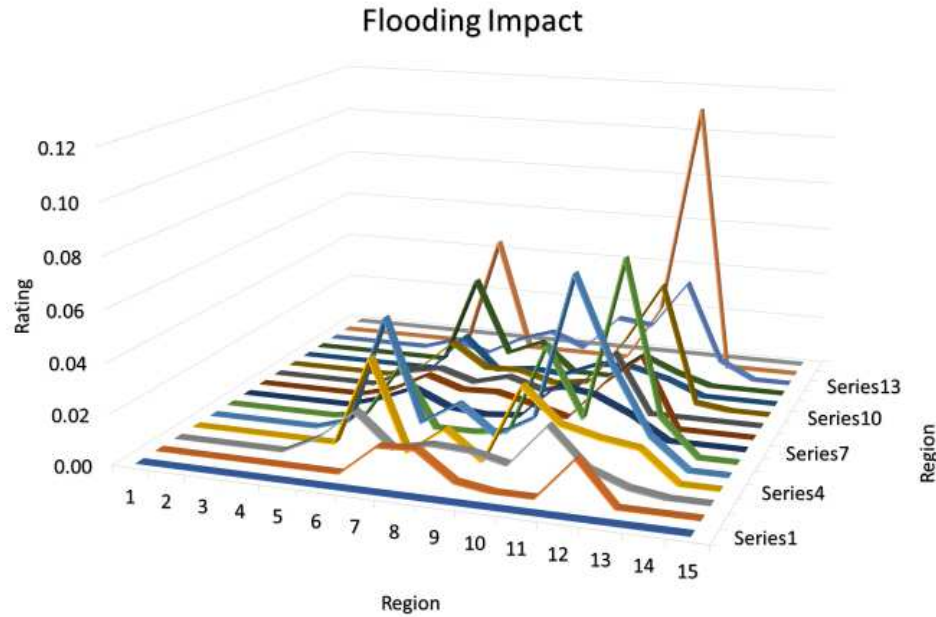
Figure 4.4: ECA for landslide impact.

Figure 4.5: ECA for rainfall impact.

Figure 4.6: ECA for deforestation impact.

Figure 4.7: ECA for storm surge impact.

Figure 4.8: ECA for wind impact.

Figure 4.9: ECA for flooding impact.

In evaluating the ECA data (Appendix A and Figures 4.4-4.9), validation of the data can be confirmed for the correlation of storm events to structural damages. Storm events such as wind intensity, landslide, rainfall, and deforestation display that the most of the values along each figure are approaching 1, indicating that the two vectors are nearly identical. However, the figures for storm surge and flooding indicate that the vectors are not identical since most of the data does not approach 1. To verify that these observations are true, the influence factor, I_x , for each storm event was determined.
