EXPERIMENTAL EVALUATION OF LOW-COST, PORTABLE, AND RAPID
NONDESTRUCTIVE EVALUATION METHODS FOR TIMBER
DISTRIBUTION POLES

A thesis submitted to the faculty of
The University of North Carolina at Charlotte
in partial fulfillment of the requirements
for the degree of Masters of Science in
Civil Engineering

2016

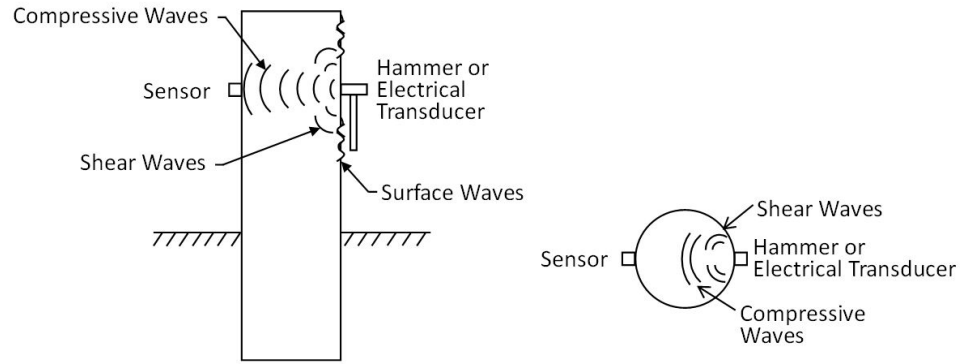
FIGURE 2.3: Schematic of the Pulse Velocity Method applied for condition assessment through the cross section of a pole

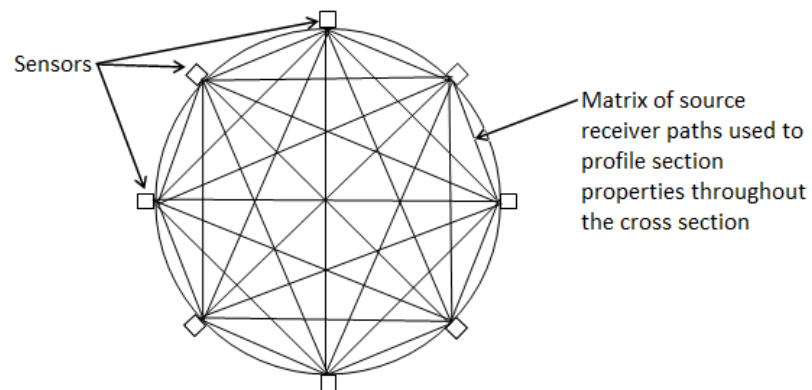
FIGURE 2.4: Analysis of source and receiver locations to measure stress wave propagation paths used to develop tomographic images

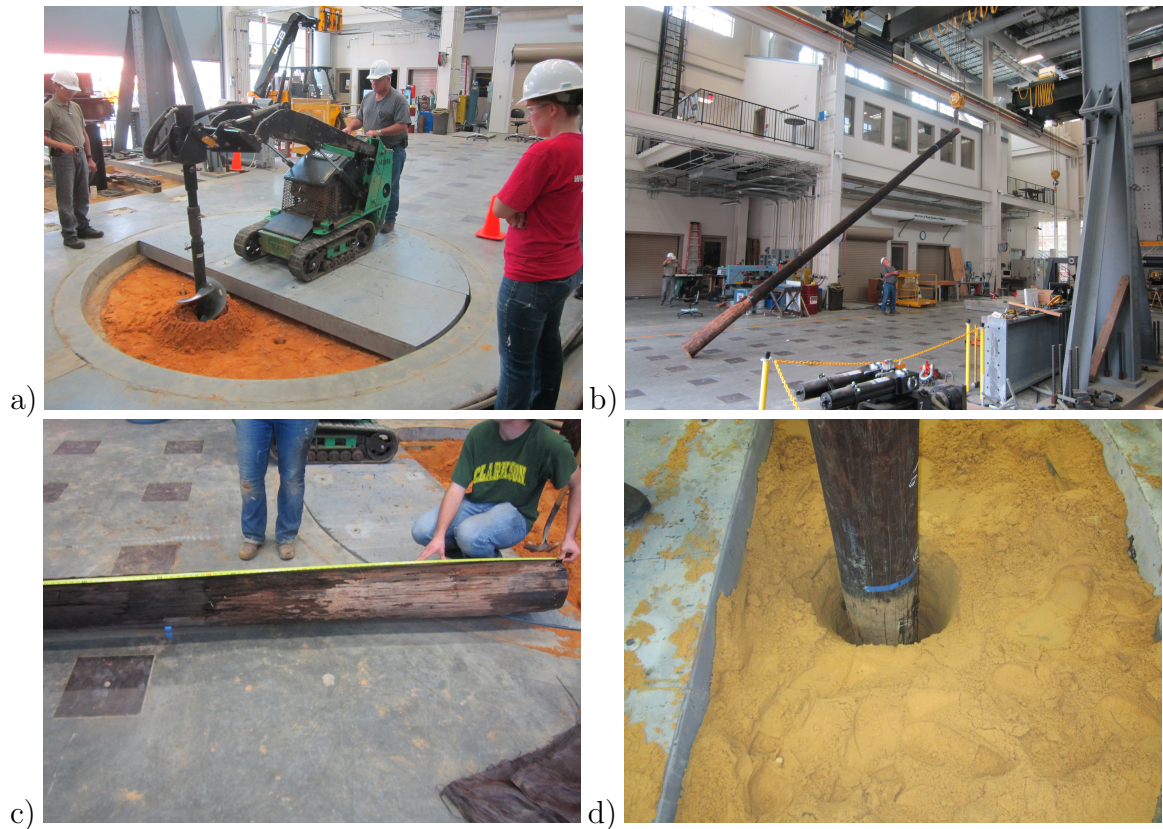
FIGURE 3.2: Installation of timber distribution poles in experimental test bed: a) augering holes with skid steer, b) lifting poles with overhead crane c) measuring pole dimensions and marking pole, d) installing pole to original depth of embedment

installation depths (Figure 3.2a). The poles were placed in the augered holes using a crane to lift the pole tops (Figure 3.2b) and, when additional support was required to prevent fracture of severely decayed poles, a telescopic hauler was used to lift the butt of the pole to prevent excessive stress in the pole during installation. Each pole in the experimental test program was installed with an embedment depth corresponding to the original depth of embedment in the field. This original embedment would be identified by visible residual soil and discoloration as well as the presence of plugs from microdrill inspections performed at the ground line (Figure 3.2c). Once the poles were in place (Figure 3.2d), the extracted sand was replaced in the holes and

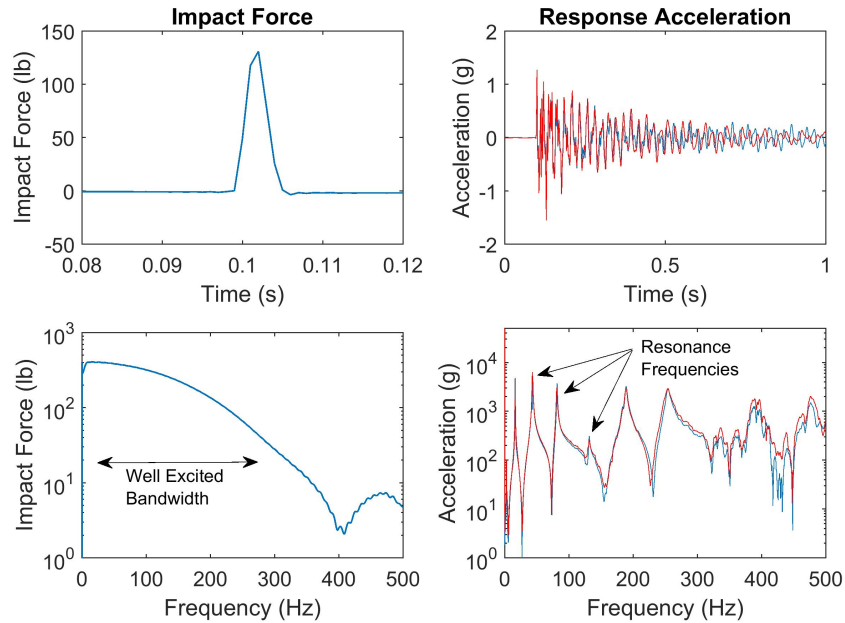
FIGURE 3.8: Overview of vibration measurement in both time and frequency domains for each test and used to calculate the frequency response functions (FRFs), although measurement of the impact excitation is not required to estimate the natural frequencies because it provides an indication of the frequency bandwidth excited but does not reflect the dynamics of the pole.

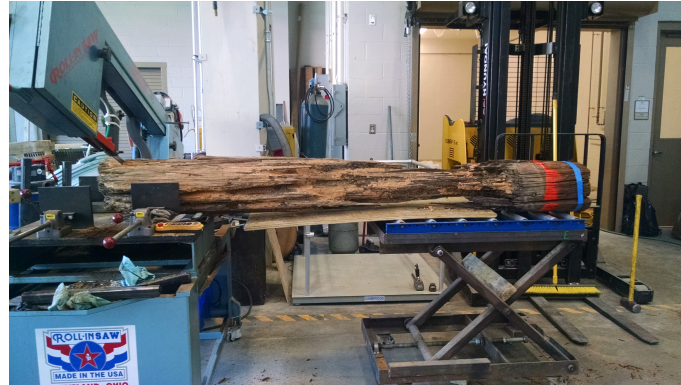
FIGURE 3.12: Destructive characterization of Pole 8 with band saw

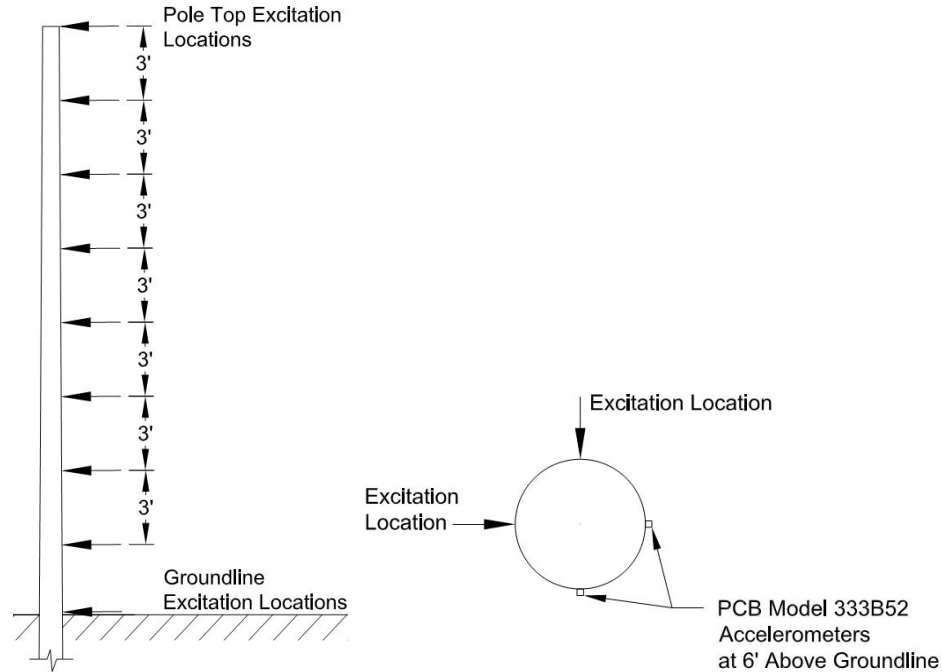
FIGURE 4.1: Locations of accelerometers and impulse excitations during experimental modal analysis of Pole 7

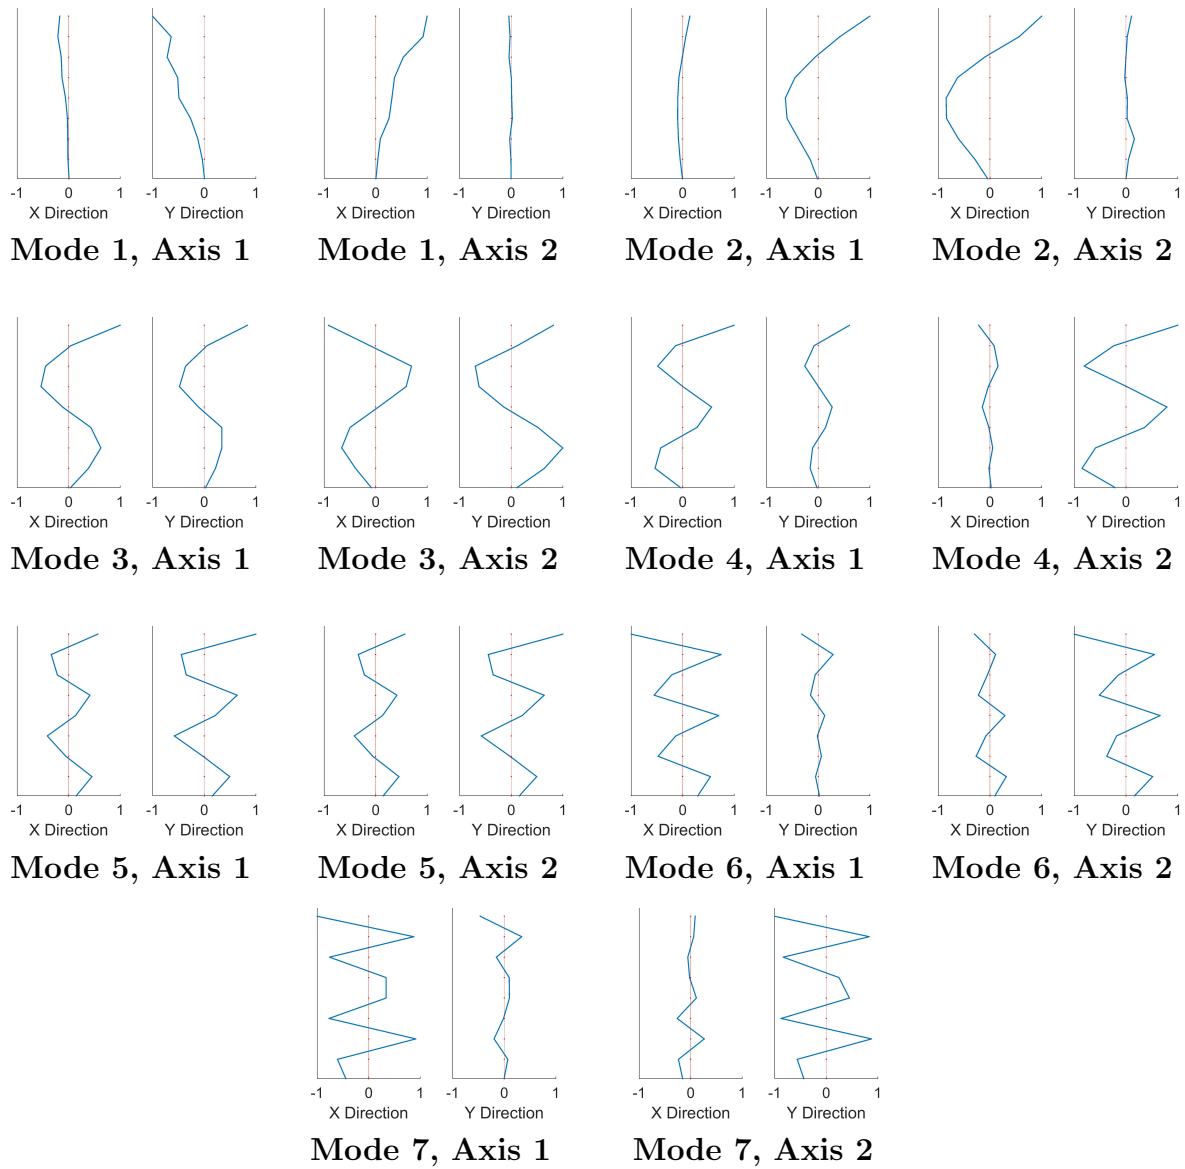
FIGURE 4.2: Mode shapes of Pole 7 determined through experimental modal analysis

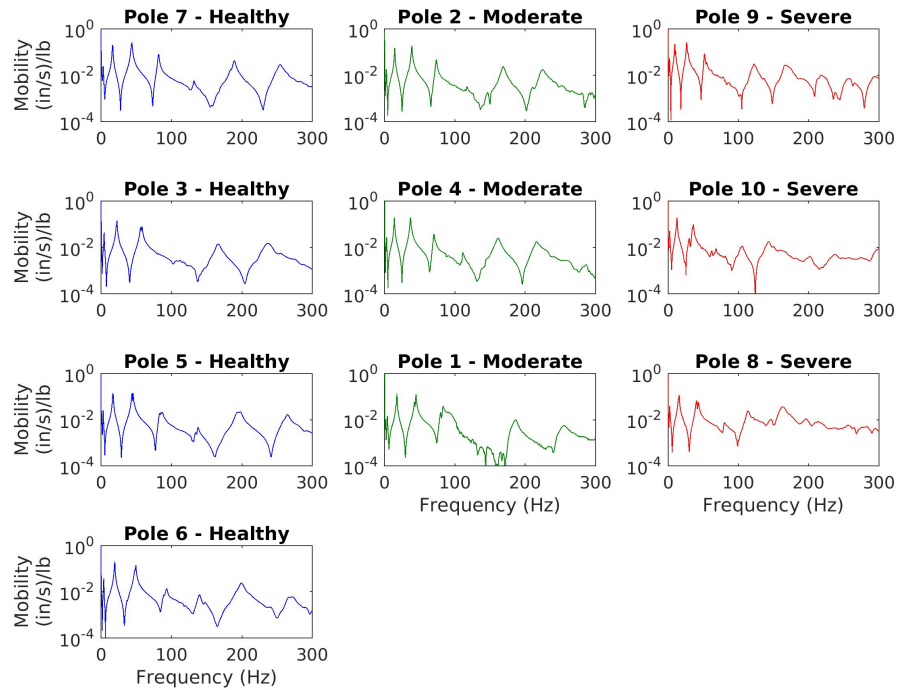
FIGURE 4.6: Frequency response functions developed from experimental vibration testing on poles installed in unsaturated soil

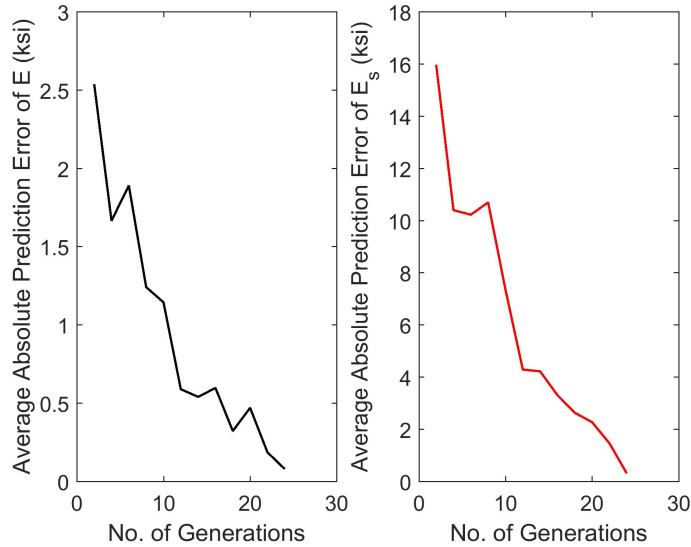
FIGURE 5.2: Average absolute prediction error for the elastic moduli of the pole and the soil with increased generations of the genetic algorithm

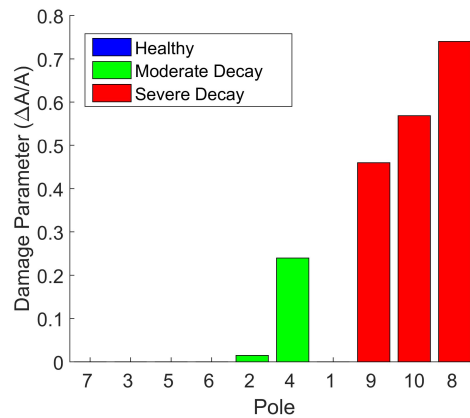
FIGURE 5.10: Damage parameter results obtained with the Rayleigh-Ritz model with explicit deterioration modeling
