THERMAL PERFORMANCE OF PRECAST CONCRETE CONNECTIONS  
EXPOSED TO FIRE

A thesis submitted to the faculty of  
The University of North Carolina at Charlotte  
in partial fulfillment of the requirements  
for the degree of Master of Science in  
Civil Engineering

JONATHAN BLACKSTONE. Thermal performance of precast concrete connections exposed to fire. (Under the direction of DR. NICOLE BRAXTAN).

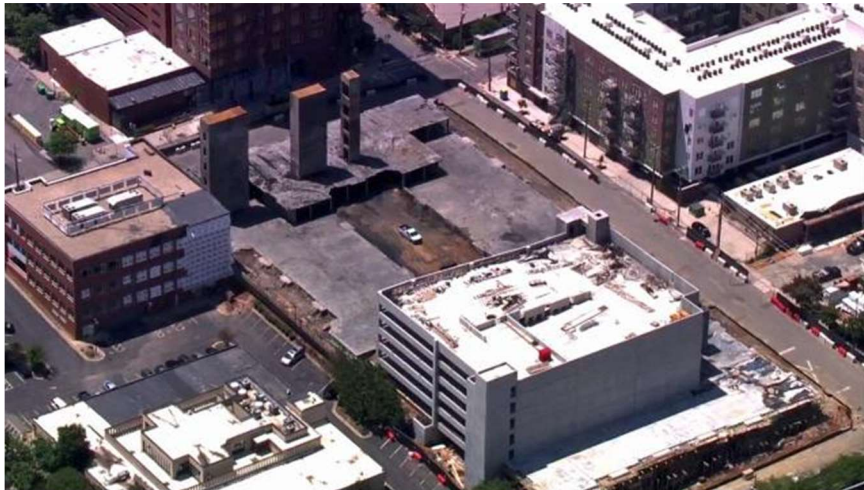
FIGURE 4.3: Post fire, remaining stairwells and parking deck (Wtvd, 2017).

structure or external. The concrete parking deck was set to be demolished and replaced to ensure structural integrity given that there was significant visible damage in the form of spalling and cracks. However, the damage from the fire was not significant enough to cause complete collapse of the structure. In other words, the structural systems in place would have generally maintained their stability, integrity, and insulation. It is important to note that the garage and apartment building were still under construction when the fire occurred. This explains why the apartment building became a singular inferno as there were little to no active or passive fire protective systems in place since the sprinkler system was not installed yet. Refer to Figure 4.1 through Figure 4.4 for the photographs of the building, fire event, and demolition.

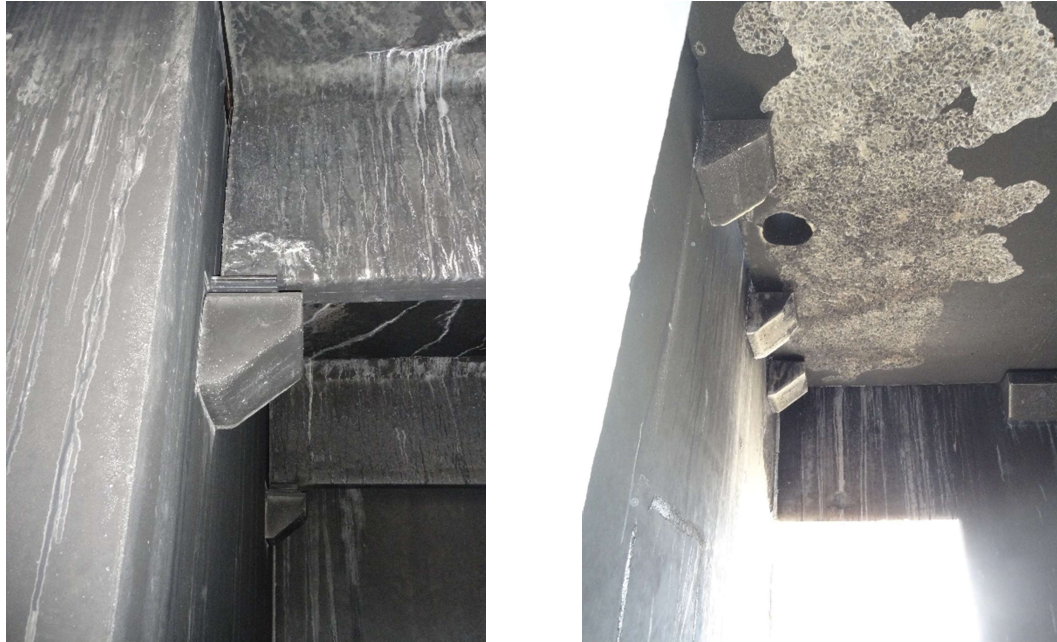
Even though the structural damage was not significant enough to cause collapse, it should be noted that the parking garage was unloaded at the time of the fire and experiencing only normal dead loads and construction live loads. Additionally, even though the fire was external to the parking deck the resulting internal temperatures of structural components throughout the deck should be considered. Those internal temperatures are critical to the overall strength and stability of the structure when considering the parking deck as fully loaded with the prescribed live load active throughout the structure. As discussed in Chapter 2, the resulting internal temperatures of structural components could lead to drastic reductions in the yield strength of steel and concrete. This raises some critical concerns when considering fully loaded parking garages experiencing adjacent building fires. Figures 4.5 and 4.6 show corbels exhibiting some of the concerns detailed in Chapter 1 regarding connecting steel elements being exposed and unprotected.

FIGURE 4.5: (a) Corbel and exposed bearing plates. (b) Ceiling spalling.

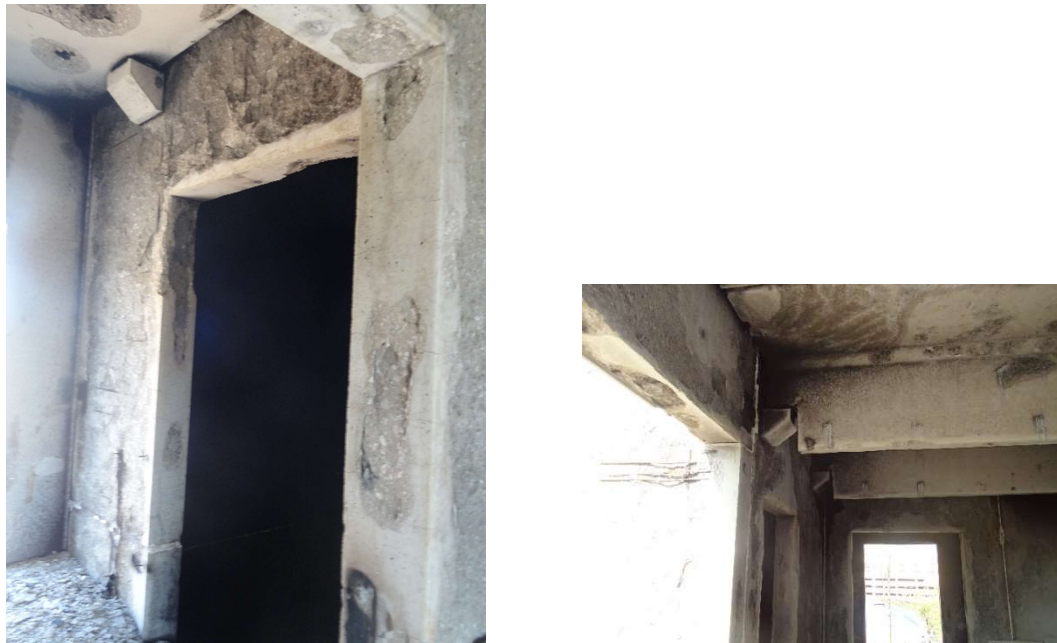
FIGURE 4.6: (a) Exposed reinforcement. (b) Corbel supporting double T joist.

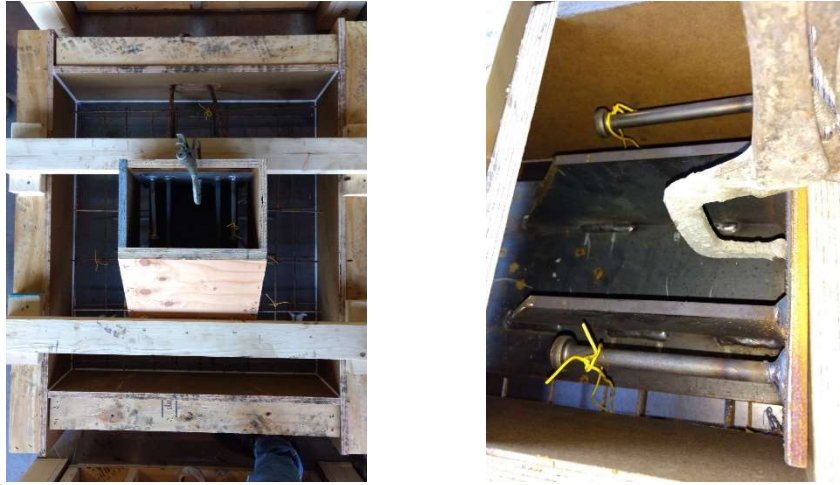
FIGURE 4.8: (a) Top down view of specimen prior to cast. (b) Interior view of corbel reinforcement.

Figures 4.8 through 4.10 document the casting process of the experimental test specimens. The NW specimens were cast on the rear face and the LW specimens were cast on the front face. For the LW specimens, the corbel was added to the specimen after casting the main wall section. It was desired to utilize three specimens for front face heating exposure. However due to different casting arrangements, it was not possible set up the

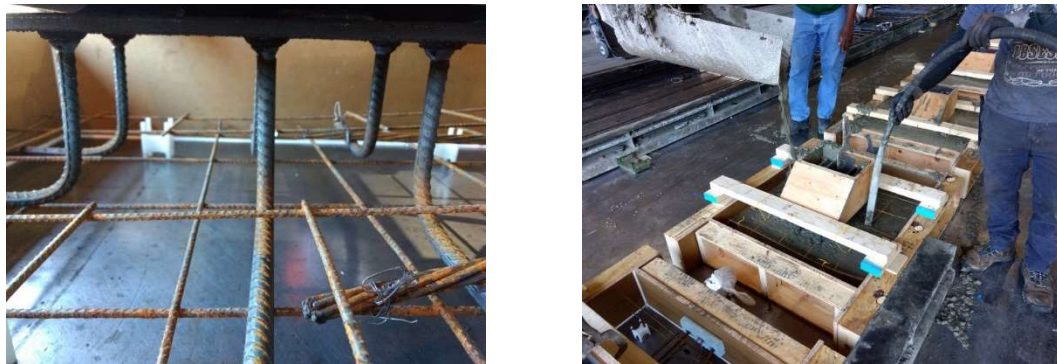
FIGURE 4.9: (a) Interior view, bent bars. (b) Pouring and vibration of specimens.

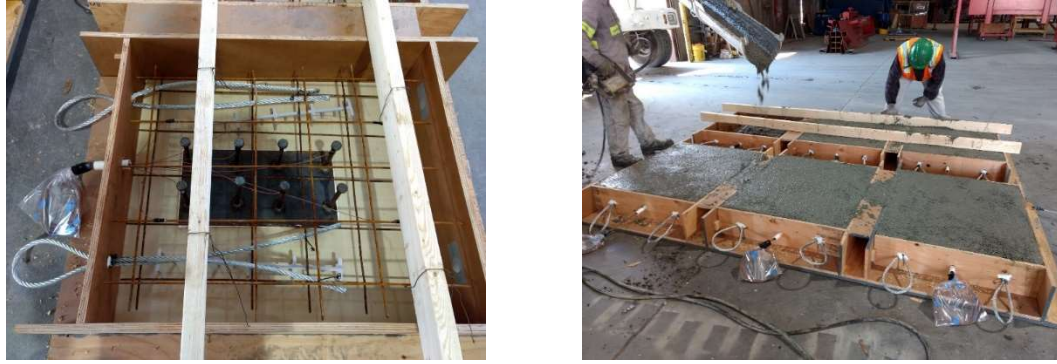
FIGURE 4.10: (a) Top down view. (b) Pouring and vibration of specimens.

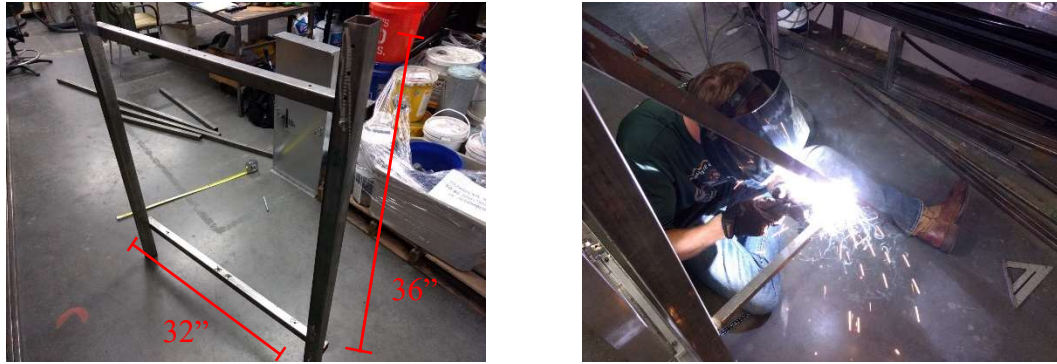
FIGURE 4.12: (a) Frame construction progress. (b) Welding of cross bars.

The concrete wall was 32" (0.8128 m) wide and 36" (0.9144 m) tall to match the width and height of two Raymax 2030 panels positioned side by side. From this, a steel frame was constructed in order to position the panels for testing. Figures 4.12 through 4.14 illustrate the frame construction process. The frame features two diagonal cross-bar connections to provide the lateral bracing. In addition, sand bags were placed on the legs to prevent overturning. Finally, the frame features multiple slots by which the elevation of the panels can be adjusted. The first slot places the panels at the height of a concrete masonry unit (CMU), for each test the specimens rested on 2 CMU blocks in order to elevate the specimen above the ground. Three holes are available above the CMU height position at 6" (0.1524 m) increments. Finally, the panels were connected to a main breaker and toggled either on or off for testing. Figure 4.14 presents photographs of the testing frame with the radiating panels installed. The panels were labeled as Panel A on the right side and Panel B on the left side.

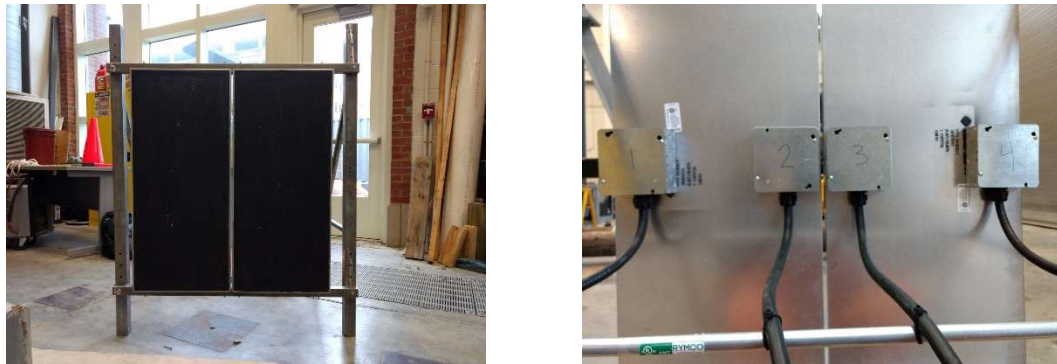
FIGURE 4.14: (a) Front view of testing frame. (b) Rear view of panels with protective connection plates.

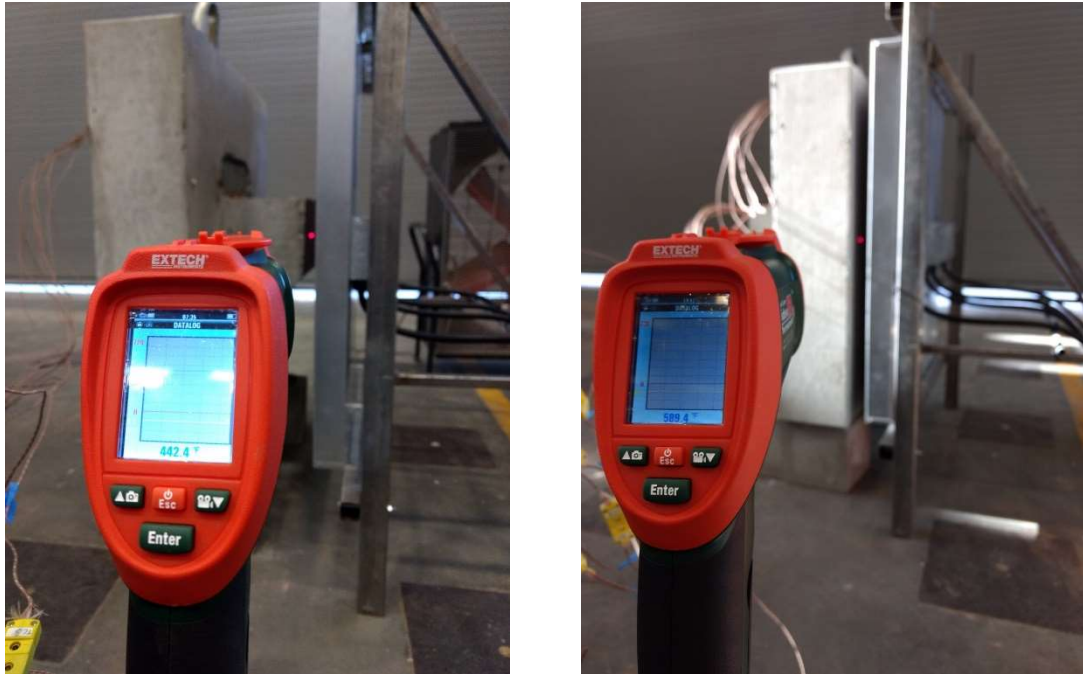
the rear wall face. The infrared camera recorded the temperature at each second throughout the duration of the test.

FIGURE 4.30: Front and rear face setups for calibration.

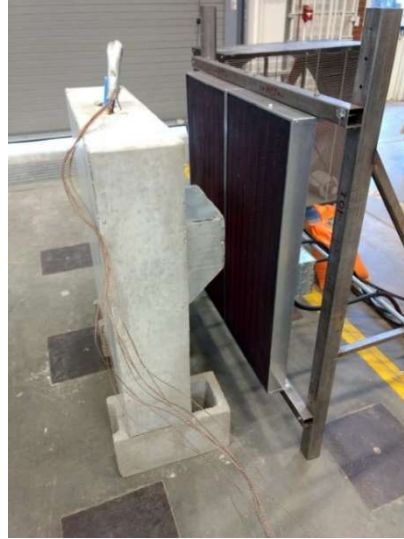
Figure 4.37 shows specimen N1 during testing with front face heating of the corbel and wall system, where the heating panel was positioned 2" (0.0508 m) from the corbel. The specimen was heated for 60 minutes and measurements for all instrumentation were taken each second.

FIGURE 4.37: Testing of specimen N1.

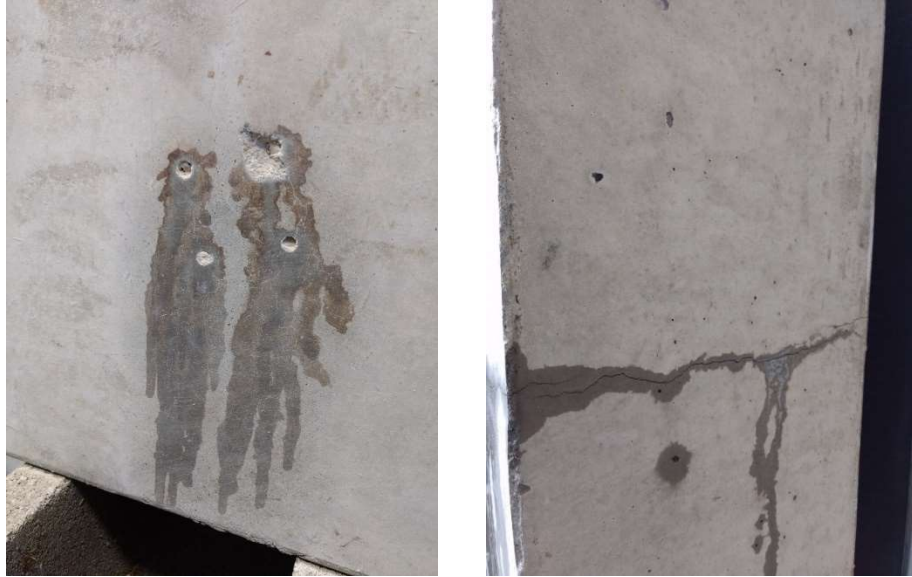
During this test, significant leakage throughout the sides and eventually the front face of the wall was observed. In addition, the plastic reinforcing chairs that remained in the specimen melted rapidly as the test began. At approximately 15-minutes into testing the reinforcing chairs melted such that the pressure from the water and plastic caused spalling on the rear face of the wall; this occurred at the location of the plastic chairs as seen in Figure 4.43. Finally, after completing the test and removing the specimen from the testing area, standard map cracking was observed on the front face of the specimen as highlighted in Figure 4.46.

FIGURE 4.43: Leakage in specimen N2: (a) Plastic reinforcement chairs. (b) Horizontal cracking.

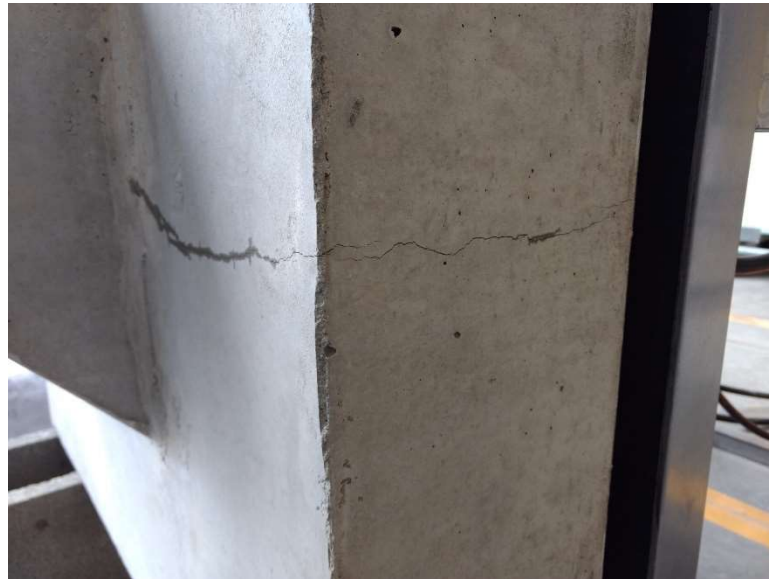
FIGURE 4.44: Specimen N2: Initial cracking and leakage, corner to front face.

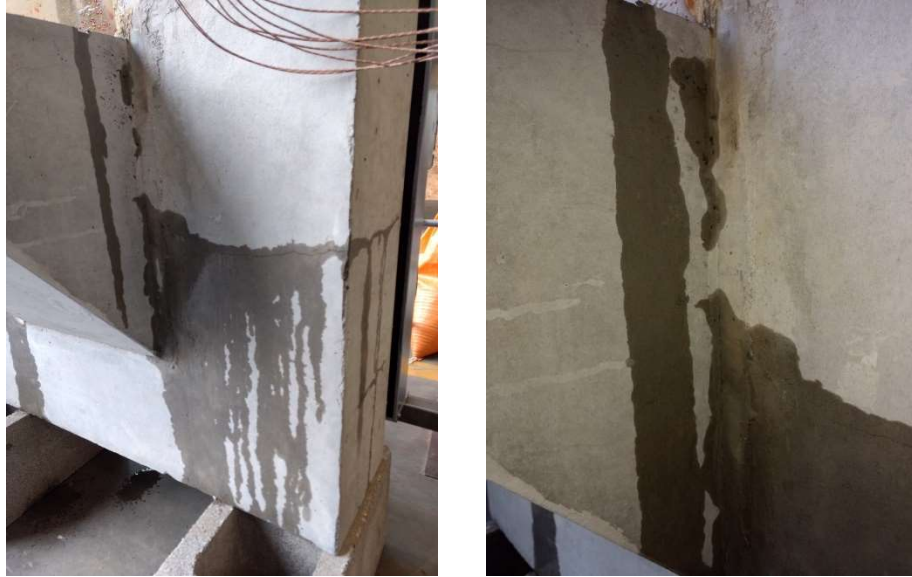
FIGURE 4.45: Specimen N2: Significant moisture leakage across specimen.

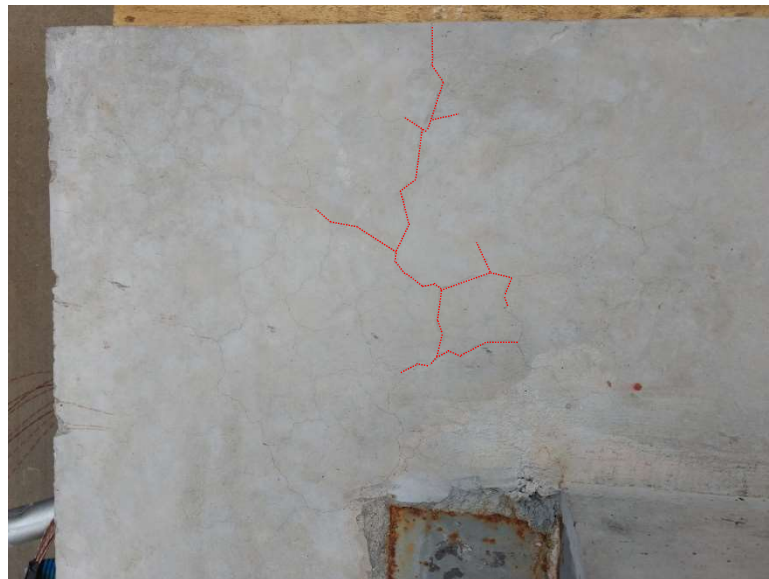
FIGURE 4.46: Specimen N2: Map cracking on corbel face after experimental test.

The most pertinent visual observations were from the rear face heating that provided consistent tiered crack formation along the sides of the specimens. On both sides of the wall, a small crack was observed within 15 minutes of testing that eventually spread across the side of the wall, on to the front face of the wall, and then towards the wall corbel interface. These observations were seen consistently throughout the rear facing tests. Refer to Figures 4.79 through 4.84 for side by side comparisons of tiered crack formation from different tests. Another consistent observation from the experimental testing was the map crack formation on the front face of the wall. This style of crack formation was observed for specimen N2, refer to Figure 4.46.

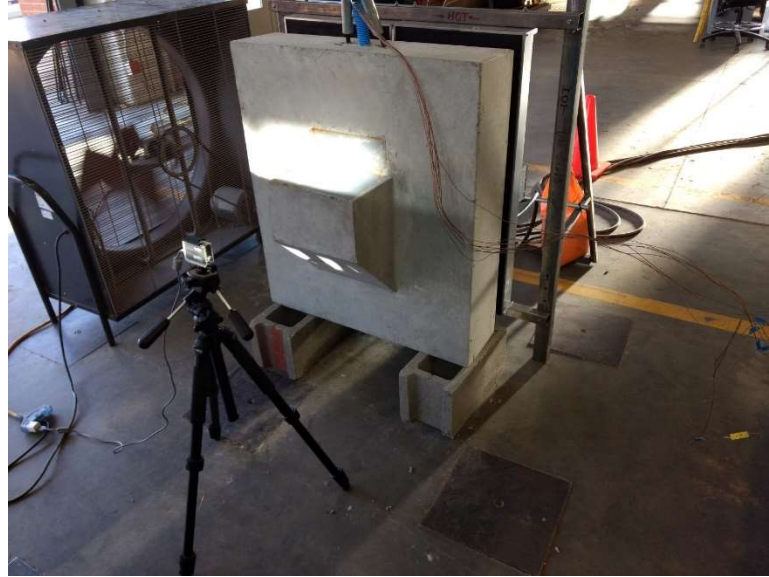
Figure 4.47 shows specimen N3, tested with back side heating of the rear face of the wall, where the heating panel was 2" (0.0508 m) from the wall.

FIGURE 4.47: Testing of specimen N3.

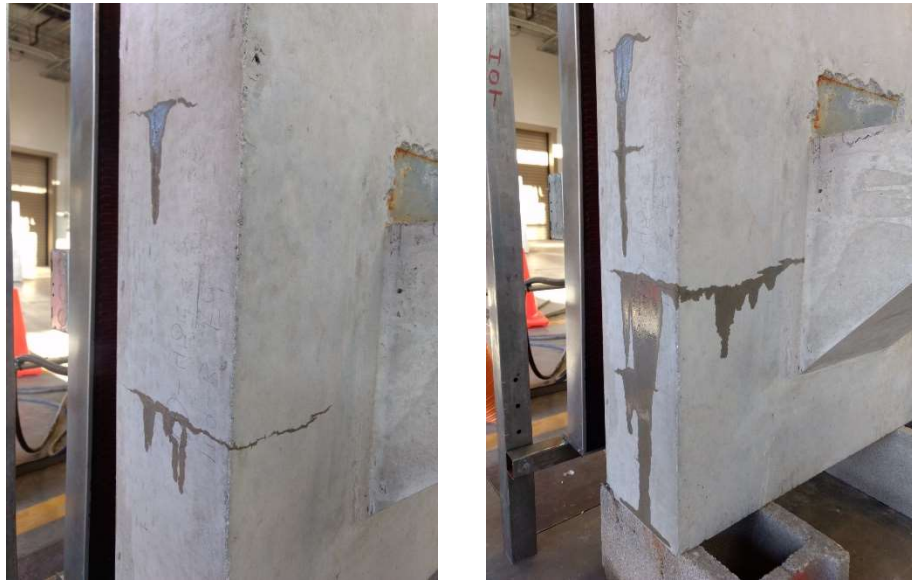
This specimen experienced cracking and leakage throughout the test comparable to specimen N2 (Figure 4.50). A discernable pattern was also observed considering the crack formation along the sides of the specimens. The horizontal cracks appear to be spaced by about 6 inches. The horizontal cracks also spread towards the front face of the wall and inwards to the corbel and wall interface (Figure 4.51).

FIGURE 4.51: Specimen N3: Formation of tiered cracking.

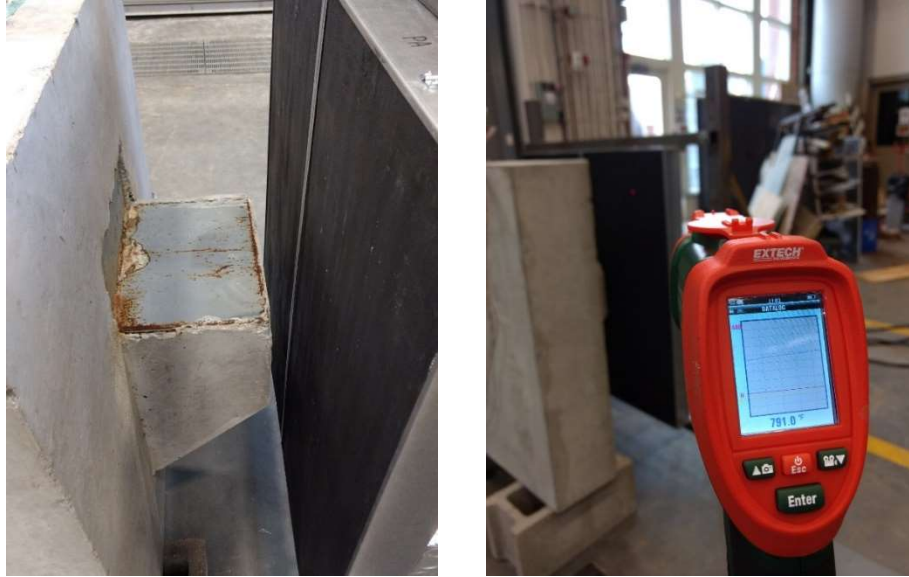
Figure 4.52 shows specimen N4 during testing with front face heating of the corbel and wall system, where the heating panel was 2" (0.0508 m) from the corbel. The specimen was heated for 60 minutes and measurements for all instrumentation were taken each second.

FIGURE 4.52: Testing of specimen N4.

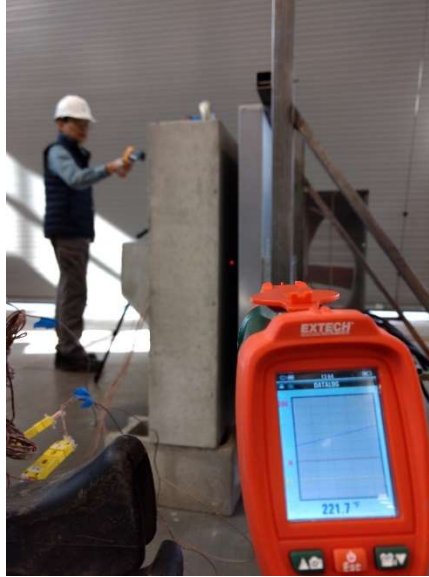
Figure 4.55 shows specimen N5, tested with back side heating of the rear face of the wall, where the heating panel was 2" (0.0508 m) from the wall.

FIGURE 4.55: Testing of specimen N5.

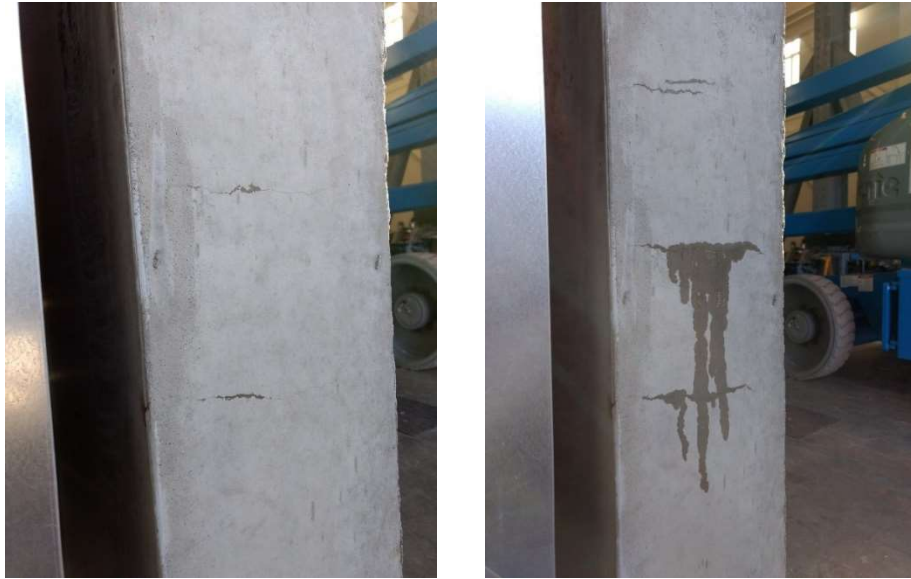
Specimen N5 was tested about the rear face of the wall. Cracking and moisture leakage occurred roughly 15 minutes into testing. A distinct cracking pattern was also observed in this test consistent with the previous rear facing experiments. The horizontal cracks appear about 6 inches (0.1524 m) above or below the previous crack, resembling a tiered or layered crack formation along both side faces of the specimen. In addition, these cracks sometimes spread to the front face of the wall and inwards towards the corbel interface. Figure 4.58 shows the cracking patterns observed.

FIGURE 4.58: Specimen N5: Formation of tiered cracking.

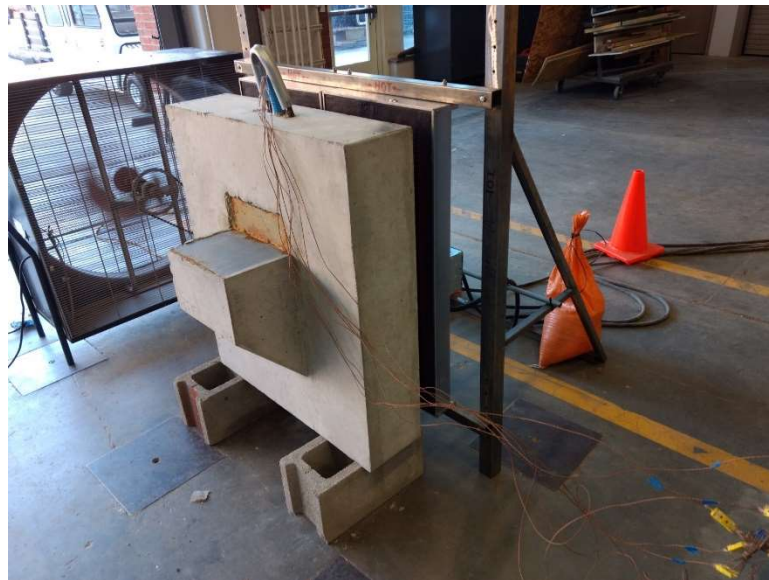
Figure 4.59 shows specimen N6, tested with back side heating of the rear face of the wall, where the heating panel was 2" (0.0508 m) from the wall.

FIGURE 4.59: Testing of specimen N6.

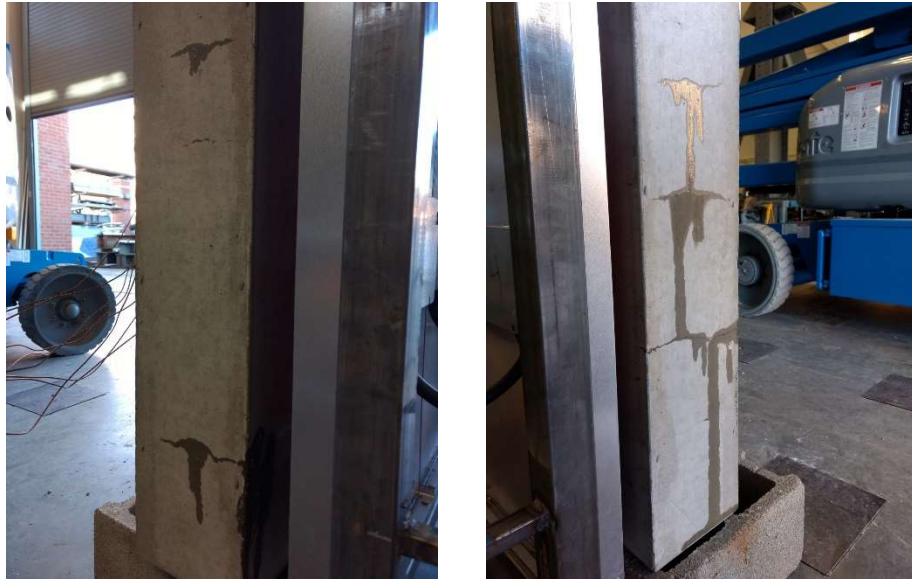
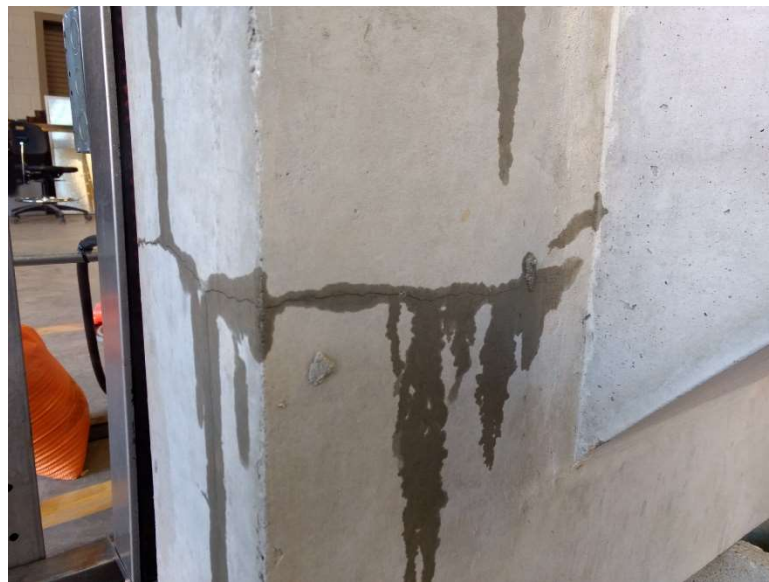
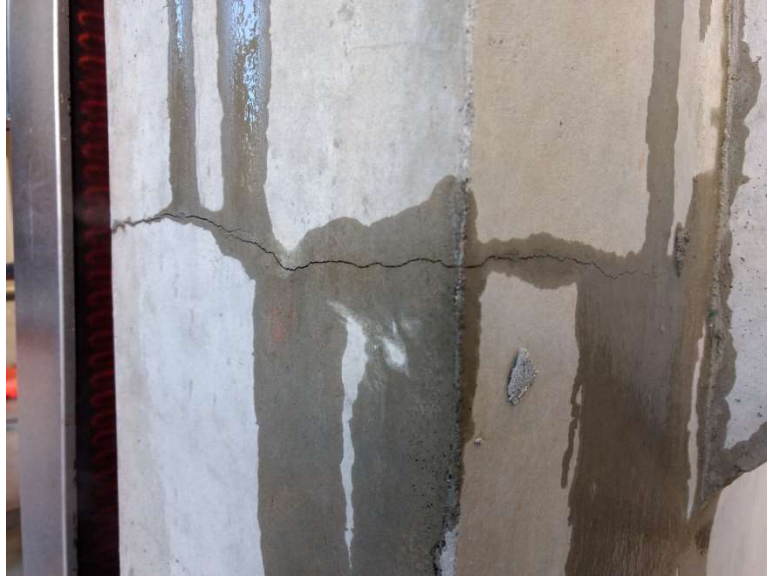
caused spalling on the rear face. Figures 4.62 through 4.64 show the crack propagation observed during the testing.

FIGURE 4.62: Specimen N6: Formation of tiered cracking.

FIGURE 4.63: Specimen N6: Cracking and leakage towards corbel and wall interface.

FIGURE 4.64: Specimen N6: Significant moisture leakage across specimen.

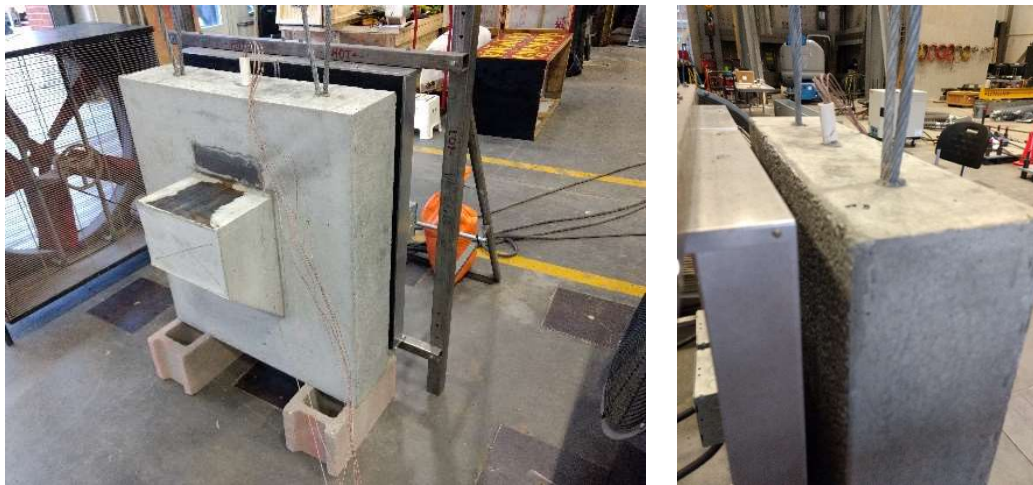
Figure 4.65 shows specimen L8 (LW) tested with back side heating of the rear face of the wall, where the heating panel was 2" (0.0508 m) from the wall.

FIGURE 4.65: Testing of specimen L8.

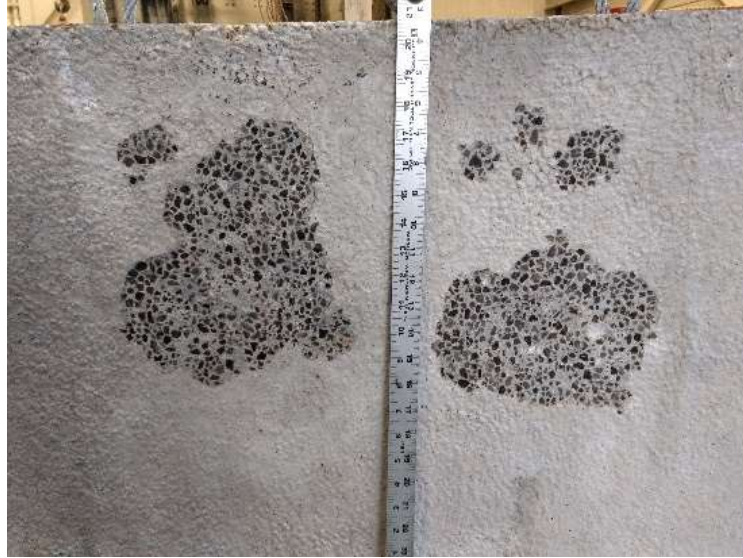
As mentioned in Section 4.2.4, the relative humidity of specimens 7-12 was approximately 95%. However, specimen L8 was not tested for the full hour duration similar to the previous 6 NW specimens. Specimen L8 experienced spalling shortly into the duration of the test. The spalling began about 5 minutes into the test and by 13 minutes was too severe, so the test was stopped in order to protect the Raymax 2030 panels from being damaged. Figure 4.68 shows the explosive spalling observed from the test.

FIGURE 4.68: Spalling damage of specimen L8.

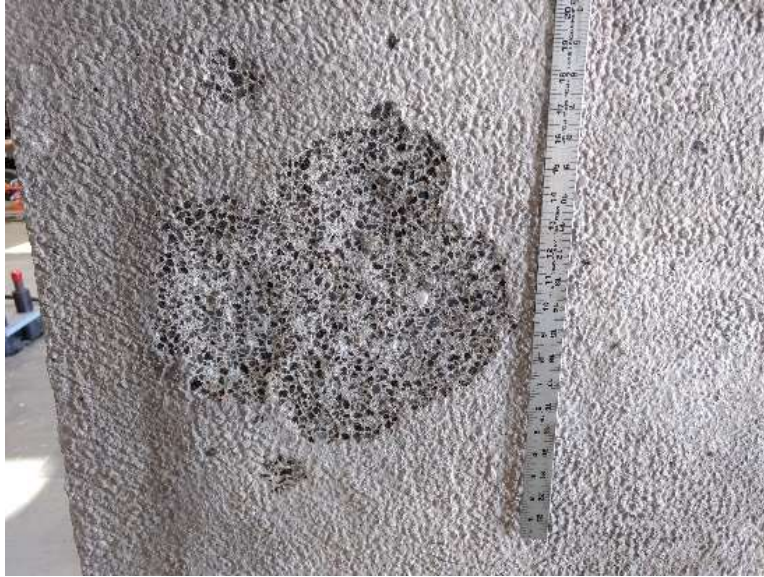
Similar to specimen L8, specimen L10 exhibited spalling on the rear face of the wall. The spalling began about 3 to 5 minutes into the testing duration and continued to increase in frequency and magnitude as the test continued. As with the previous test, at about 20 minutes, the panels were turned off and the test was interrupted in order to protect the panels. However, the spalling that occurred from both tests left several holes punctured in the ceramic face of the heating panels. The damage can be seen in the white discolorations in Figure 4.73.

FIGURE 4.72: Spalling damage of specimen L10.

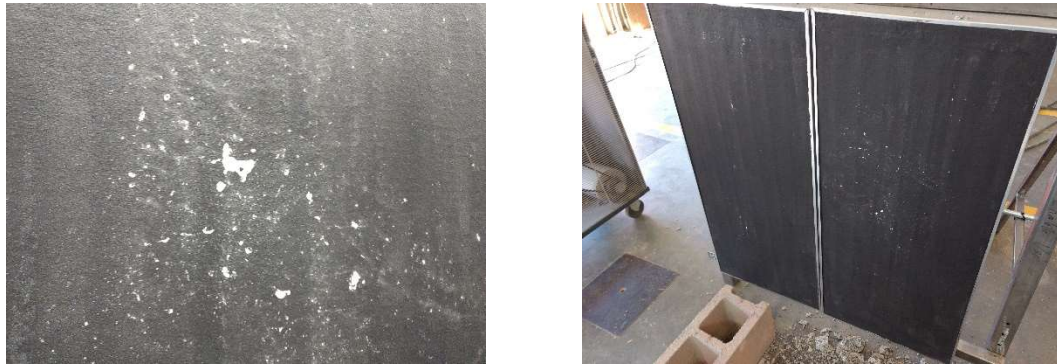
FIGURE 4.73: Raymax 2030 panel damage from spalling.

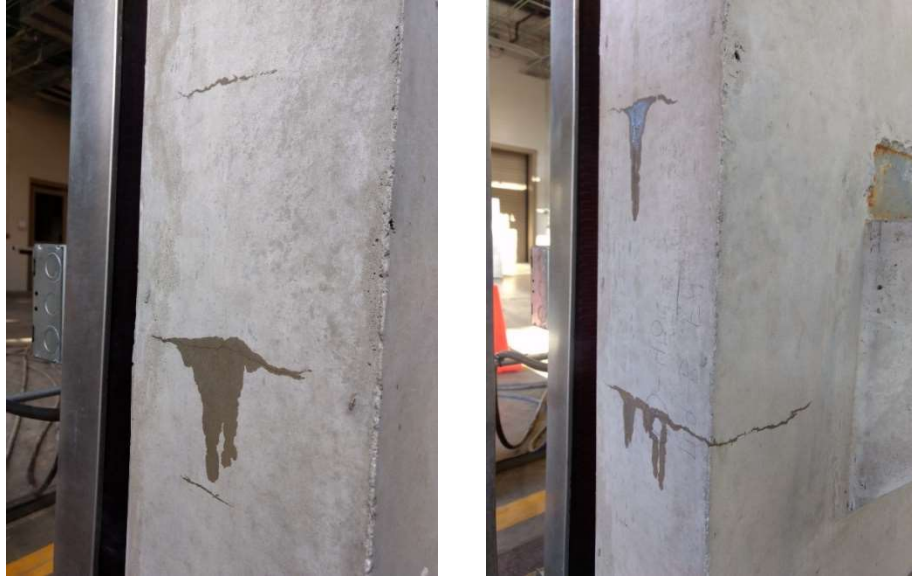
FIGURE 4.79: (a) N2 at 30 minutes. (b) N3 at 30 minutes.

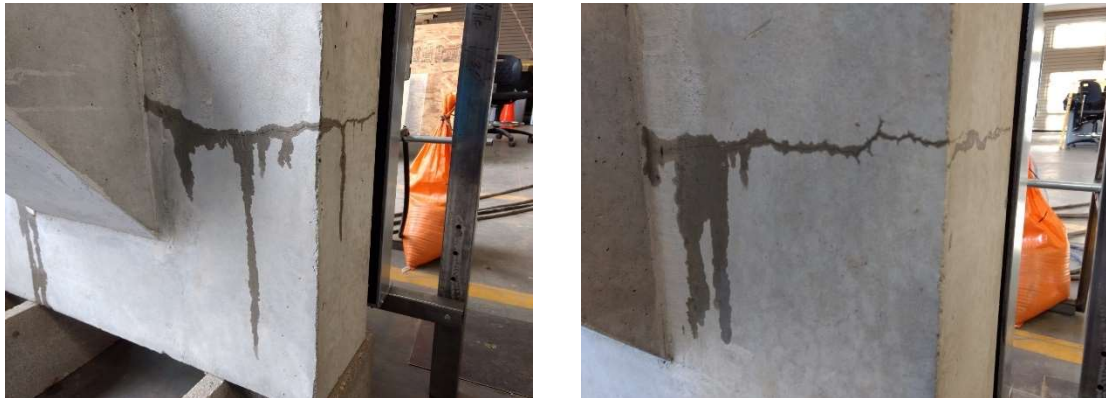
FIGURE 4.80: (a) N2 at 45 minutes. (b) N3 at 45 minutes.

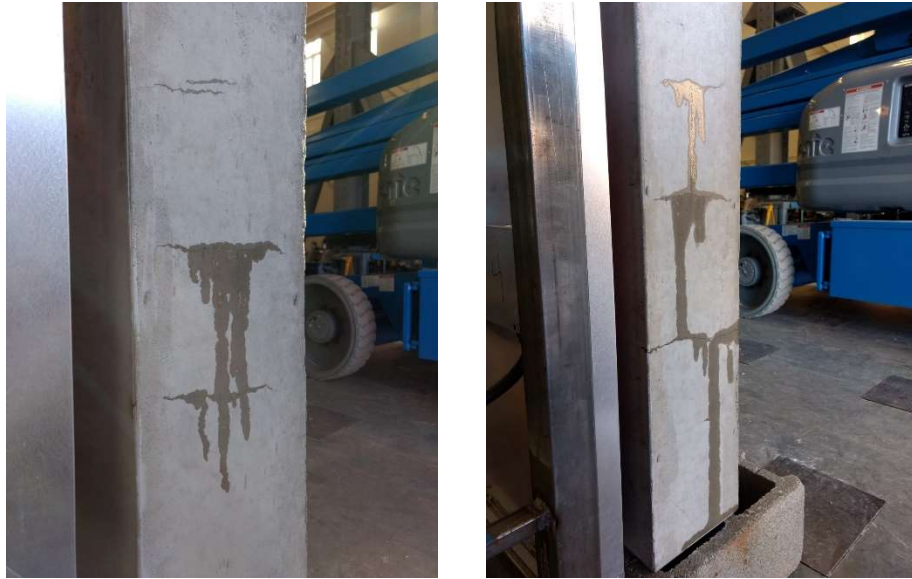
FIGURE 4.81: (a) N5 at 30 minutes. (b) N6 at 30 minutes.

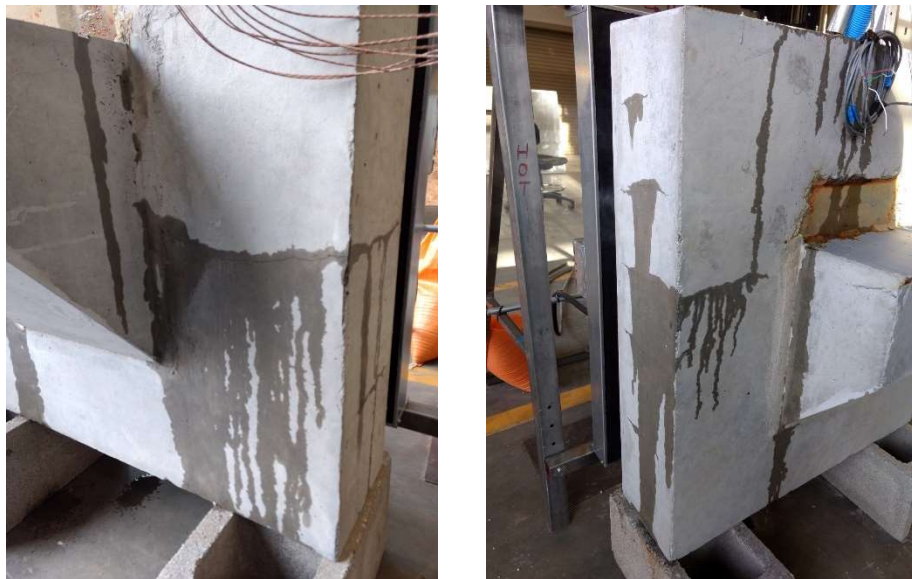
FIGURE 4.82: (a) N2 at 45 minutes. (b) N5 at 45 minutes.

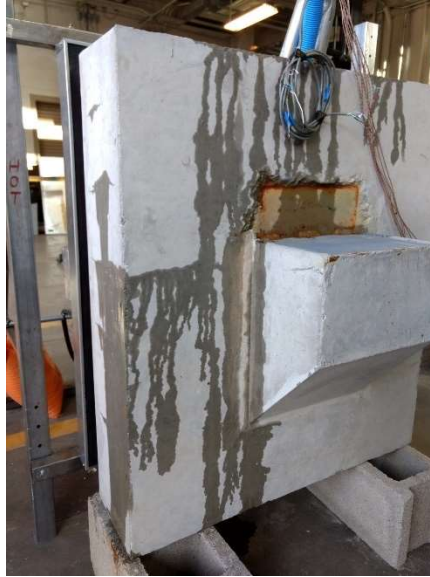
FIGURE 4.83: Full test duration cracking and leakage, N5.

It is important to remember that the NW specimens were tested at 85% moisture content. Considering an optimal moisture content for testing, these specimens possess more water than the 50-75% preferred by ASTM E119 under Section 6.2.1. The water within the specimens likely pooled or collected around the locations of the rear reinforcing mesh and either the bent or headed bars. During the duration of the test, the heat radiated from the panel drove the moisture out of the specimen towards the sides, as seen from the previous figures. Eventually those cracks spread towards the front of the wall and ultimately on to the corbel itself. This could raise significant concern for a full-scale adjacent building fire, where corbels on the opposite side of structural columns or walls are exposed to heat from behind. As the following figures display, cracks and moisture will develop between the corbel and wall interface without originating from the tiered cracking observed on the sides of the wall. This experimental fire scenario simulated a relatively low temperature fire, 563 °C, for only a 1-hour duration. Assuming that ASTM E119 represents a comparable fire scenario, strictly concerning maximum temperatures and a full fire duration, the

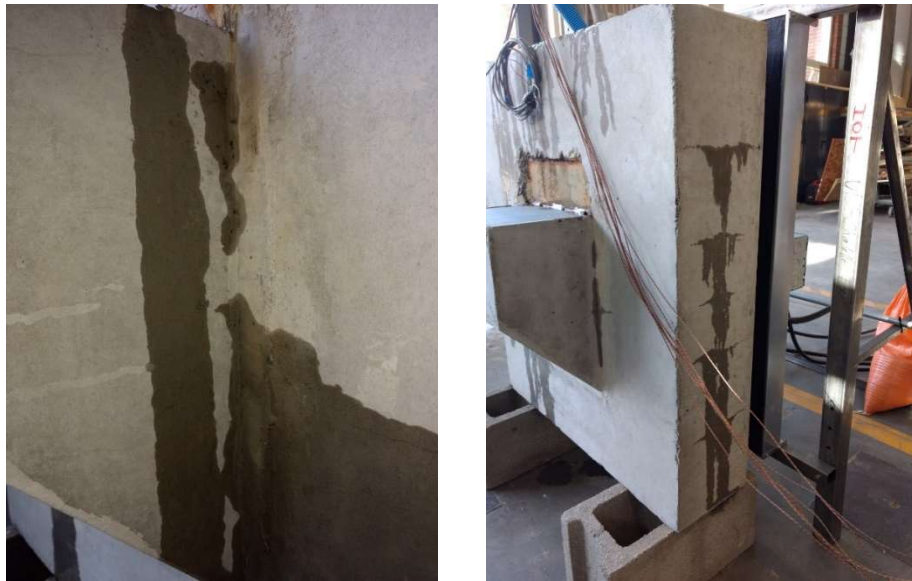
experimental fire scenario completed is of much smaller scale. There should be reasonable concern for concrete corbels that are not directly in a structural fire but are exposed to an external fire and therefore become susceptible to the increase in temperature, which leads to the formation of cracks and escape of moisture.

FIGURE 4.84: (a) Isolated corbel cracking, N2. (b) Isolated corbel cracking, N5.
