AN INVESTIGATION OF STRUCTURED LIGHT SCANNER CALIBRATION
DEGRADATION

A thesis submitted to the faculty of
The University of North Carolina at Charlotte
in partial fulfillment of the requirements
for the degree of Master of Science in
Mechanical Engineering

2020

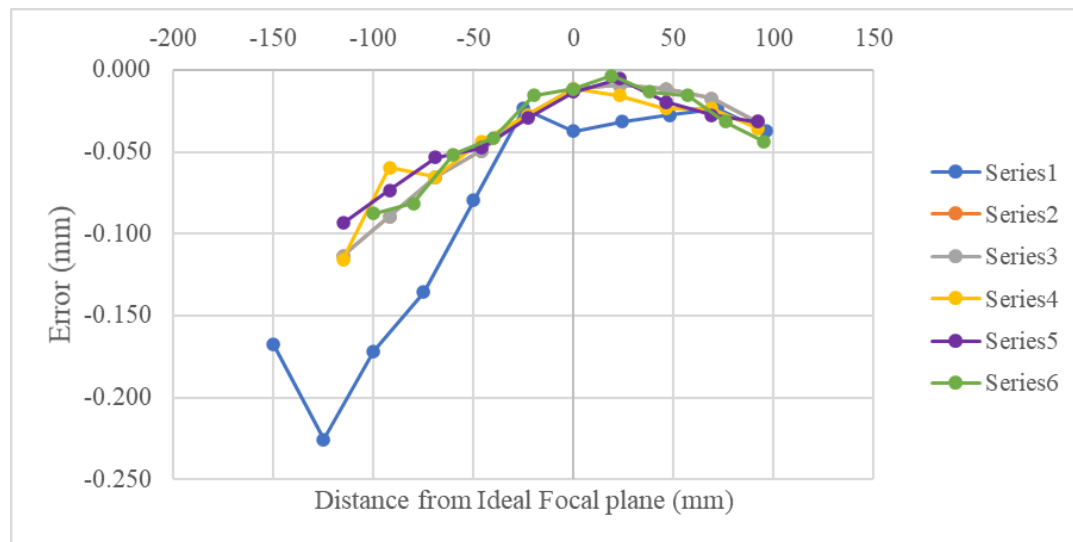
FIGURE 3-1: Calibrated Sphere Results

A previous experiment briefly explored this distortion was conducted for a different research experiment. The basics of the experiment was that a precision matte tooling ball was scanned at a variety of depths through the measurement volume. This experiment was repeated once at the beginning of the first day and again at the end of the day. It was also repeated at a partial way through the week, at the end of the week, and one week later. The results can be seen in FIGURE 3-1.

Series1 was scanned approximately four weeks after a calibration. Series2 and Series3 were both on the same day of the calibration Series2 directly after and Series3 at the end of the day. Series4 was at the end of the second day, Series5 after 4 days and Series6 after a week.

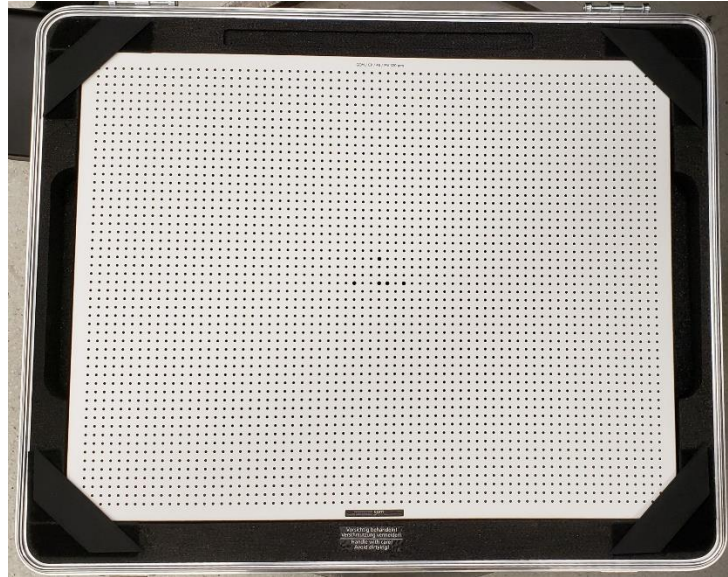
FIGURE 4-2: Calibration Dot Plate

The calibration procedure is rather straightforward. The system is oriented perpendicular to the calibration dot plate and scanned at 12 different heights and at 6 more angled positions. The calibration dot plate can be seen below in FIGURE 4-2.

The dot plate has 5 larger targets in the center used for making sure the scanner is focused on the center of the plate. Three images of the calibration orientations can be seen in APPENDIX A.

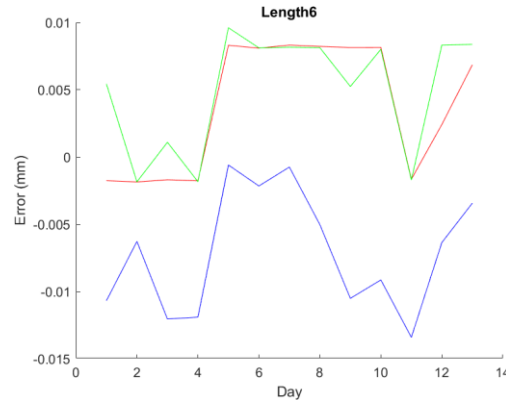
FIGURE 6-4: Experiment 1 Length 6

trends of the length errors. The length errors can be seen in APPENDIX C. An example of one of the length errors plotted against time can be seen below in FIGURE 6-4.

This plot was chosen to show the trend of having a peak for a couple of days during the middle of experiment. While looking at the length errors in conjunction with the environment plots it seems that there may be some relation to the pressure or an inverse relation to the relative humidity. The partial pressure of humidity was also calculated, and the errors were plotted against those as well. This was to better determine if there was a relationship between the humidity and the errors. The colors correspond to the positions in the measurement volume, red is the close position, green is the middle position, and blue is the far position. If there is a relation it will be easier to see in FIGURE 6-5, FIGURE 6-6, FIGURE 6-7, and FIGURE 6-8.

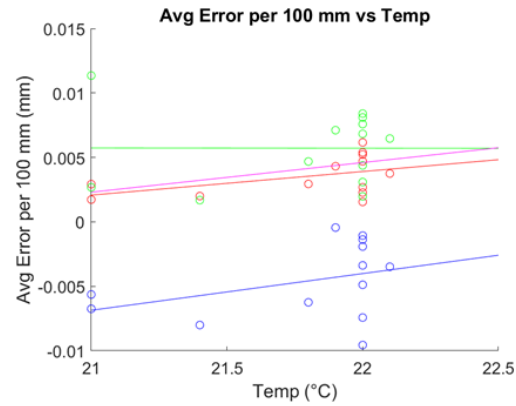
FIGURE 6-12: Experiment 1 Normalized Error

The errors were also normalized to a single length of 100 mm and plotted against temperature. Linear best fit lines were found whose color correspond to their data and the expansion for aluminum at 100 mm was also plotted in magenta. This can be seen below in FIGURE 6-12. The slopes for the lines can be found in **Error! Reference source not found..**

measurements. Also, if the humidity changes it would also affect the measurements, just not as much as temperature would. When considering the best fit slopes, the data is inconclusive to if there is a relation. When looking at experiment 1 or 3 it one might be able to justify a relationship. When taking into account experiments 2 and 4 the slopes are too different to suggest a relationship.

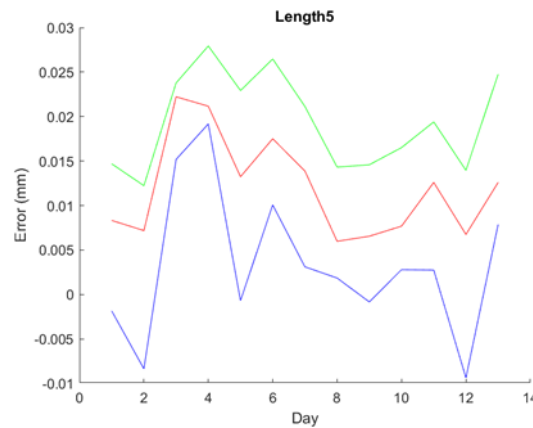
FIGURE 6-16: Experiment 2 Length 5

There doesn't seem to be much of a relationship with the environment besides an inverse relationship with the relative humidity of the environment. The correlation charts can be seen in FIGURE 6-17, FIGURE 6-18, FIGURE 6-19, and FIGURE 6-20.
