LABORATORY VALIDATION AND INITIAL FIELD EVALUATION OF A
VIBRATION-BASED TECHNIQUE FOR CONDITION ASSESSMENT OF
TIMBER UTILITY POLES

A thesis submitted to the faculty of
The University of North Carolina at Charlotte
in partial fulfillment of the requirements
for the degree of Masters of Science in
Civil and Environmental Engineering

STEVEN DULIN. Laboratory Validation and Initial Field Evaluation of a Vibration-Based Technique for Condition Assessment of Timber Utility Poles.
(Under the direction of DR. MATTHEW J. WHELAN)

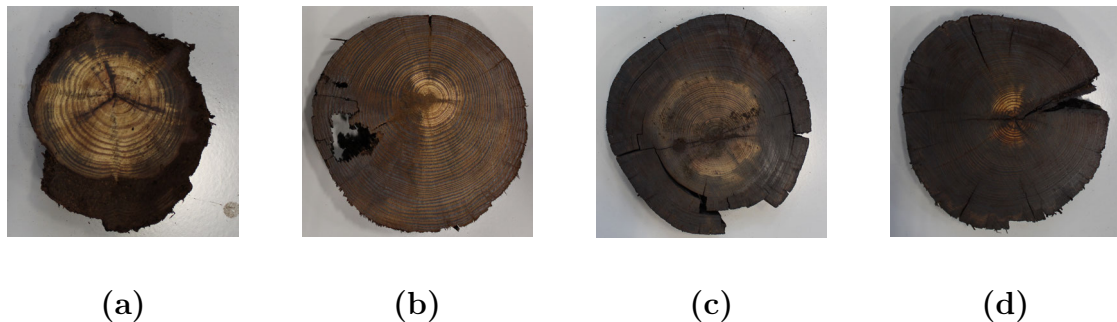
FIGURE 1.1: Common types of cross section damage: (a) shell rot (b) pocket rot (c) shake (d) checking; heart rot not pictured

The National Electric Safety Code (NESC) specifies that a timber utility pole must retain $2/3$ of its original design strength to remain in service (Rural Utilities Service, 2013). Utilities must regularly inspect and maintain pole systems, and they must remove and replace poles that have declined below the strength requirements specified by the NESC (Rural Utilities Service, 2013; Morrell, 2008; Mankowski et al., 2002). Decay in the cross section of the pole is the primary reason for the removal of timber poles from service (Morrell, 2008). Decay and other damage to the cross section are typically classified into one of five categories: shell rot, pocket rot, heart rot, ring shake, and checking (Figure 1.1). Shell rot is decay that develops in the outer

layers of the cross section of the pole. Pocket rot is decay that develops within the cross section. Heart rot is a special case of pocket rot where the decay develops in the heartwood of the pole. Ring shake occurs when the growth rings of the pole separate from each other. Checking occurs when the sapwood of the pole shrinks around the heartwood of the pole, causing radial cracking from the outer surface to the center of the cross section. Shell rot and shake are of particular concern, since these forms of damage compromise the outer layers of the cross section of the pole, and therefore, have a dramatic effect on the bending strength of the pole. Checking does not have a significant direct effect on the bending strength of timber poles (Wood et al., 1960).

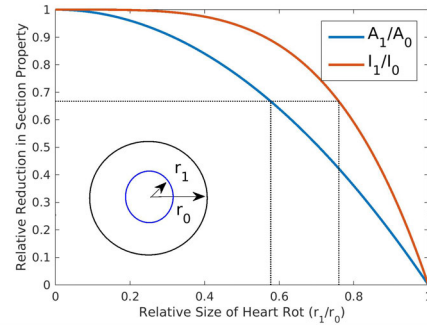
FIGURE 2.2: Relative reductions in cross sectional area and moment of inertia associated with decay. a) Shell rot; b) Heart rot

is most debilitating to the flexural strength of a pole and is, therefore, the type of decay that is typically of most concern. The effects of shell rot and heart rot on the sectional properties of a circular cross section are shown in Figure 2.2. As the size of the damaged area in a cross section increases, the cross sectional area and second moment of area of a pole decrease rapidly due to shell rot. The strength of the pole falls below design strength requirements when decay affects just 10-20% of the radial dimension of the cross section of the pole. Heart rot, by contrast, must affect 55-60% of the radial dimension of the cross section in order to reduce the strength of a pole below design requirements.

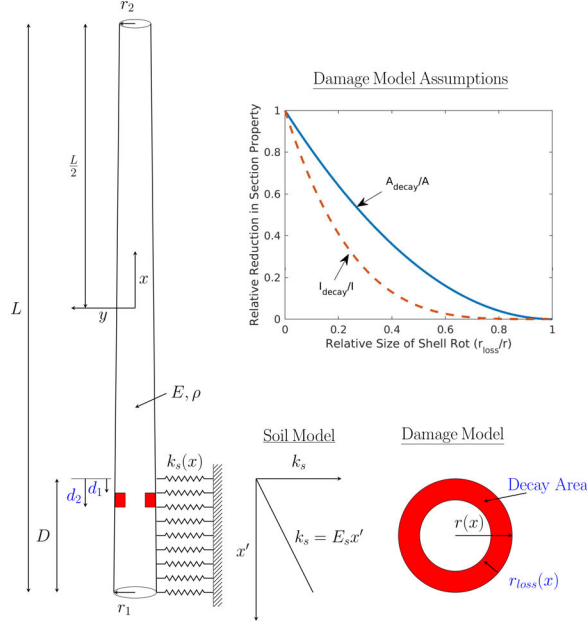
FIGURE 2.4: Rayleigh-Ritz Model with decay parameter, DP (Barber, 2016)

as well as sinusoids for the higher order terms. A total of 250 basis functions were used to develop the Rayleigh-Ritz model using precalculated integrals in a MATLAB routine to provide for solution of natural frequencies of the model in approximately 1/20 of a second.

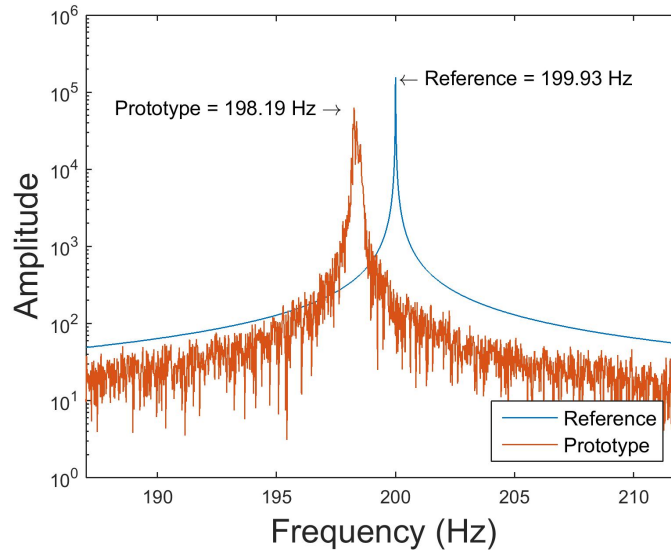
FIGURE 3.9: Windowed frequency spectra obtained from measurement of steady-state harmonic motion at 200 Hz

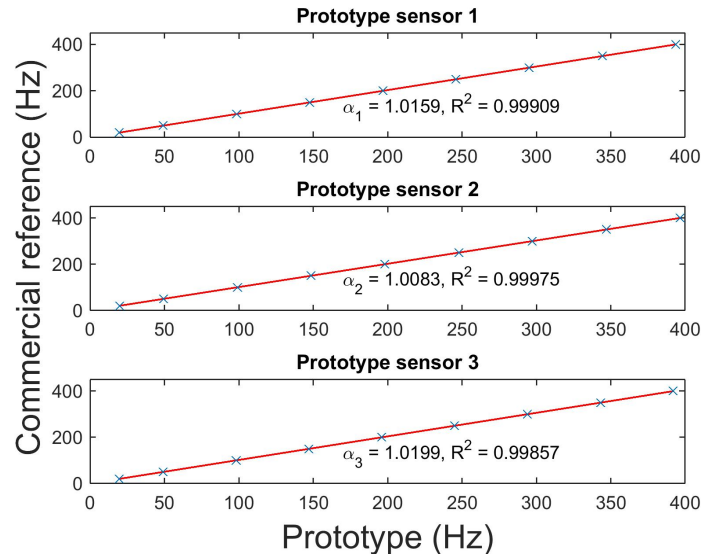
FIGURE 3.10: Linear regression of correction factors for the three prototype accelerometers developed in this study.

ble for the discrepancies in time and frequency measurements. The correction factors for each prototype were calculated using linear regression with the y-intercept constrained to zero (Figure 3.10). Constraining the linear regression to pass through the origin permits the correction of frequency estimates through a single scalar multiplier applied to the sampling clock of the prototype sensor. Correction factors for each of the three accelerometers were greater than one, which indicates that all clocks were faster than the reference clock, and the worst error in the sampling rate of the clocks was approximately 2%. The R^2 values for the linear regressions for Prototypes 1, 2, and 3 were 0.99909, 0.99975, and 0.99857, respectively, which indicates that a linear correction factor is suitable over the range of frequencies tested. Comparison of measured time histories (Figure 3.11) and frequency response functions (Figure 3.12) after the compensation for the differences in clock frequency was applied reveal strong correlations between measurements obtained with the developed prototype and the

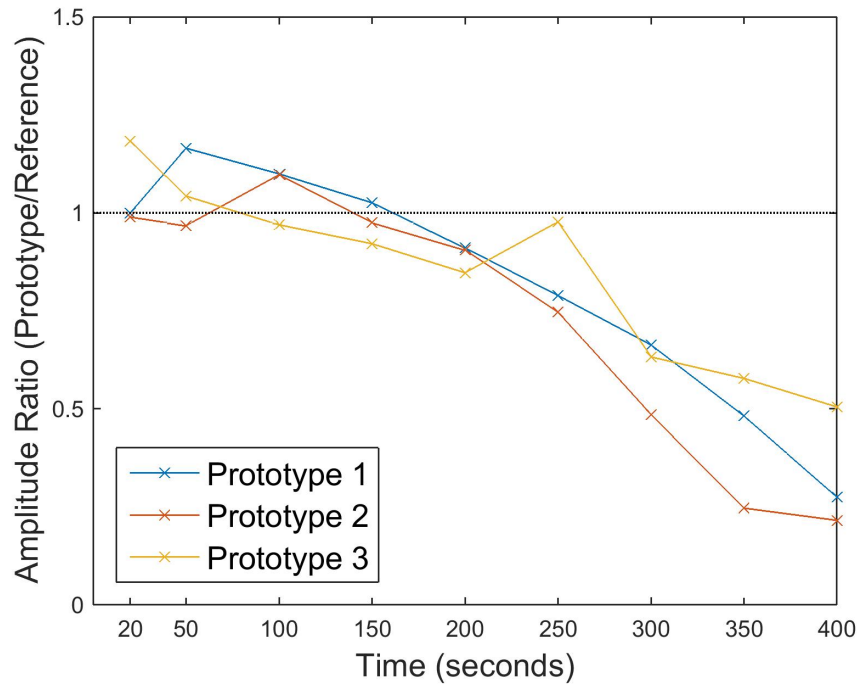
FIGURE 3.14: Discrepancy in acceleration amplitude measured by prototype system and commercial reference system during laboratory performance characterization

of this amplitude discrepancy. Since the ultimate goal of the measurement system is only to estimate natural frequencies, differences in the acceleration amplitudes are not a concern and the amplitude loss does not appear to affect the accuracy of the frequency estimates. However, if the discrepancy is a result of electrical filtering in the accelerometer or other performance limits of the sensor, then a higher quality accelerometer may be needed for the prototype to reliably detect the higher natural frequencies of in-service utility poles.

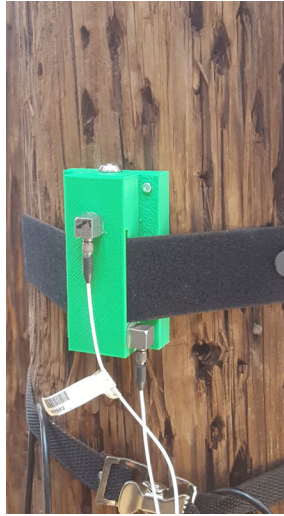
FIGURE 3.15: Photograph of prototype installation on timber pole with cable-based accelerometers installed on the case of prototype for reference measurement

Reference accelerometers were attached to the prototype case with hot glue to allow for acquisition of simultaneous measurements from both the prototype sensor and the commercial measurement system (Figure 3.15). The reference accelerometers were attached to measure vibrations along orthogonal axes, which may differ if the pole cross section is asymmetric or there is decay in the pole. The orientation of the prototype and reference sensors in relation to these axes and the pole cross section are depicted in Figure 3.16. Validation measurements were obtained using two separate configurations. In the first configuration, the prototype was secured to the surface of the pole along axis 1. In the second configuration, the prototype was secured along axis 2. In both configurations, the elevation of the prototype was six feet above grade following the recommendation developed in Barber (2016). The pole testing procedure was the same for both sensor orientations and consisted of a total of 15 impulse excitations, or strikes, performed on each of the ten poles. Acceleration data was measured for four seconds following each strike. Strikes 1-5 oriented the hammer to excite vibration modes primarily along axis 1, strikes 6-10 excited vibration modes along axis 2, and strikes 11-15 excited vibration modes along axis 3, which is 45 degrees between axes 1 and 2.

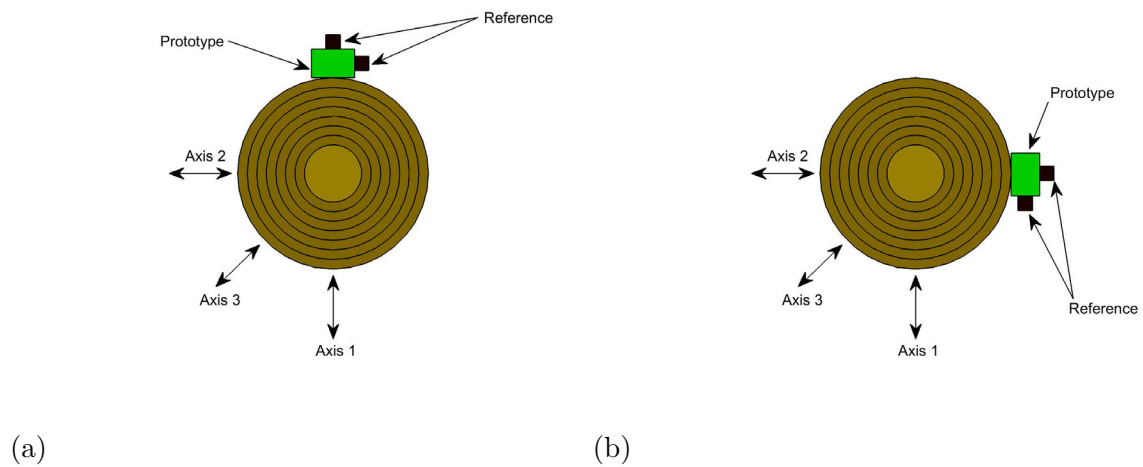
FIGURE 3.16: Prototype orientation relative to pole cross section a) Orientation 1; b) Orientation 2

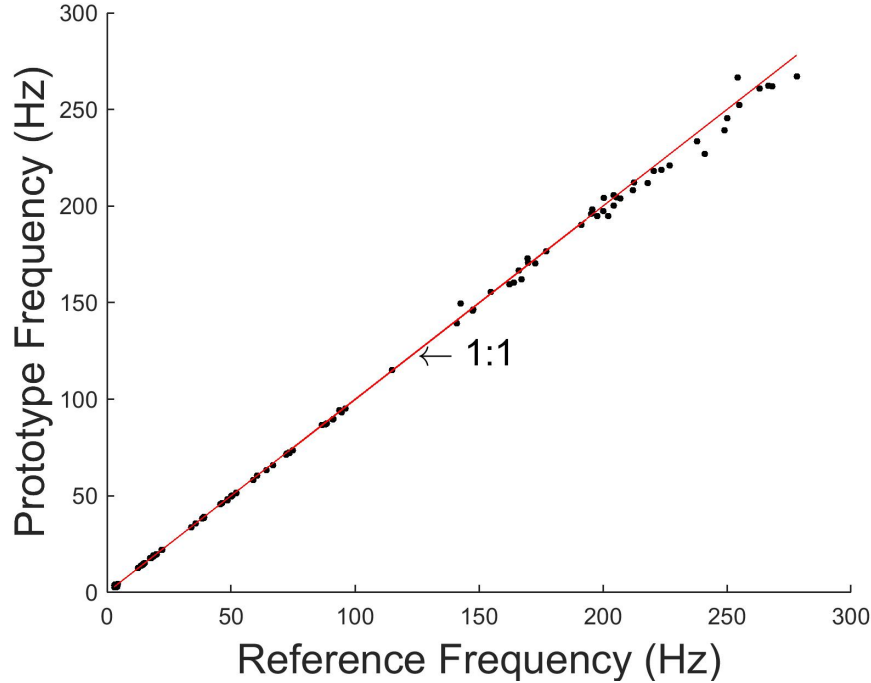
FIGURE 3.17: Comparison of frequency predictions obtained from prototype and reference systems based on concurrent measurements

deemed to be able to reliably estimate frequencies within 3.7% of the value predicted by the reference accelerometer with 95% confidence.

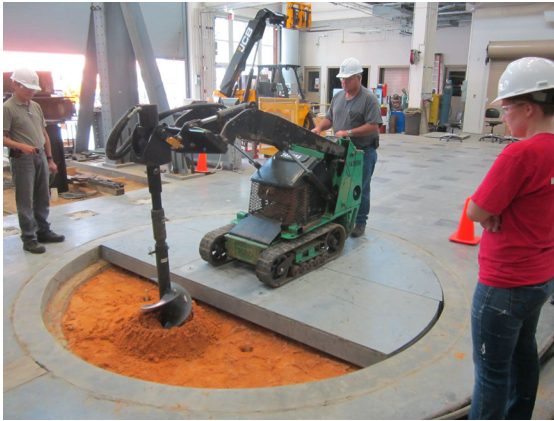
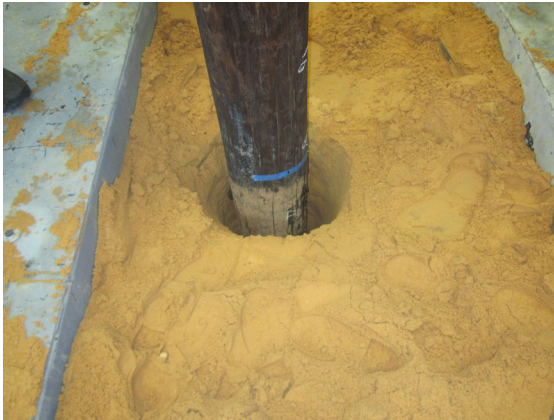
FIGURE 4.1: Preparation of experimental test pit for pole installation: a) augering of hole to embedment depth, b) placing pole to mimic field condition, c) set of ten poles installed in test pit

Following on the initial research performed by Barber (2016), a set of ten additional timber utility poles were embedded in the same poorly-graded sand in the cylindrical, concrete-lined geotechnical test pit used in the original research. Holes for pole installation were augured using a four foot long, 16 inch diameter auger bit and bit extension (Figure 4.1a). Laboratory embedment depths were set to match the field embedment depths of the pole by using the presence of residual soil, coloring of the pole, and presence of any plugs from prior inspection to identify the location of the ground line. An overhead crane was used to lift the poles and install them in the augured holes (Figure 4.1b). A photograph of the complete experimental test setup with all 10 poles installed in the test pit is provided in Figure 4.1c. The height, base circumference, top circumference, and embedment depth were measured before the poles were installed (Table 2). The poles were numbered from 11 to 20 since they supplement the original set of 10 poles tested in Barber (2016). The extent of decay in the region below the groundline varied across the set of 10 poles tested. The external appearance of the embedded portion of the poles is shown in Figure 4.2, and qualitative descriptions of the health of the embedded portions of the poles in the second set are given in Table 3. In general, the severity of the decay in the poles with the most significant section loss did not appear to be as severe as the three poles with the most severe section loss in the original study, although several of the poles did have advanced section loss.

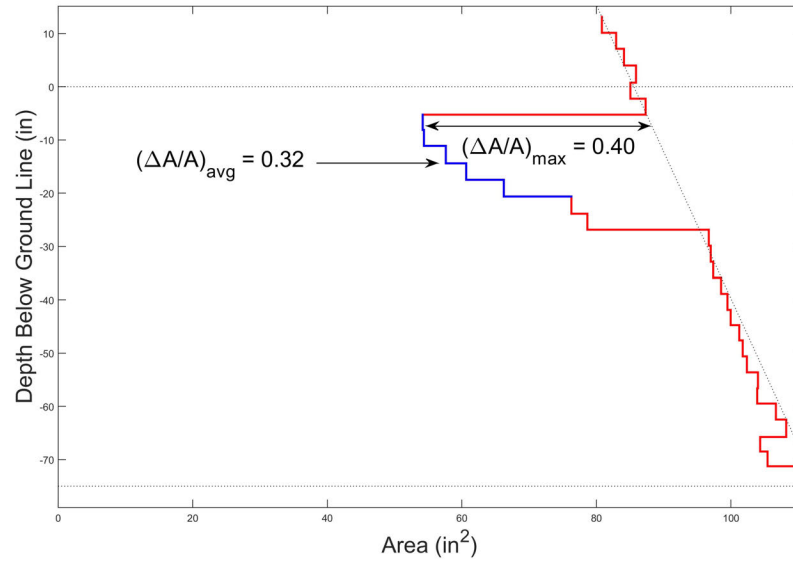
FIGURE 4.4: Calculation of maximum and average loss in the cross section from 6 to 18 inches below ground

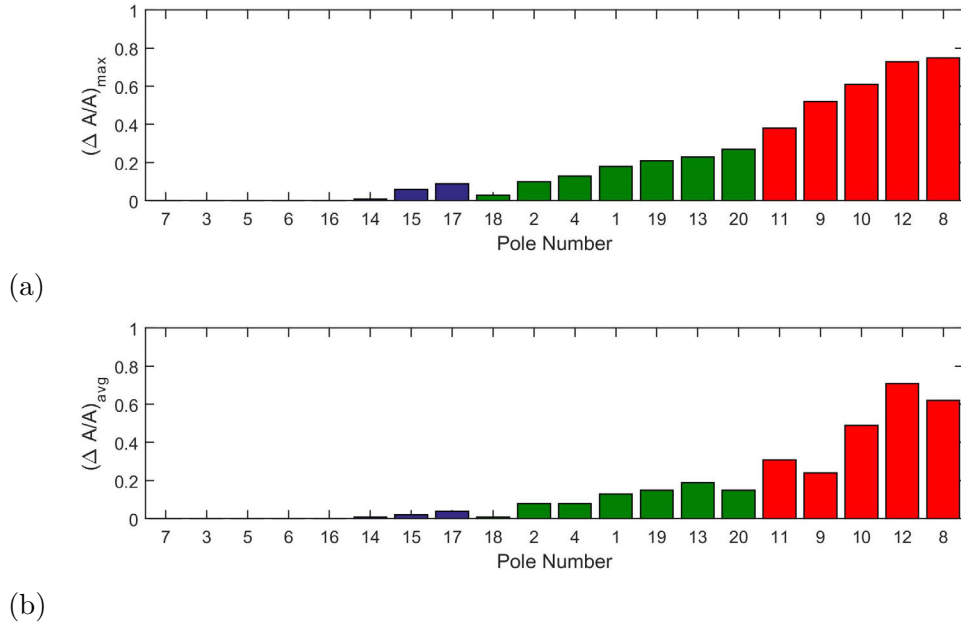
FIGURE 4.7: Loss in cross section of poles calculated as: a) $(\frac{\Delta A}{A})_{max}$ b) $(\frac{\Delta A}{A})_{avg}$

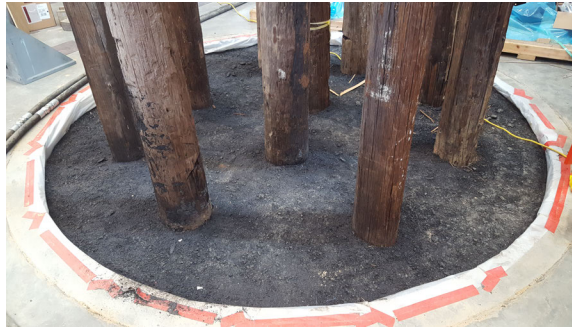
FIGURE 4.20: Asphalt encasement of the second set of ten poles in the experimental test pit

placed in the test pit to encase the set of timber poles at the ground line. The previously described condition assessment procedure is repeated on the poles encased in asphalt, and the performance of the method is evaluated through comparison with the results of the initial laboratory validation testing. Finally, an initial evaluation of the ability of the method to produce accurate natural frequency estimates from vibration measurements of in-service poles is performed. A field validation procedure is developed, and poles scheduled for immediate removal are tested. The frequency spectra and estimated natural frequencies of the poles are analyzed to evaluate the reliability of the vibration measurements.

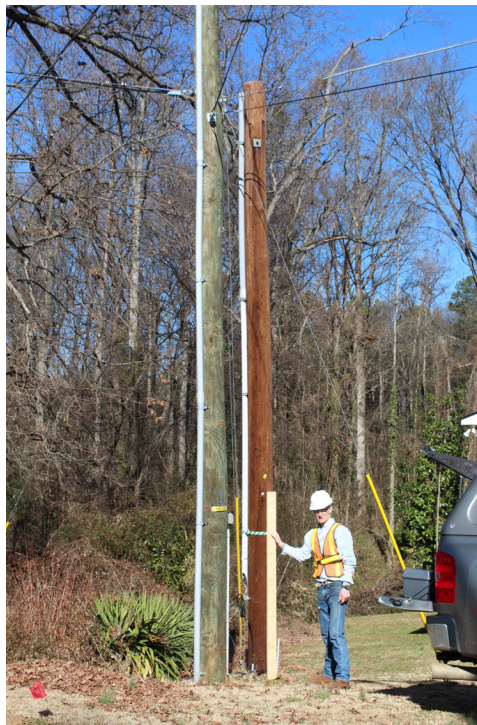
FIGURE 1.1: Example photograph of a pole with height reference used to estimate above ground height

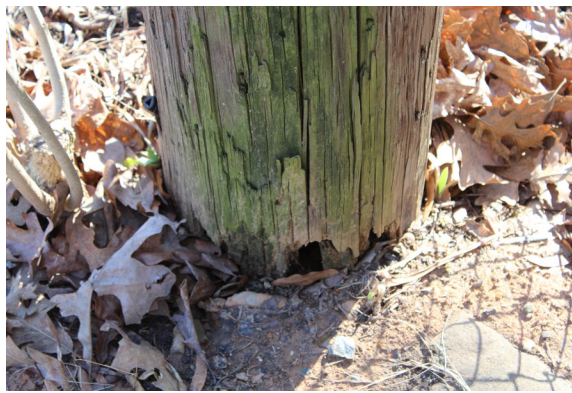
FIGURE 1.3: Photograph of visible symptoms of decay in a pole near the ground line

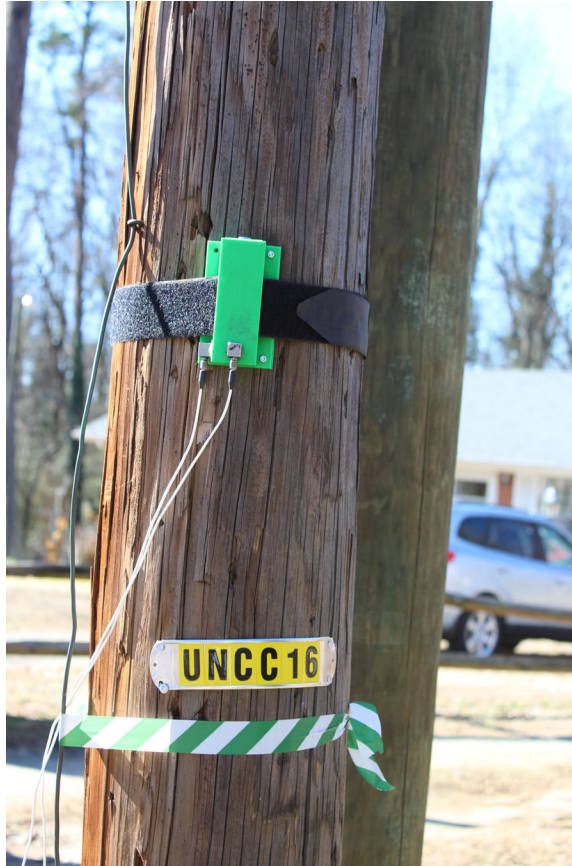
FIGURE 1.4: Prototype and wired accelerometers secured to pole Pole 16 on Axis 1 at an elevation of 6 feet above ground

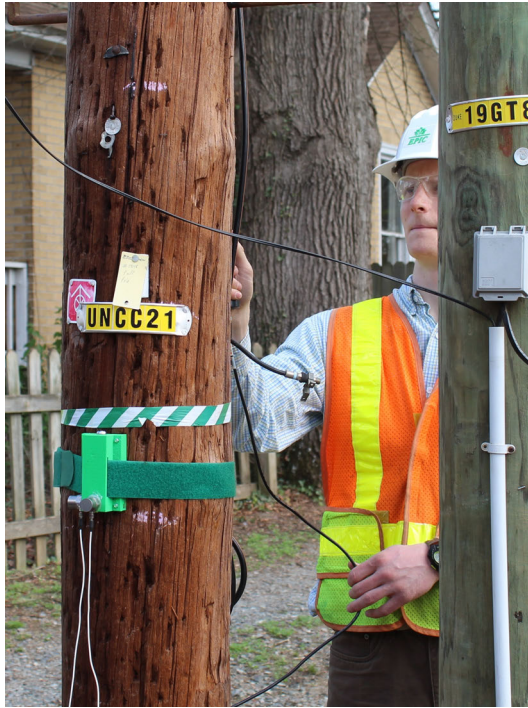
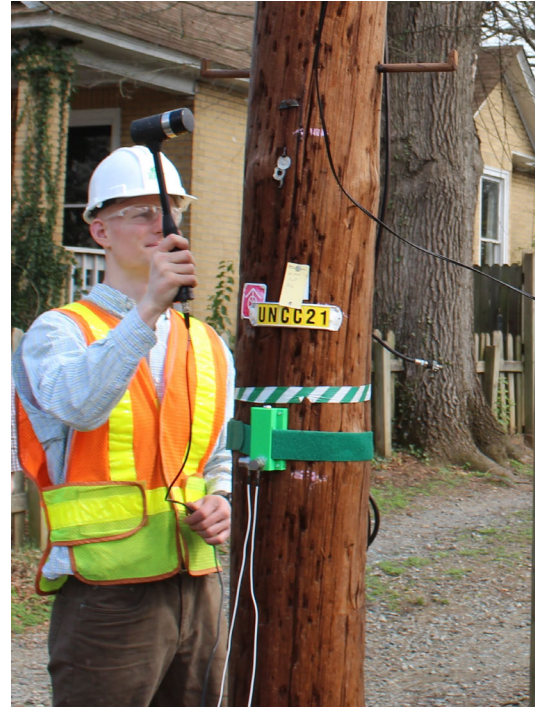
Five hammer strikes at 4 ft elevation in direction of Axis 1

Five hammer strikes at 4 ft elevation in direction of Axis 2

FIGURE 5.5: Impulse excitation of modes in direction of a) axis 1 b) axis 2

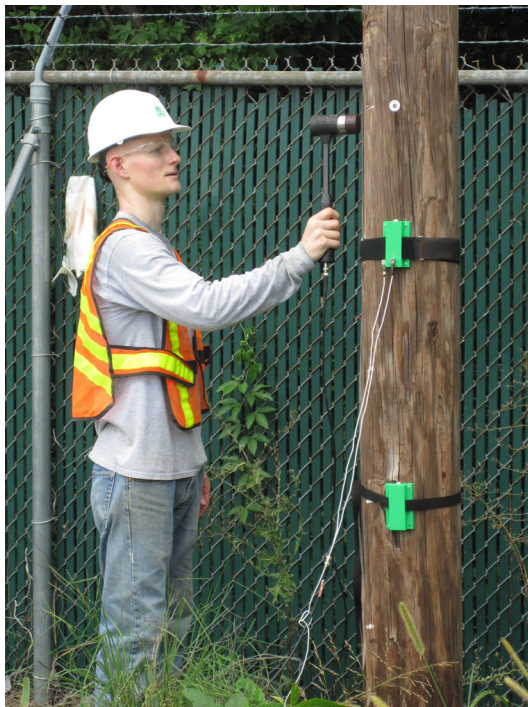
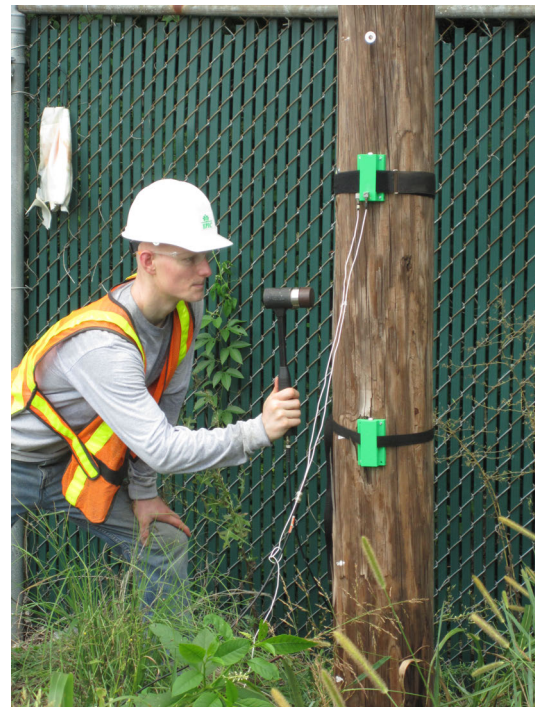
FIGURE 5.6: Impulse excitation of modes in direction of axis 2 at a) 6 feet b) 4 feet above ground

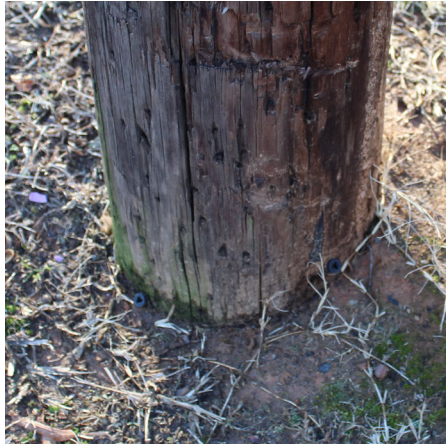
FIGURE 5.8: Photographs of ground line conditions of poles tested in initial field assessment

line are shown in Figure 5.8. Algae growth on Pole 10 can be seen near the ground line, suggesting the presence of consistent moisture and the possibility of conditions promoting decay. The original ground line of Pole 11 was covered with fresh soil excavated for the embedment of a replacement pole prior to the time of field testing. The photograph of Pole 12 shows the steel reinforcement used to reinforce this pole while in service. Algae growth and section loss from decay can also be seen at the ground line in the photograph of Pole 13.

Pole	Description of pole and condition
Pole 10	Mostly healthy with mild to moderate decay. Algae growth observed at ground line in situ. No supported infrastructure.
Pole 11	Severe decay just below ground line detected after pole removal. Supporting telecommunications lines in multiple directions
Pole 12	Reinforced with steel reinforcement while in-service. Algae growth observed at ground line in situ. Severe decay below the ground line resulting in loss of the embedded portion of the pole during removal.
Pole 13	Algae growth and section loss due to decay observed at ground line in situ. Severe decay below the ground line resulting in loss of the embedded portion of the pole during removal.
Pole 14	Mostly healthy with mild decay. Appears to be the healthiest pole tested in the initial field assessment.

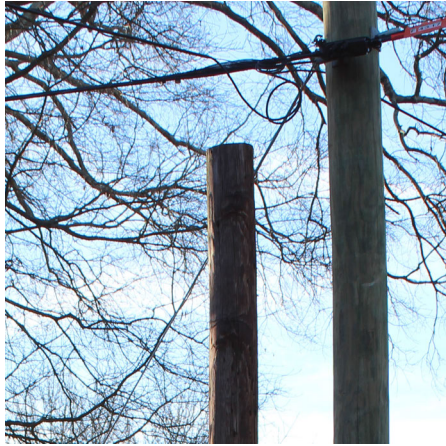
Pole 10

FIGURE 5.9: Photographs of electrical and telecommunications infrastructure supported by in-service poles tested in initial field evaluation

Photographs of the infrastructure at the top of each pole are shown in Figure 5.9. The poles Pole 10, Pole 12 and Pole 14 are not supporting any infrastructure and, therefore, can be assumed to have a free support condition at the top. Pole 13, and Pole 14 were still supporting telecommunication lines at the time of testing. These lines may provide additional localized stiffness to these poles at the point of attachment. This is particularly true for Poles 11 and 13 where the telecommunication lines were also secured to the adjacent replacement pole. The short span of the telecommunications line leads to greater local stiffness than a typical span between normally spaced utility poles.
