EXPERIMENTAL STUDY FOR DETECTION OF THERMAL RUNAWAY, EXPLOSION,
AND FIRE IN LI-ION BATTERIES INITIATED BY HOT PLATE METHOD

A dissertation submitted to the faculty of
The University of North Carolina at Charlotte
in partial fulfillment of the requirements
for the degree of Master of Science in
Civil Engineering

2022

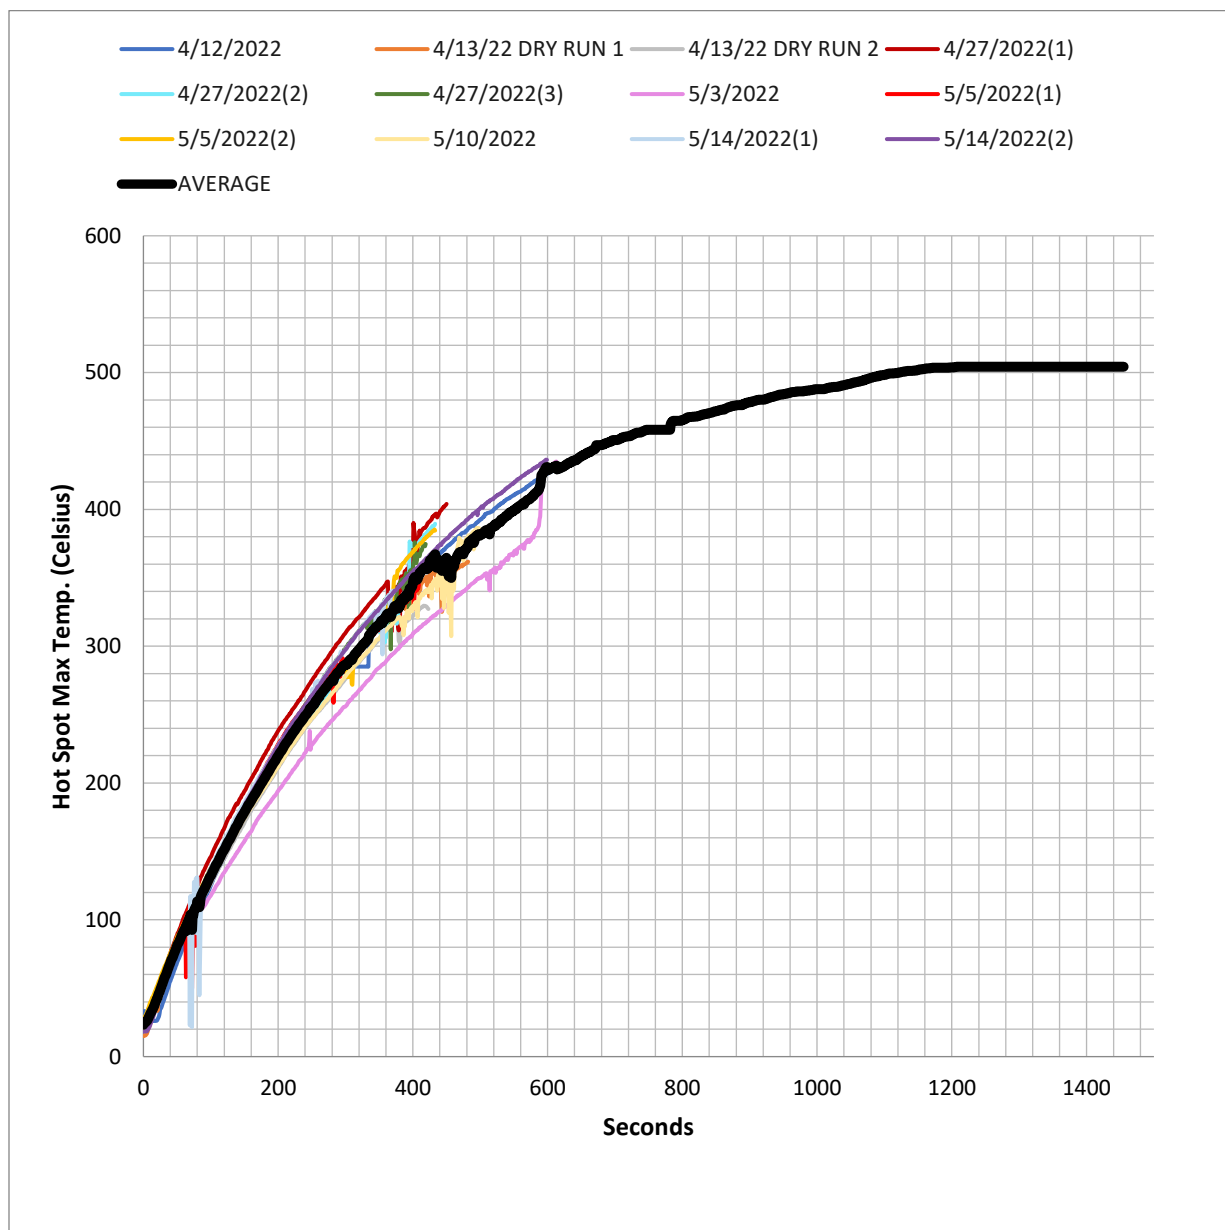
Figure 3-5: Hot plate temperature data w/ adjusted average curve

aimed at the hot spot and activated, while the plate was allowed to heat from an inactive ambient temperature to its maximum temperature, which was determined after no increase in temperature was observed for some time. A plate heating rate was plotted using the time of plate activation, after first activating the temperature logging device, with the timestamp of the first data point logged. This process was repeated to determine the heating consistency of the plate. While the plate consistency was deemed sufficient to begin testing, the same plate temperature recording method was used during several subsequent battery tests to monitor any depreciation in performance of the plate over time. To improve efficiency of the test procedure, plate temperature was spot checked but not recorded in some tests as extended consistency was confirmed. The data sets used to check plate consistency were plotted together, along with the average heat rate adjusted for outliers caused by interruptions in some plate data logging sessions, which can be seen in Figure 3-5.

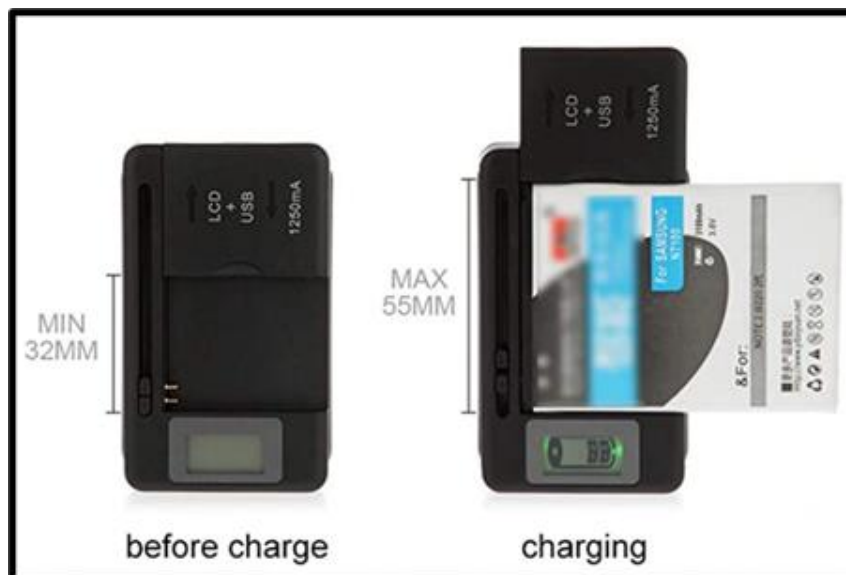
Figure 3-6: Rizer prismatic charger

The prismatic, hard-cased ICRs and both cylindrical chemistries (IMR, INR) were tested individually. Before setting up the test system, the SOC of each battery was checked and increased if desired. Two “universal” chargers with SOC displays were used, one designed for prismatic LIBs (brand: Rijeer), and the

other designed for multiple sizes and types of cylindrical cells, not just LIBs (brand: EASTSHINE), can be seen in Figure 3-6 and Figure 3-7 respectively.

The Rijer charger was also able to be used as a battery discharge device by unplugging the charger with a non-zero SOC battery still connected, the battery becomes the liquid crystal display (LCD) screen power source. The 18650 cells were not able to be discharged by the EASTSHINE charger. The Rijer charger had disadvantages as well; it would not charge some prismatic cells with 4 charging prongs, which were more common (compared to 3-prong), its SOC display intervals were only every 25%, compared to the more accurate 20% for the EASTSHINE charger.

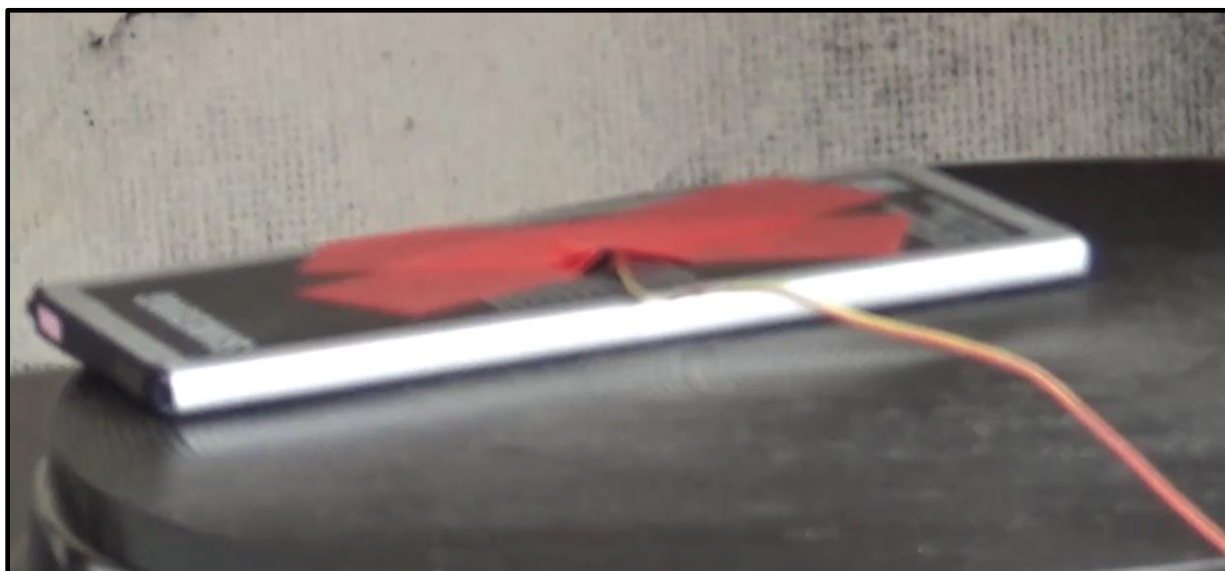
Figure 3-8: Single prismatic cell placement

The surface TC is applied to the batteries along its longest edge opposite of the hot plate, using heat resistant tape in addition to the self-adhesive included by the manufacturer. The batteries were placed on the approximate surface hot spot location before activating the plate. For the cylindrical 18650 cells, pointing the positive end cap left and angled slightly toward the digital camera, kept the safety vent activation in view. This specific placement was not adopted immediately, but as the vents were found to be the consistent first point of 18650 failure under thermal abuse (see chapters 4 and 6), this placement proved most advantageous. An image of both cell types placed for testing can be seen in Figure 3-8 and Figure 3-9 and, where an alternative 18650 placement in Figure 3-10 from the 5.3.22 test was only used once for individual testing due to safety concerns (see chapters 4 and 6).

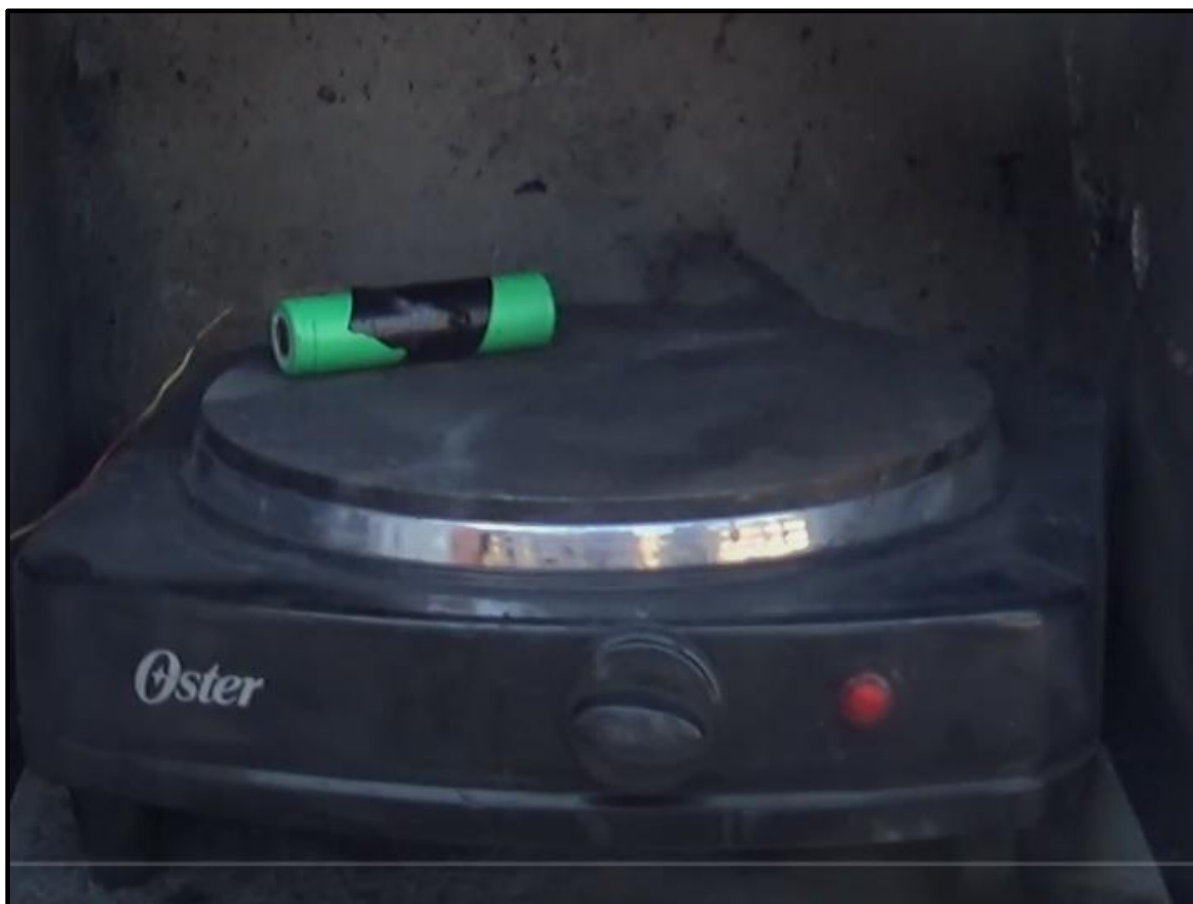
Figure 3-9: Single 18650 placement

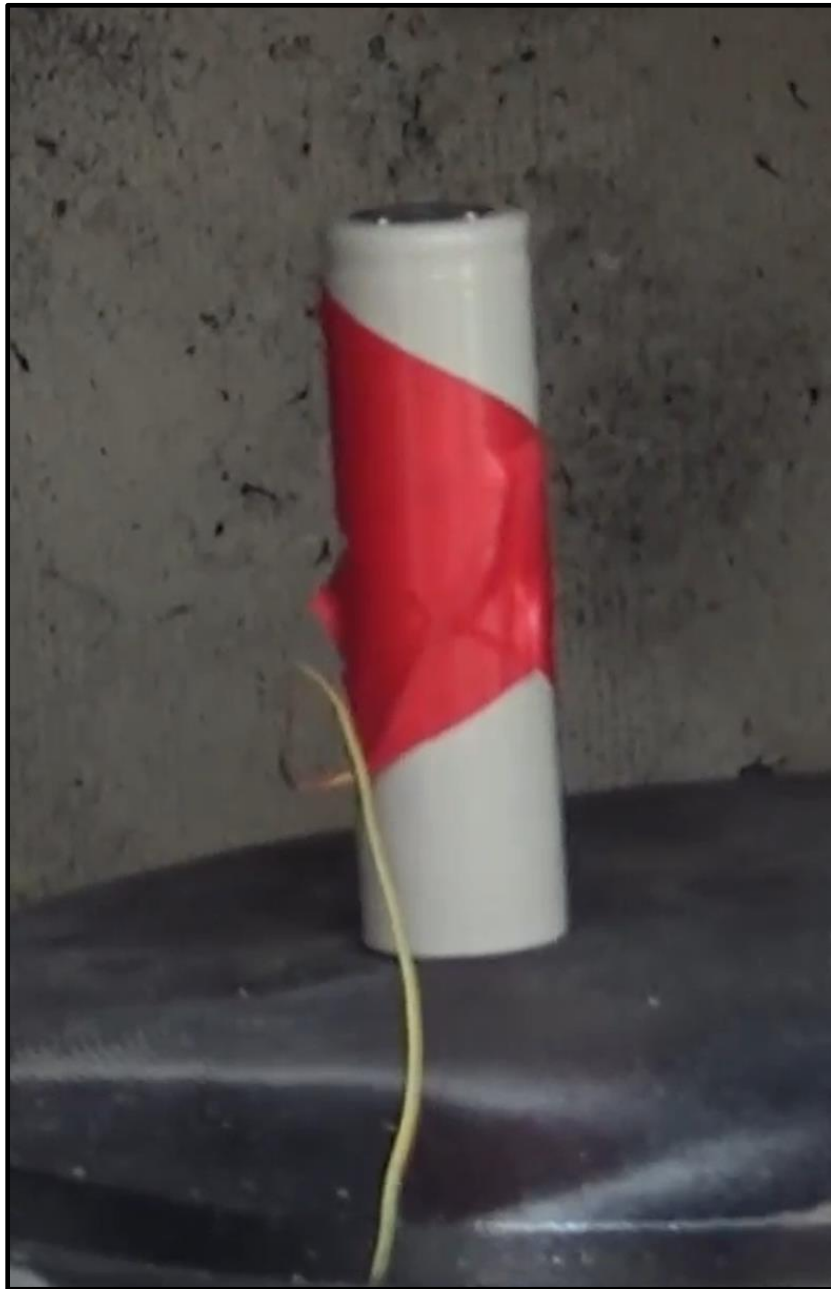
Figure 3-10: end cap placement 5.3.22

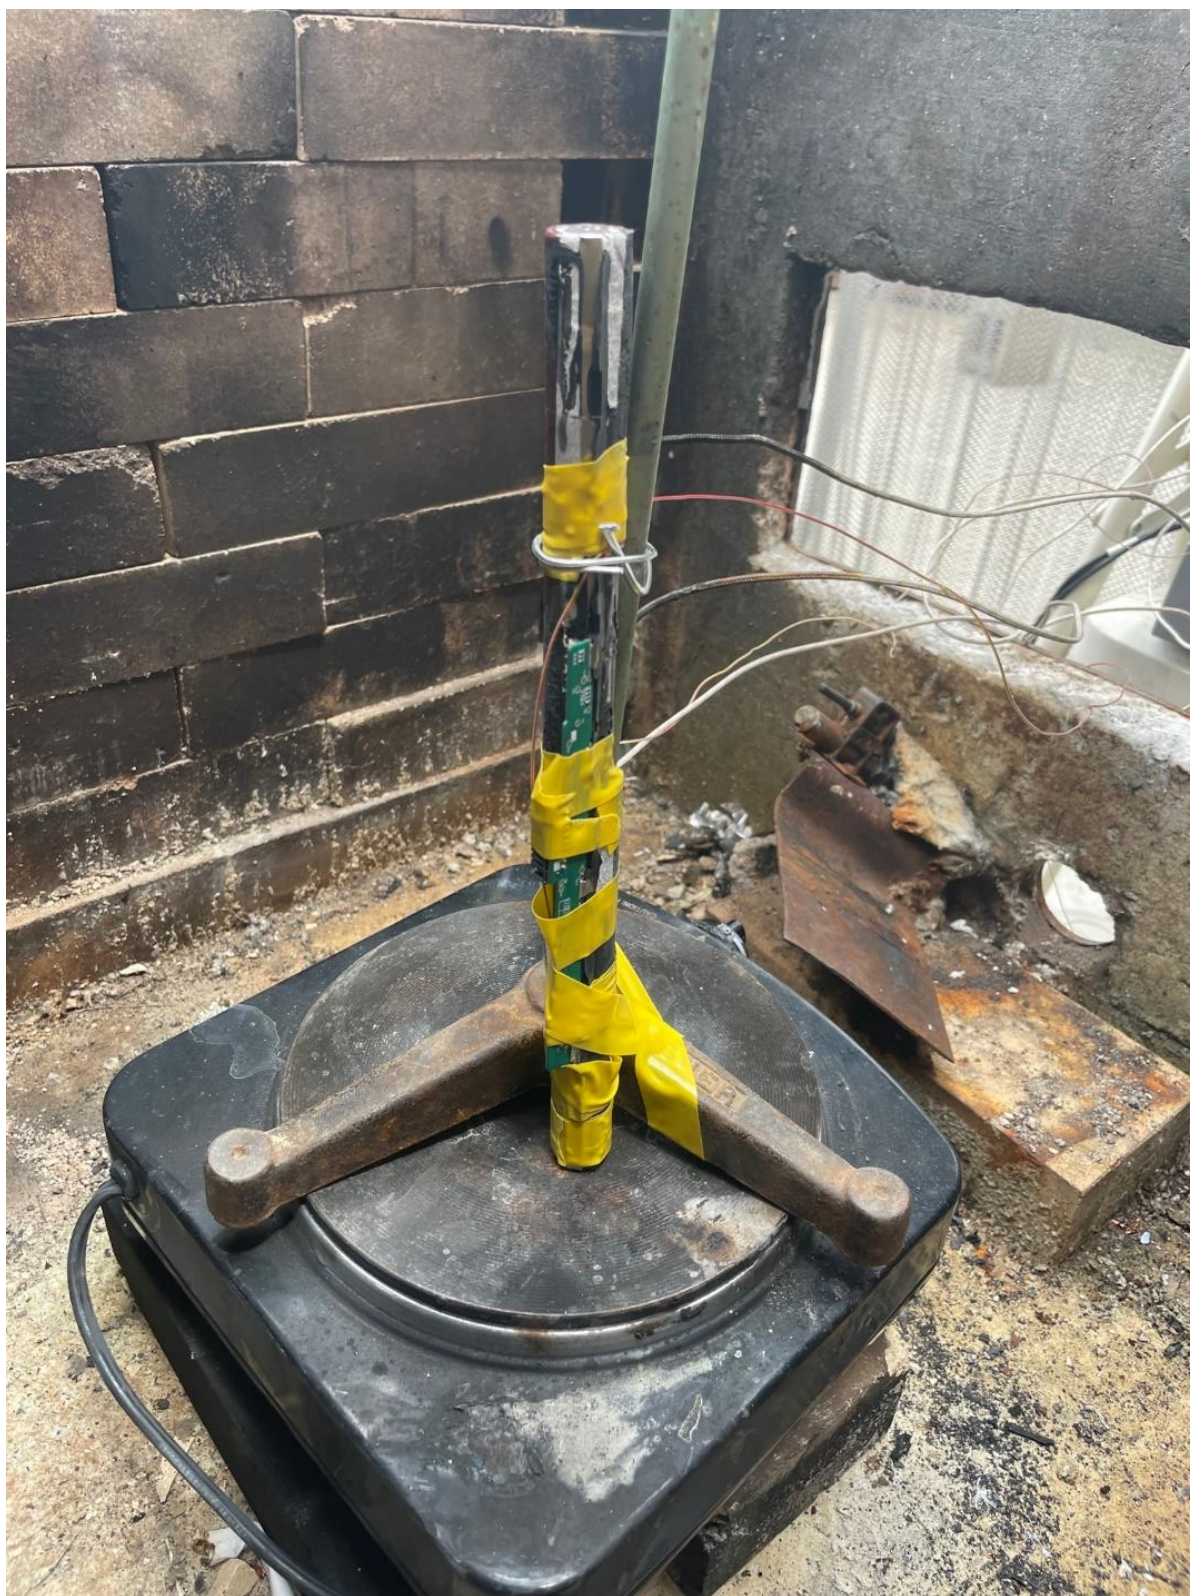
Figure 3-13: Multi-18650 plate setup

Based on the consistent failure of previously tested single-cell 18650s at their positive end caps, for multi-18650 tests, batteries were connected at their end caps with the positive ends pointing up towards the next battery (when applicable). This configuration focused any high temperature material from lower batteries into the battery it was touching. The bottom battery was placed on the hot plate maximum point on its negative end while a retort stand was used to support the tall column of batteries, see Figure 3-13 that also shows TC connectivity along the sides of each battery.

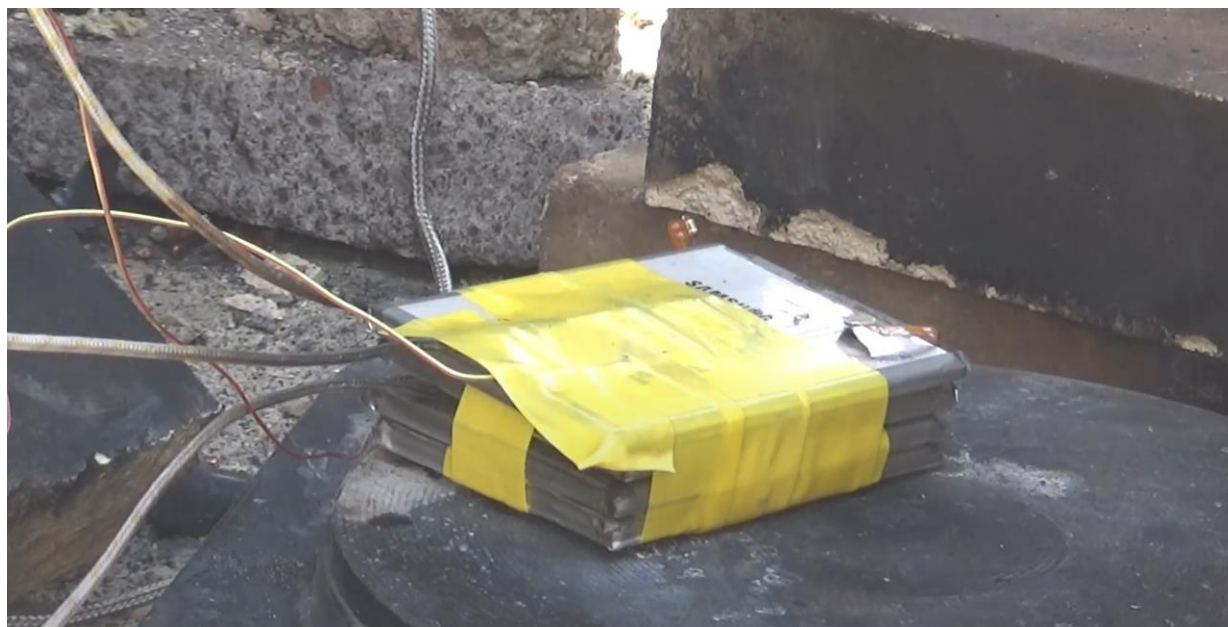
Figure 3-14: Multi-pouch plate setup

For pouch propagation tests, the batteries were stacked by their broad surface directly above each other with surface TCs placed in between each layer at the center of the batteries. The digital camera still in Figure 3-14 shows this configuration and alternate viewing angle.

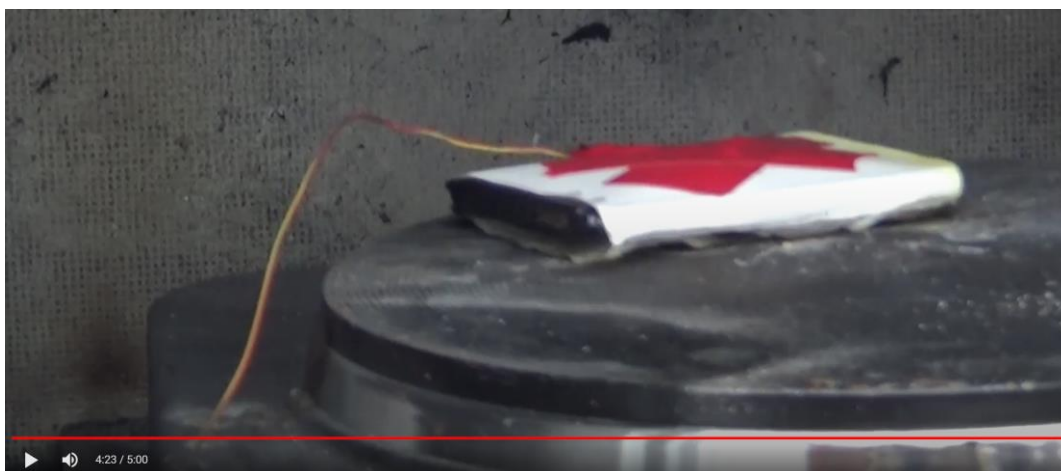
Figure 4-2: 1sec before rapid expansion/explosion [4:23 (vid.), 245sec (data)] 5.4.22

Video stills showing physical observations are given in Figure 4-2 through Figure 4-5. Digital camera recording was briefly stopped accidentally 35 seconds after the explosion, but recording was restarted 74 seconds later, which was determined using the continuous IR video. Nothing significant was missed in this filming gap. It should be noted that the digital camera used for all tests would sometimes break videos into two separate files on its own, but there is no loss of footage between the first and second video (see 6.2.22[1] videos). This consistently happened around 17 minutes and 2 seconds of recording, which is an uncommonly long test length, but it did occur a few times.

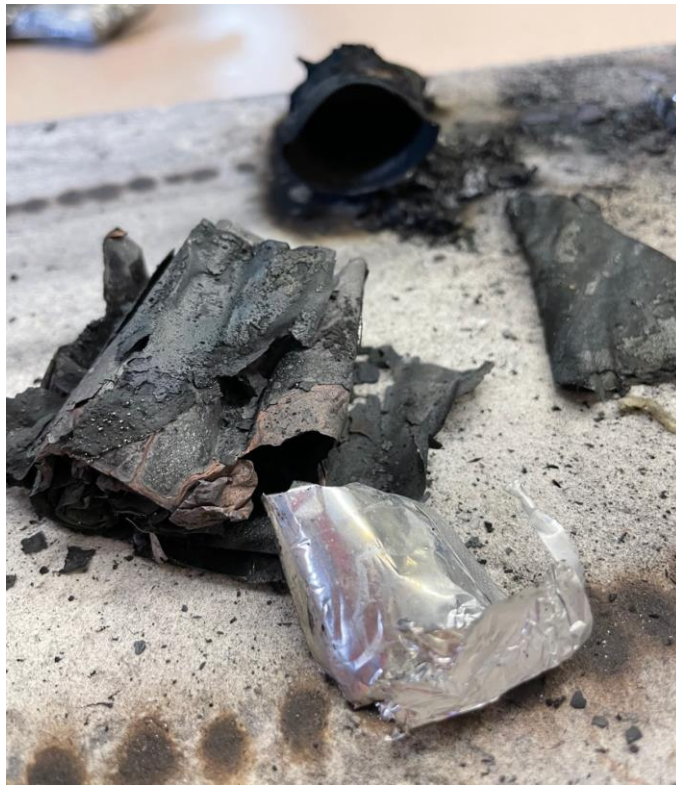
Figure 4-8: 5.4.22 post-condition photo 1

Since most battery shrapnel pieces landed behind the hot plate, on the box furnace's removeable, ceramic-fiber plate, examination of the fragile pieces was able to occur without disturbing them. Figure 4-8 shows the charred, book-like inner layers, and the cavity in the casing from where they were expelled, while the silver-colored foil is believed to have been the outermost layer just inside the casing.

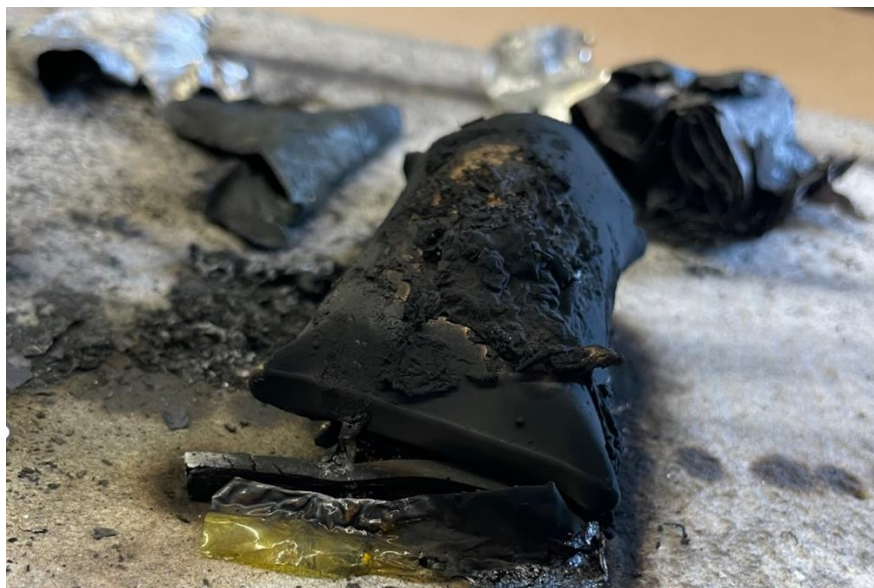
The opposing view, shown in Figure 4-9, displays the melted, plastic end-tab where the charging prongs were located, which is also where the small flame occurred for the duration of the fire.

Figure 4-9: 5.4.22 post-condition photo 2

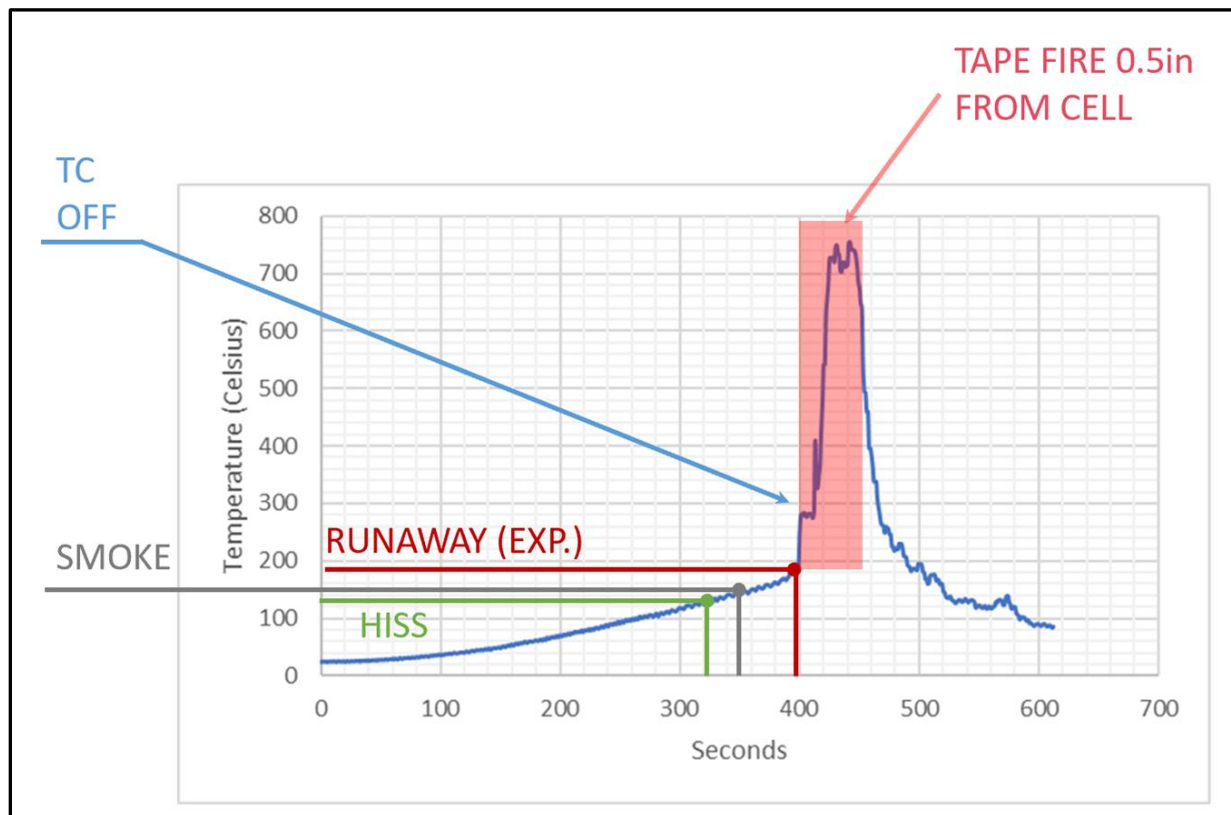
Figure 4-10: TC data 18650 INR 100% 2600mAh 4.27.22 (3)

The following information details a selected individual test (4.27.22[3]) of a cylindrical LIB. The TC temperature recordings for the INR (NMC) 18650 battery with 100% SOC is plotted over the time from hotplate activation, shown in Figure 4-10, where key failure events are called out.

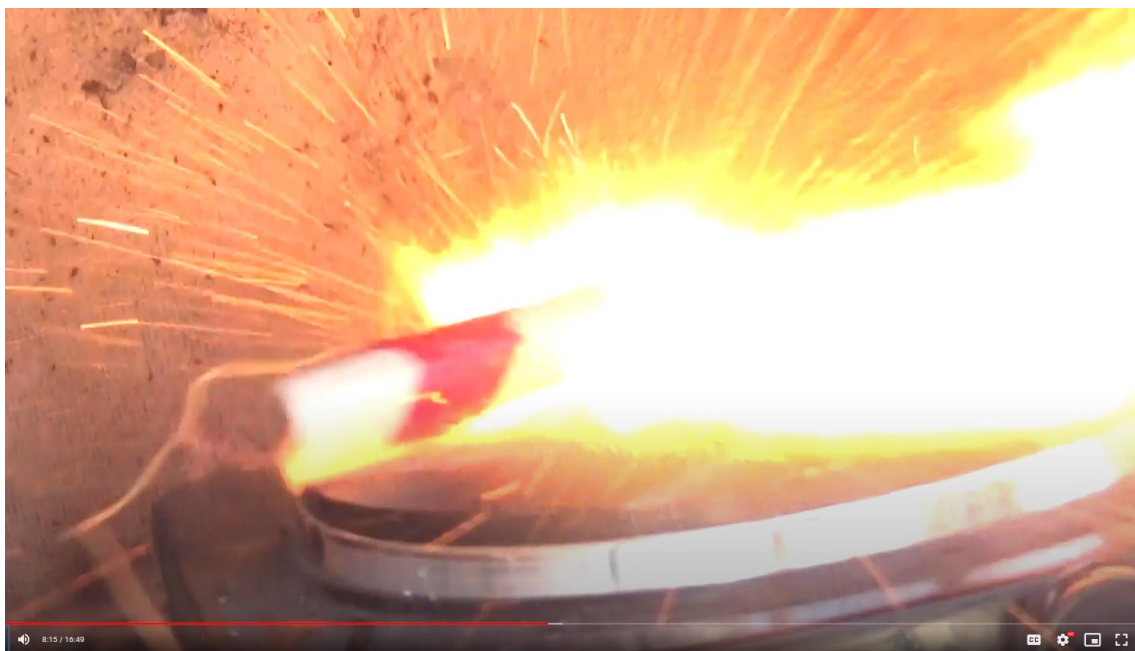
Figure 4-11: Moment of explosion [8:15 (vid.), 399sec (data)]4.27.22 (3)

At the beginning of the test and video, the hotplate was turned on but was not plugged in from the previous test, so the SmartConnect TC network was restarted 96 seconds (called out at 90 seconds) into the video, leading to the difference in video-to-TC time of events. The IR video was not restarted. This mistake highlights the need for clear voice callouts of actions in the video, along with the utilization of timestamps for all equipment. The first rapid spike in temperature between 399 and 400 seconds, signifies the time of the explosion event, which in this case was a rapid explosion of sparks causing a projectile action by the battery, shown in Figure 4-11.

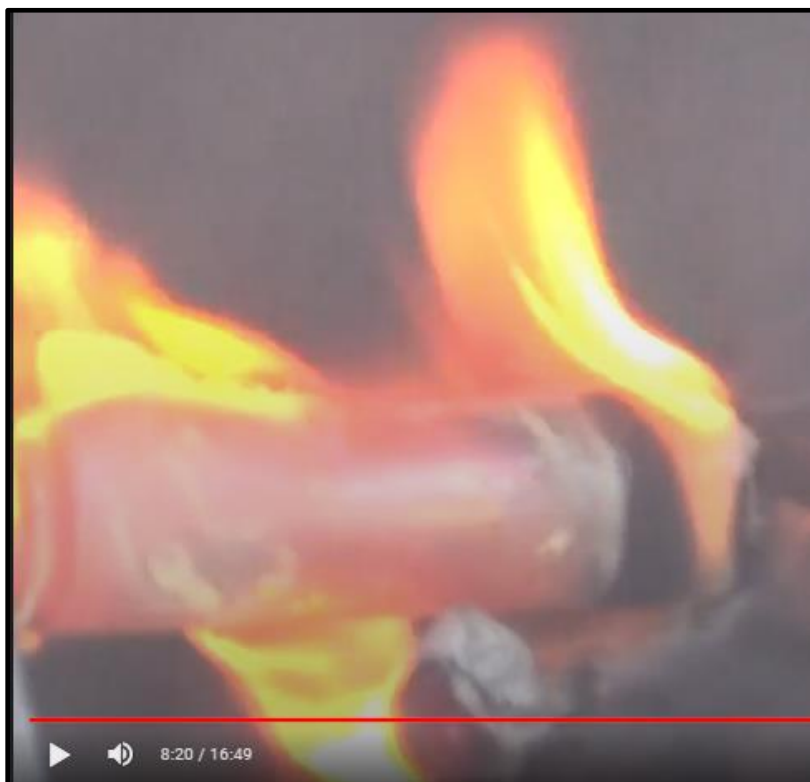
Figure 4-12: 5sec after explosion [8:20 (vid.), 404sec (data)] 4.27.22 (3)

The battery became red hot for over a minute and a maximum temperature of 755 °C was recorded. In this instance the TC was less than a half inch away from the resting, but burning, battery. The battery became lodged in between the hotplate and ceramic wall allowing a fraction of the TC tape to remain in contact with the battery for a few seconds. Soon after the tape and TC were disconnected but came to rest on the hotplate right next to the battery. This moment of TC disconnect can be seen clearly in the temperature data plot, where just after the 400-second mark, the plot suddenly plateaus from its rapid increase in heat for a few collection cycles, before the tape it is connected to catches fire causing the second rapid increase in temperature. The only visible flames were that of the burning tape, which lasted just under a minute. When the TC data is viewed alongside the video, the approximate 440-445 (sec) TC point coincides with the extinguishing of tape flames; this leads to the rapid drop in recorded temperature to the cooler air in the test chamber, which also validates the response and accuracy of the TC. Note that a slow-motion video (SMV) of the fire event in this test was captured and is available as a supplemental file, however, this is the only test a SMV is available. The video stills showing these physical observations are given in Figure 4-12 and Figure 4-13.

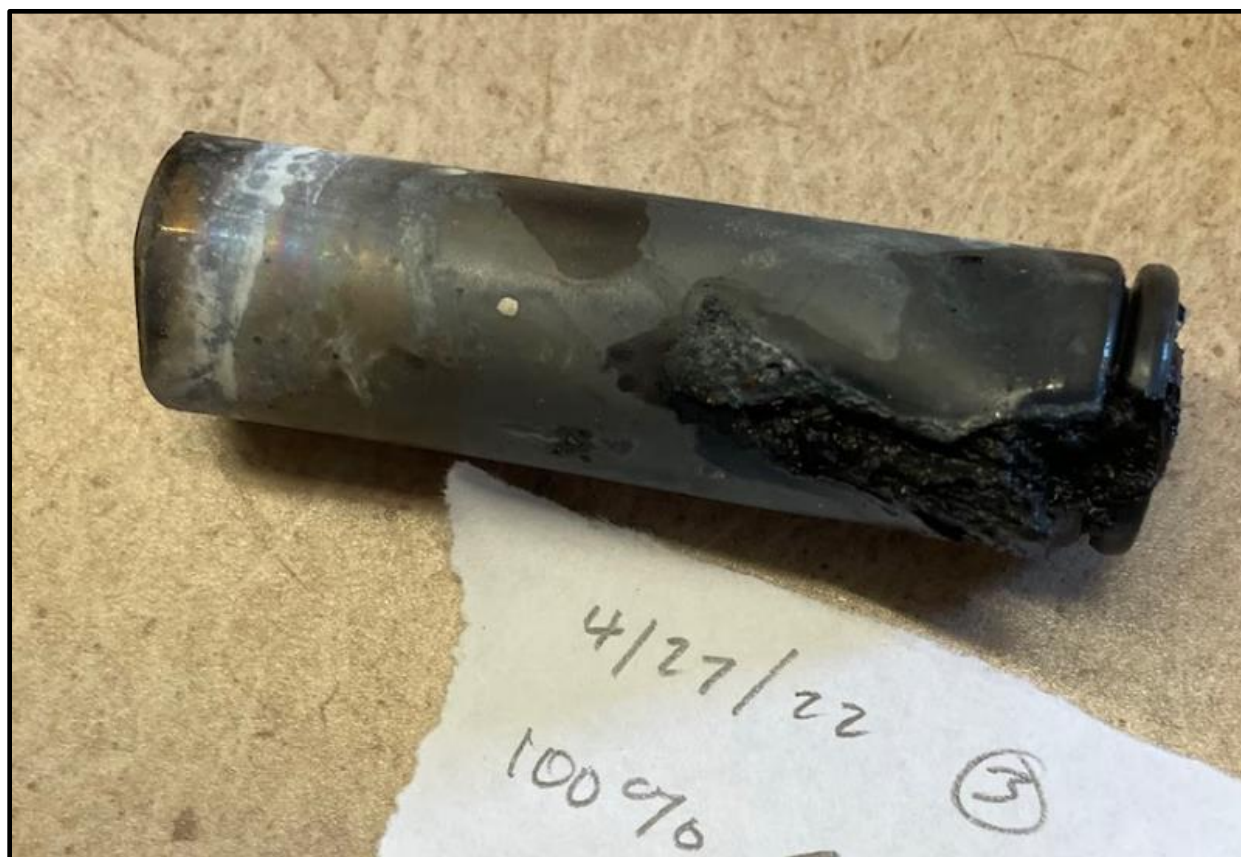
Figure 4-17: Post-test condition 4.27.22 (3)

Once the battery had sufficiently cooled for handling, its post-test condition was noted, and its mass was recorded and compared to its pre-test mass. For this test, 15.4 grams of mass was lost during the test. Upon inspection a significant gash in the battery casing was seen travelling from the edge of the positive end cap, down the side of the casing for over an inch. A post condition picture can be seen in Figure 4-17.

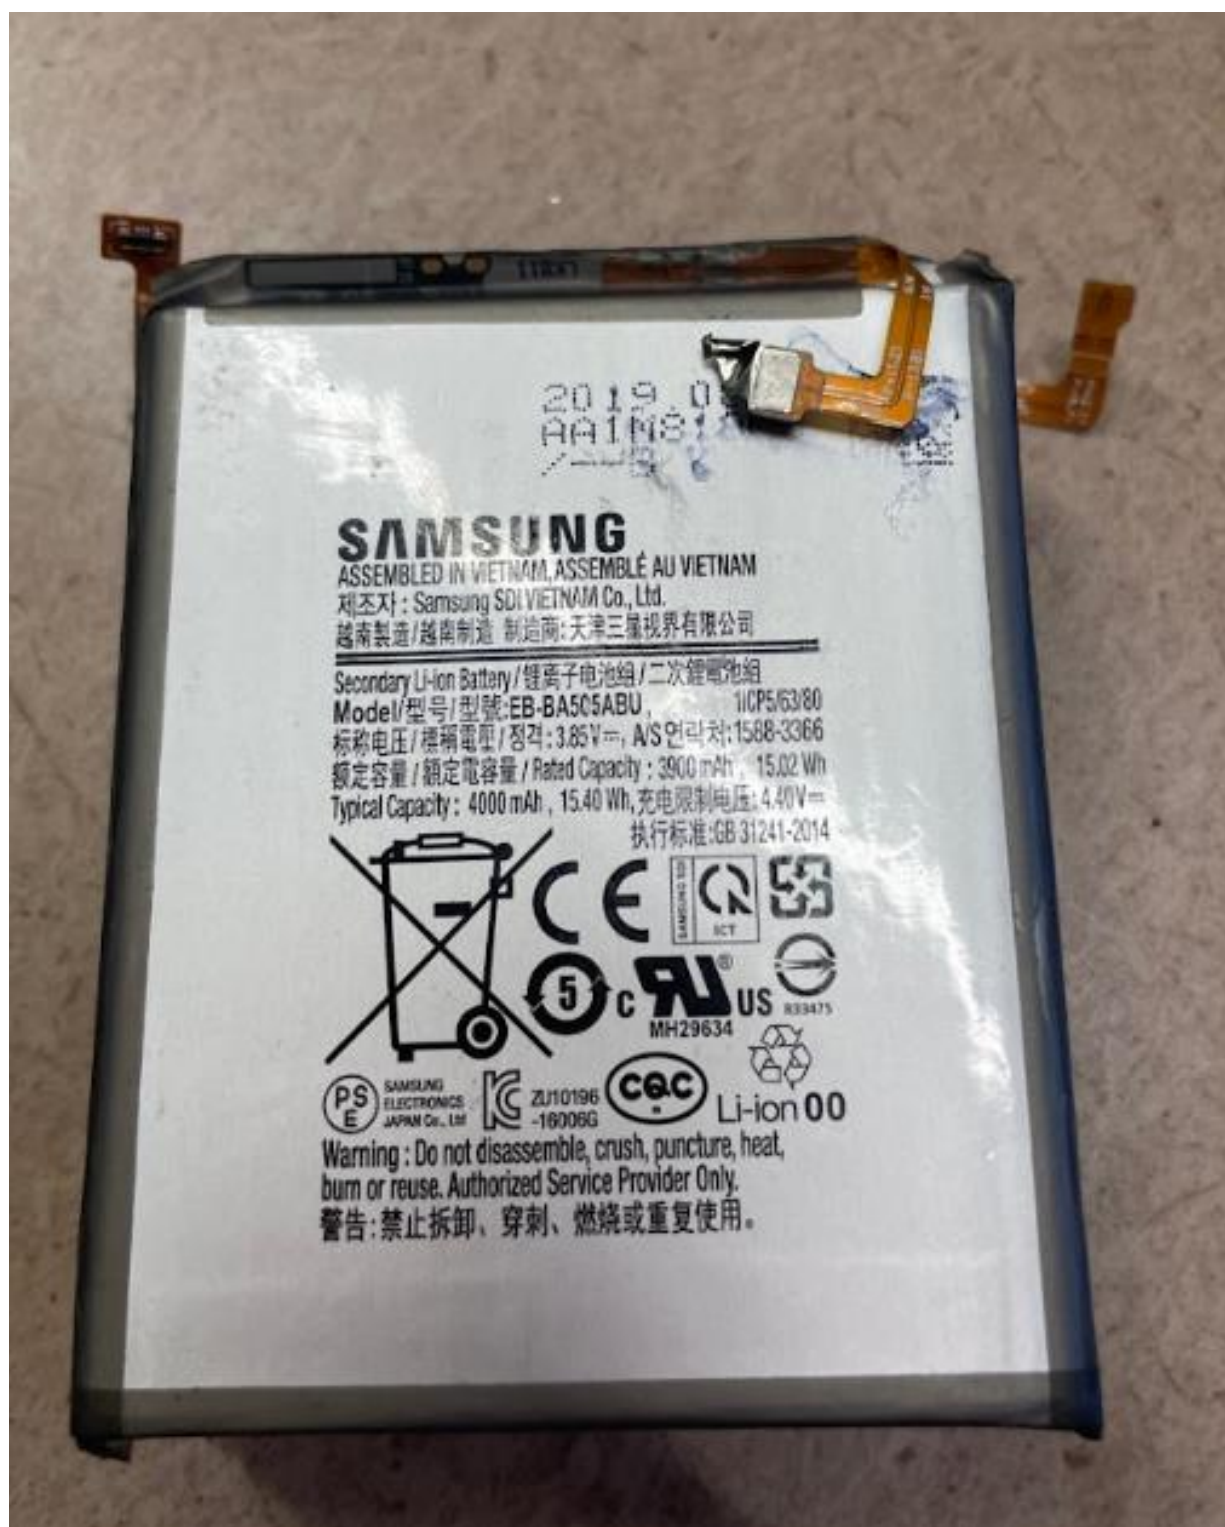
Figure 5-2: Label of multi-pouch test cells

The following information details the two multi-pouch LIB tests performed, where both tests consisted of four Samsung (model #: EB-BA505ABU) ICR (LCO) cells extracted from a used laptop battery module, seen in Figure 5-2.

While these pouches' chemistry is not listed on the label, their cathode materials were confirmed using the manufacturers safety data sheet [39]. These are the only pouch cells that were tested throughout the scope of this research.

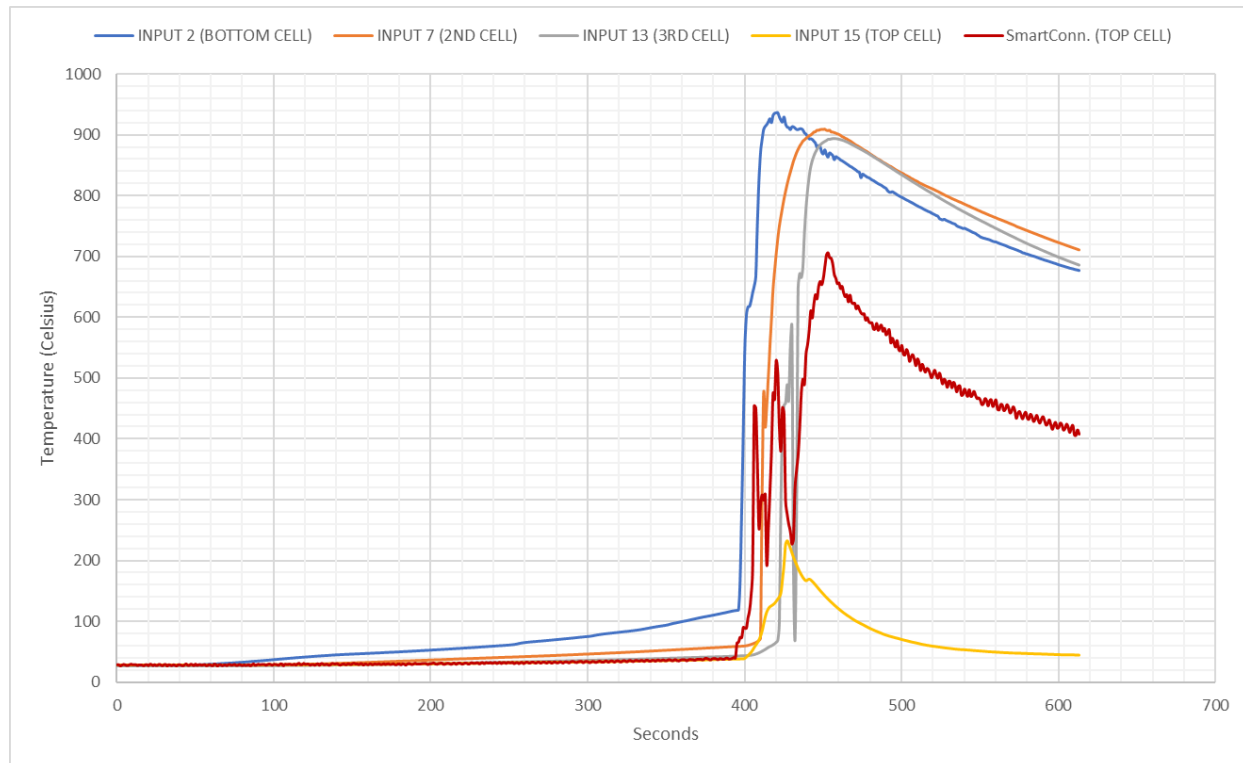
Figure 5-3: Combined DAQ and SmartConnect TC data plot 6.8.22

The following information details the first multi-pouch LIB test performed (6.8.22). The TC temperature recordings from both the DAQ and SmartConnect systems, were combined and plotted over the time from hotplate activation and are shown in Figure 5-3.

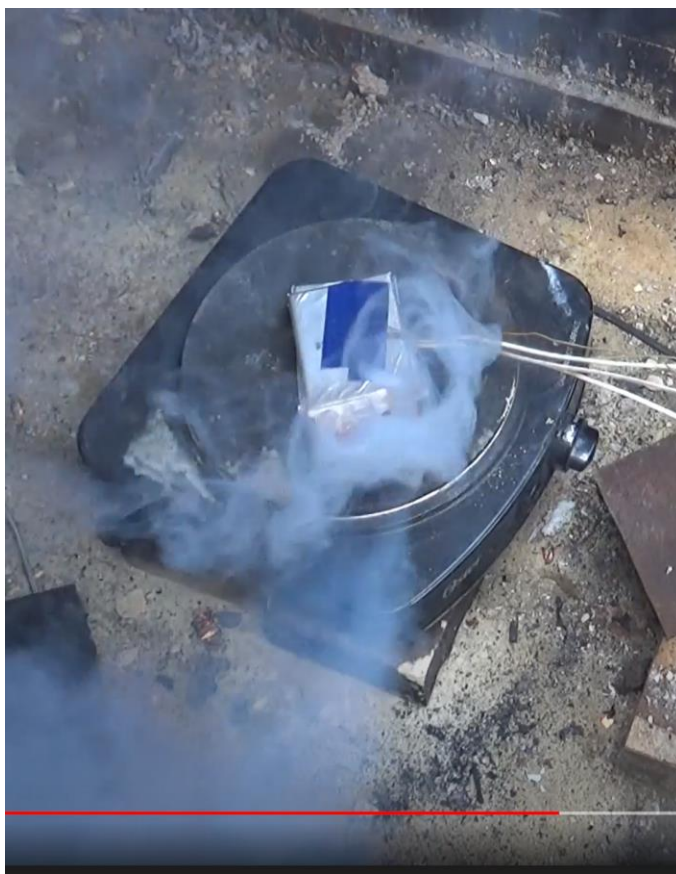
Figure 5-4: First hiss after 1sec, bottom cell [6:59 (vid.), 384sec (data)] 6.8.22

With the overhead digital camera angle used for this test, clear identification of cell expansion was not available. The first notable activity occurred when the bottom cell casing failed and an audible release of pressure (hiss) was heard, which was immediately accompanied by heavy smoke which filled the containment box and momentarily blocked out the camera view. Video still shots of this event can be seen in Figure 5-4 and Figure 5-5, where the time of the video is listed along with corresponding time of TC data after the activation of the hot plate.

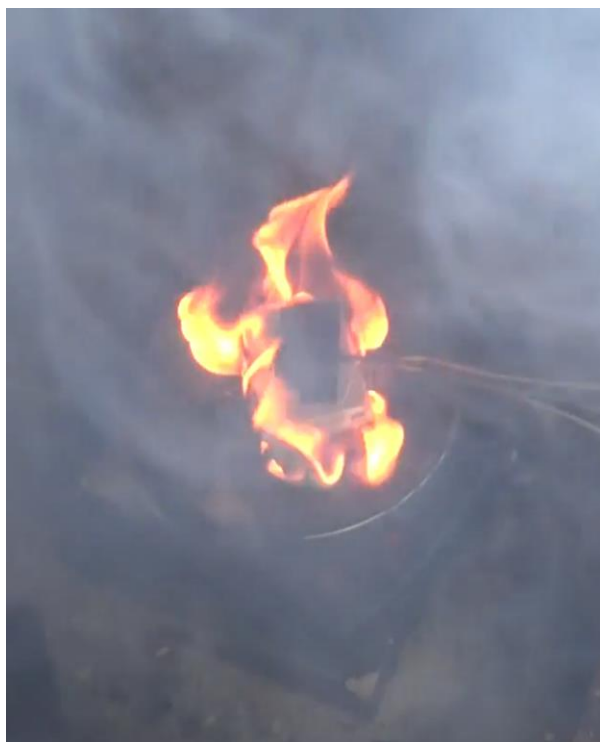
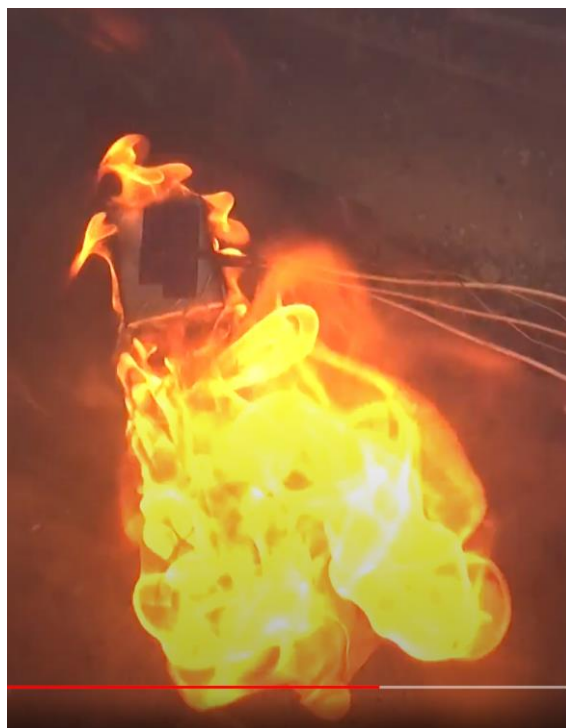
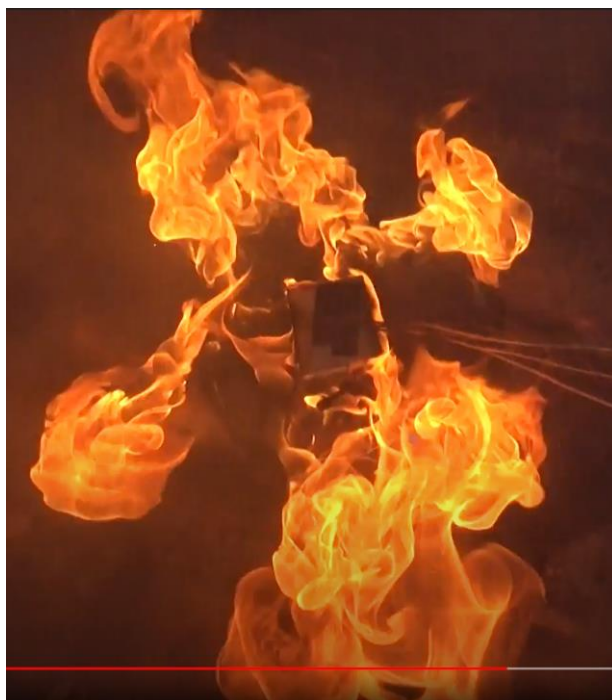
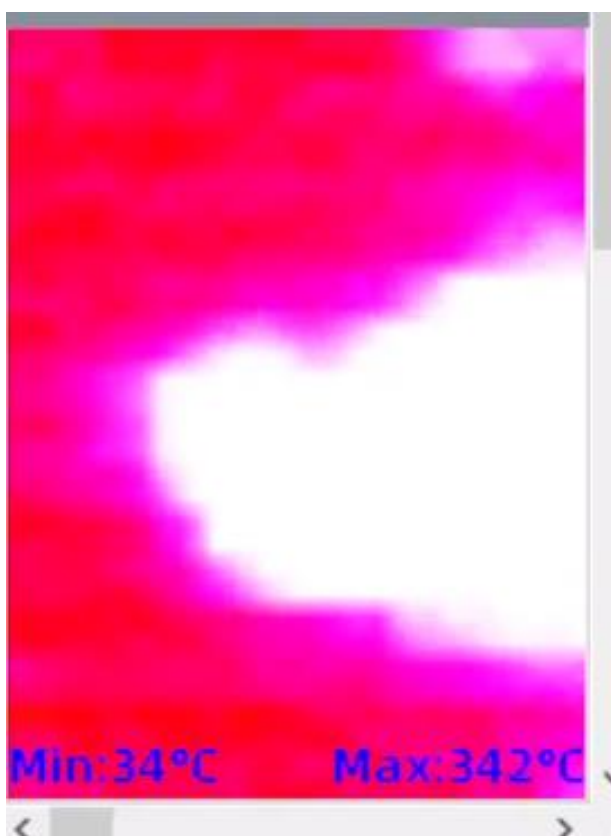
About 6 seconds after this first smoke event, a fire developed in the bottom cell which engulfed the stack of cells. After another 6 seconds, this fire had advanced into audible jet like flames, first coming from one side of the battery, but 2 seconds later jet-flames were emitting from both sides. Each stage of progression in the first fire event can be seen in order in Figure 5-7 through Figure 5-12.

Figure 5-7: First ignition, bottom cell [7:05 (vid.), 391sec (data)] 6.8.22

Figure 5-9: First jet after 2sec, bottom cell, [7:13 (vid.), 399sec (data)] 6.8.22

Figure 5-11: Additional jets other side [7:15 (vid.), 401sec (data)] 6.8.22

Figure 5-12: IR jets other side [7:06 (IR vid.), 401sec (data)] 6.8.22

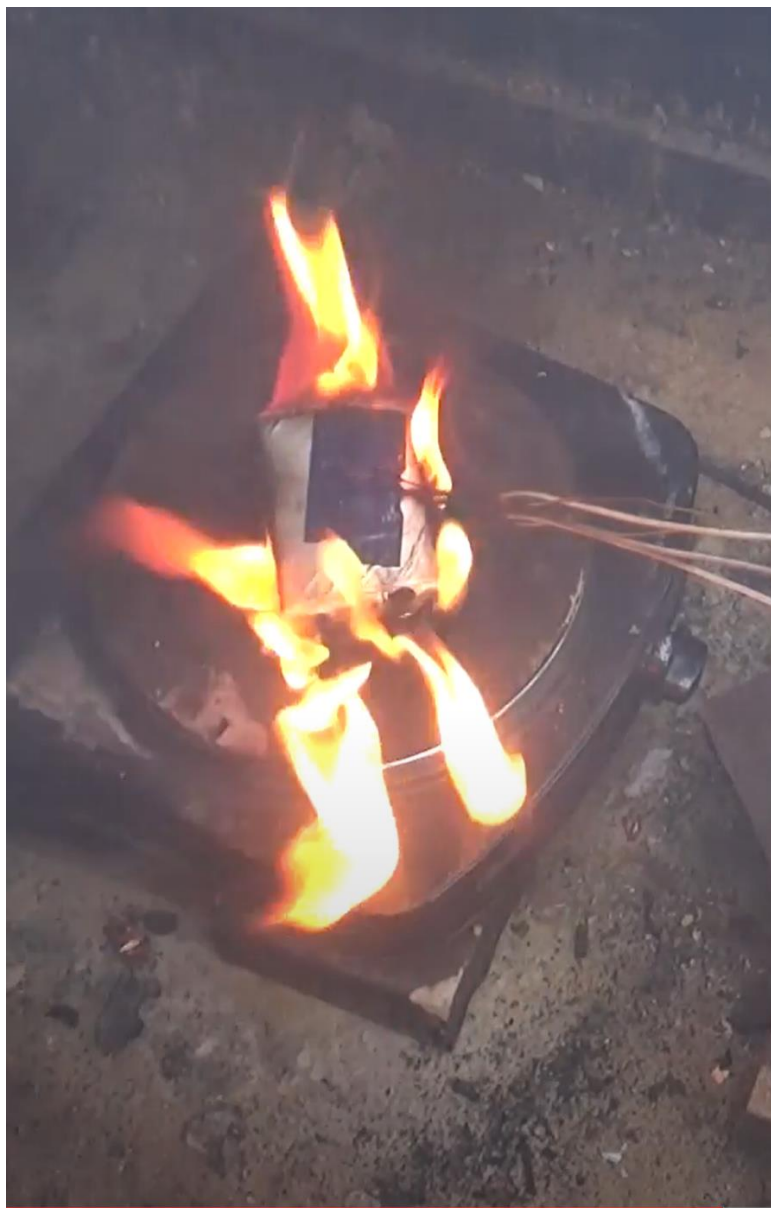
Figure 5-13: Mini jets the second before jet 2 [7:22 (vid.), 408sec (data)] 6.8.22

After the first jets subsided, the stack was still mostly engulfed in flames which were originating from the bottom of the stack. Before the next jet-flames, some “mini-jets” were seen expelling from what is believed to be the second cell from the bottom for a second or two. The progression from the small to large jets is shown in Figure 5-13 through Figure 5-17.

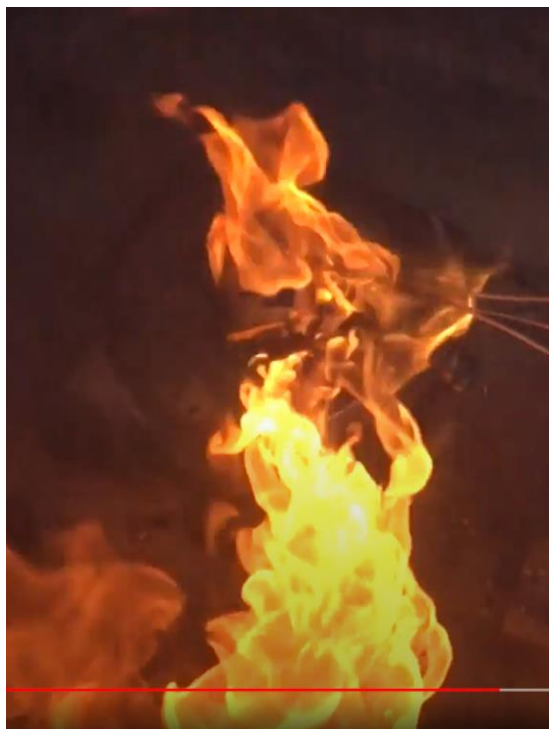
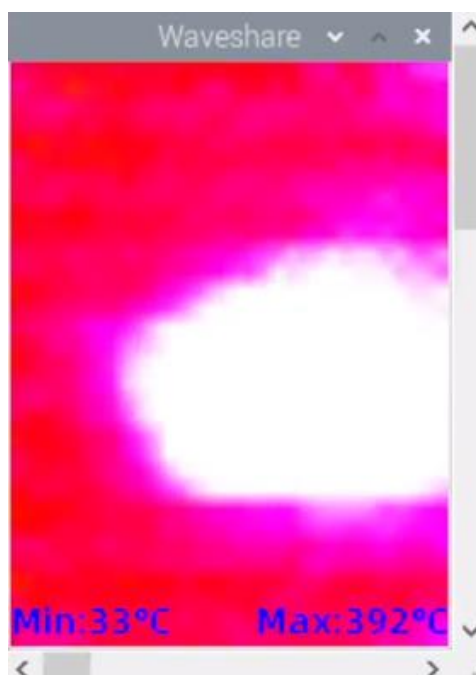
Figure 5-15: Approx. max point jet 2, (2nd cell?) [7:27 (vid.), 413sec (data)] 6.8.22

Figure 5-16: IR Approx. max point jet 2, (2nd cell?) [7:18 (IR vid.), 413sec (data)] 6.8.22

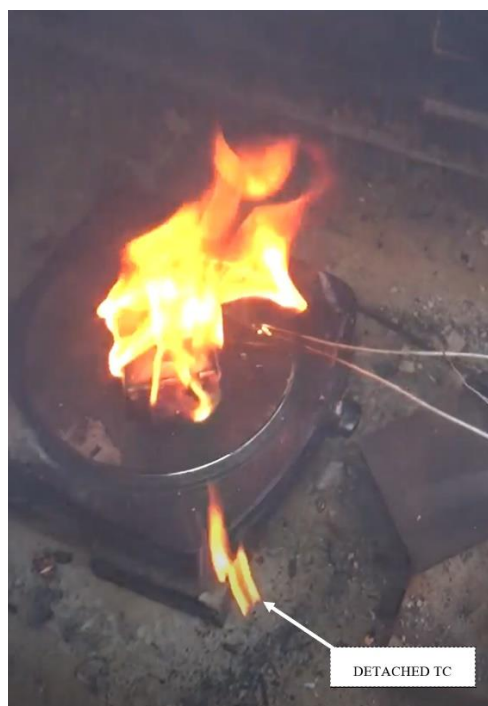
Figure 5-17: Top-cell DAQ TC detaching [7:31 (vid.), 417sec (data)] 6.8.22

About one second after the cessation of the second jet-flames, the top-level DAQ TC fell off and away from the batteries with flaming tape attached at its measuring end, which can be seen in Figure 5-17 (SmartConnect TC remained intact).
