EXPERIMENTAL STUDY FOR DETECTION OF THERMAL RUNAWAY, EXPLOSION,
AND FIRE IN LI-ION BATTERIES INITIATED BY HOT PLATE METHOD

A dissertation submitted to the faculty of
The University of North Carolina at Charlotte
in partial fulfillment of the requirements
for the degree of Master of Science in
Civil Engineering

2022

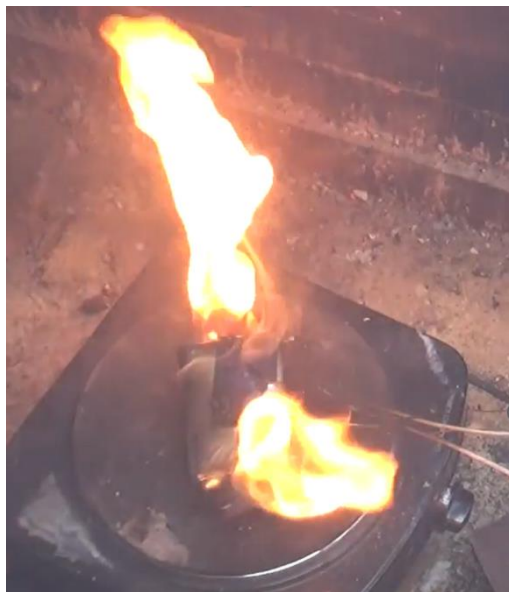
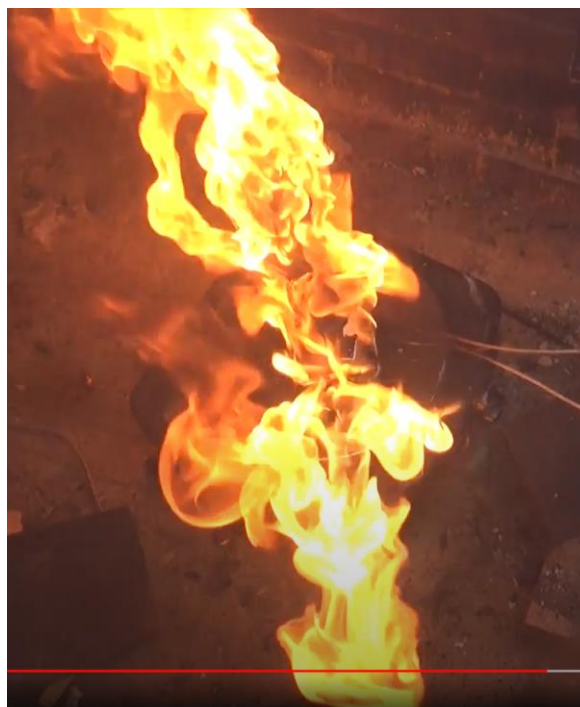
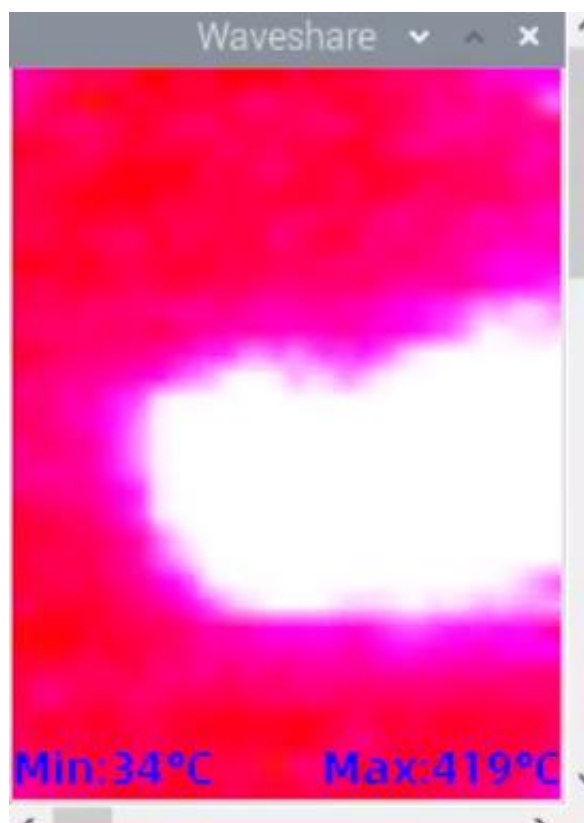
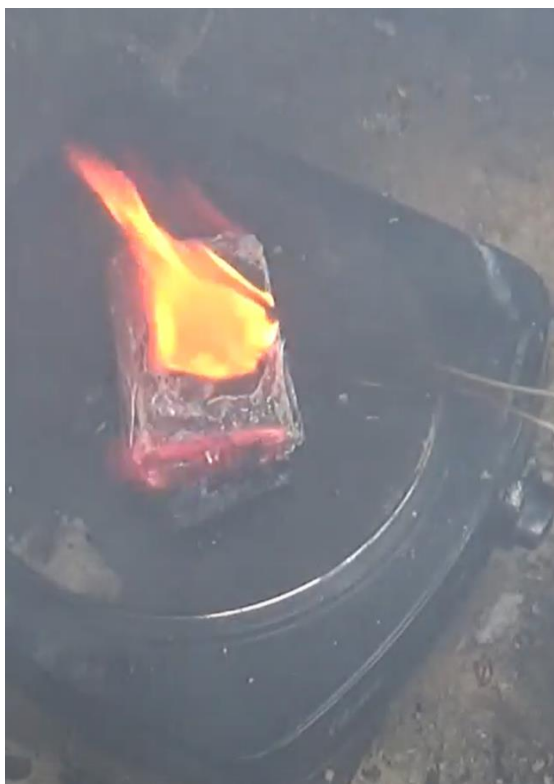
The third and final session of jet-flames again started on one side, but quickly progressed to a dual-sided jet. This 6-second jet event subsided into small flames flickering from each end of the top cell for a few seconds, while the tape used to secure the top TC's burned with a longer, larger, and more audible flame. Once the cell flames extinguished, the red-hot inner layers of the top cell could be seen across the elliptical endcap of the now expanded cell. This size of the red-hot area reduced concentrically toward the

center of the cell over 40 seconds. The progression of this final fire event is shown in Figure 5-19 through Figure 5-24.

Figure 5-19: 3rd and final jets both sides, (top cell only?) [7:40 (vid.), 426sec (data)] 6.8.22

Figure 5-21: Approx. max point jet 3 [7:44 (vid.), 430sec (data)] 6.8.22

Figure 5-22: IR approx. max point jet 3 [7:35 (IR vid.), 430sec (data)] 6.8.22

Figure 5-23: Red-hot top-cell w/ subsiding flames [7:55 (vid.), 441sec (data)] 6.8.22

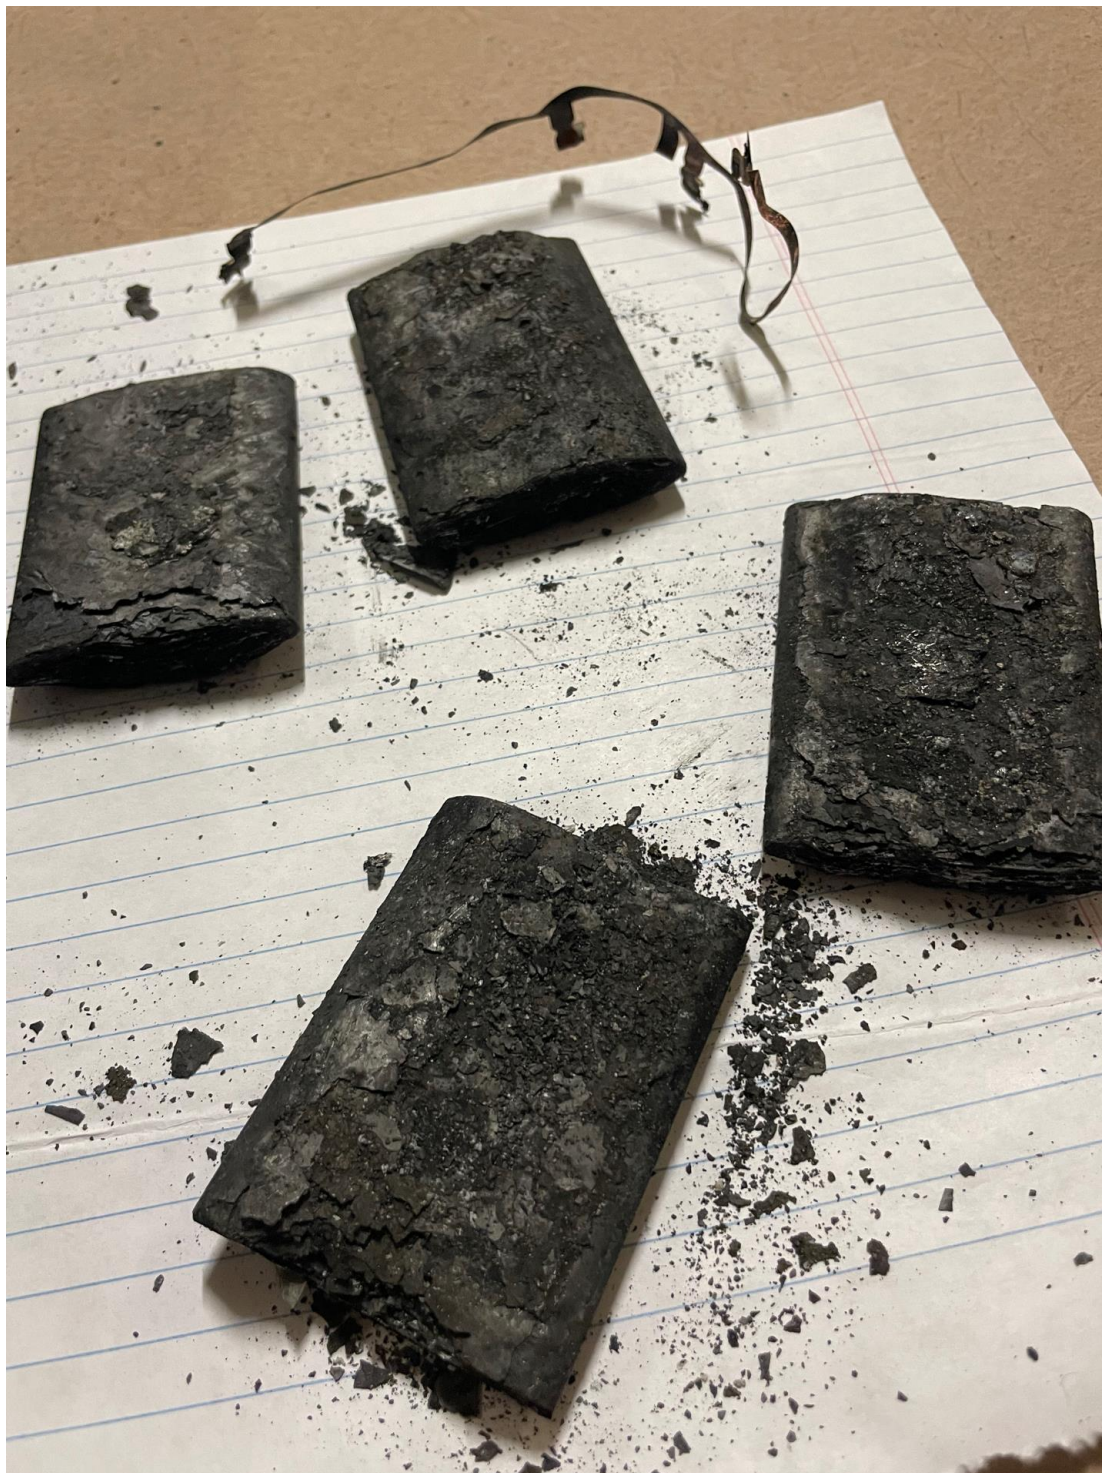
Figure 5-25: Post-condition of all 4 cells (order unknown) 6.8.22

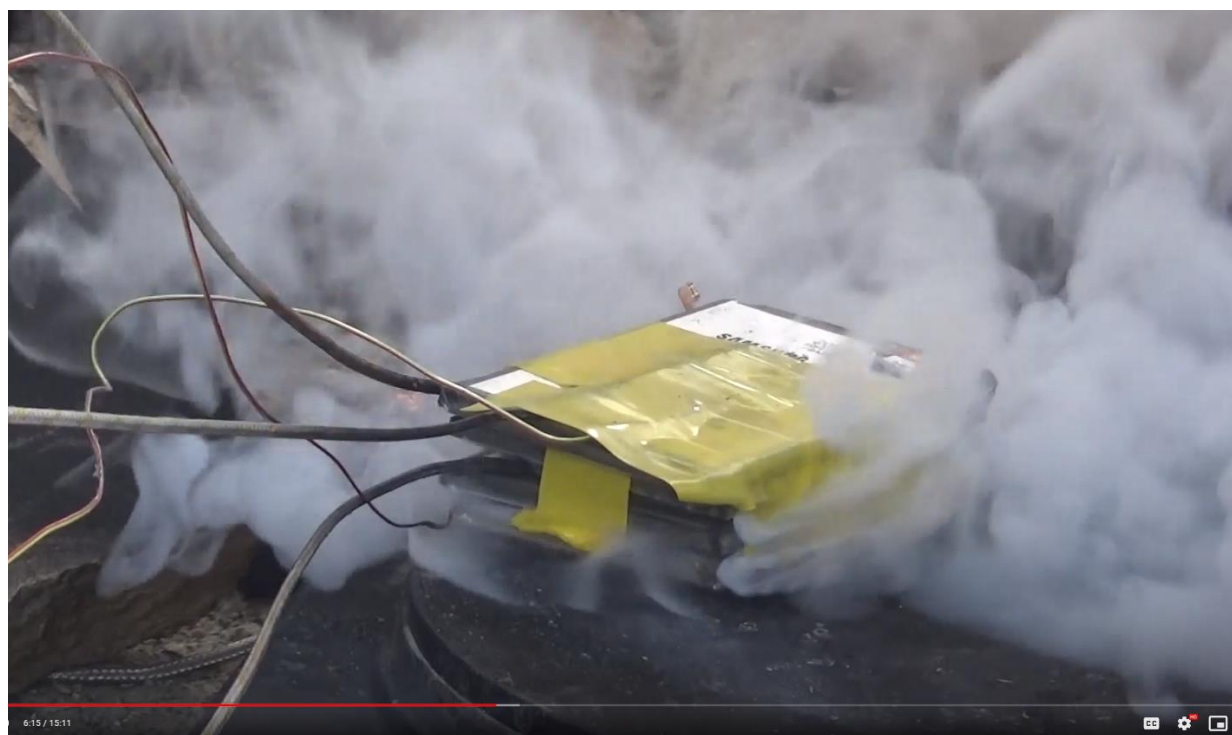
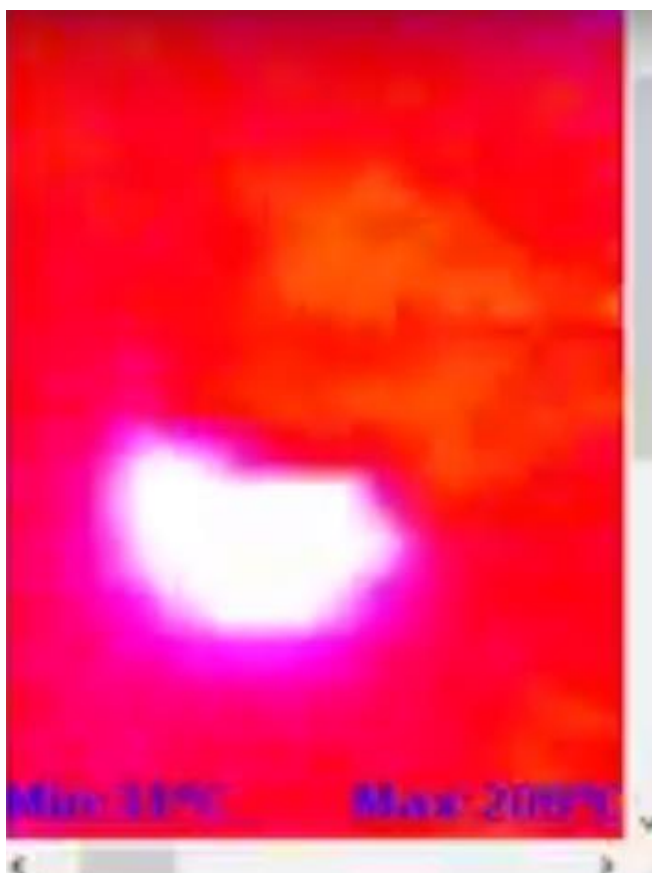
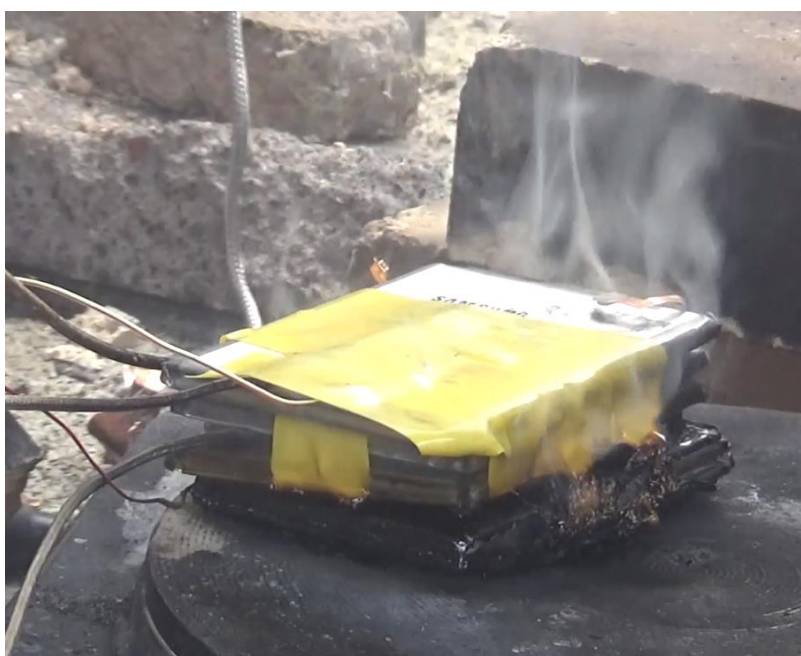
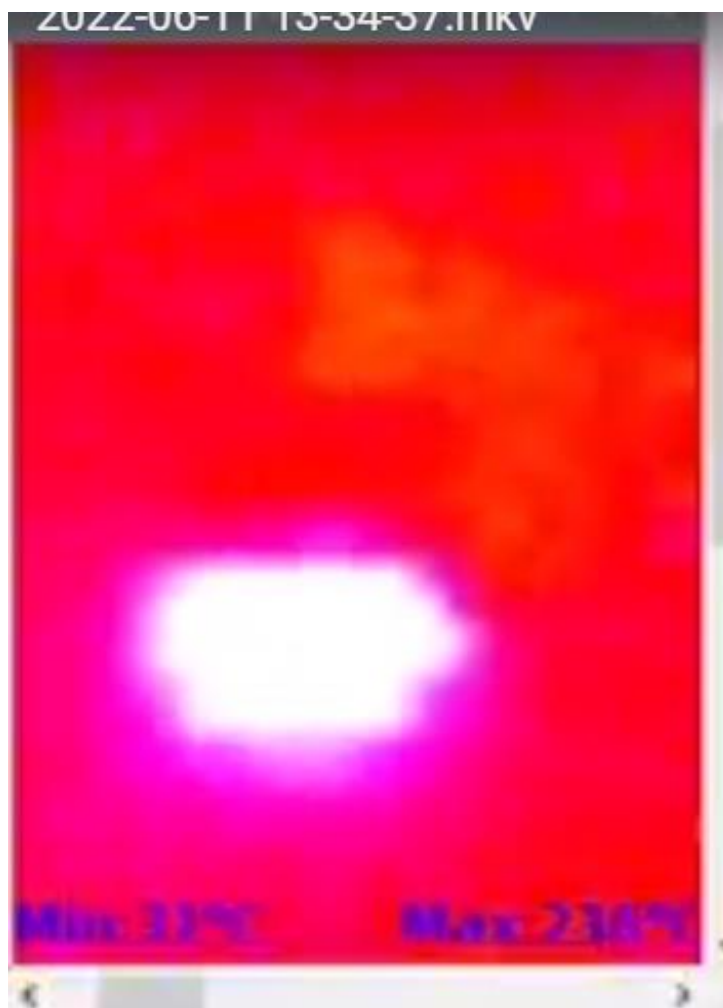
The first reaction occurred at the bottom cell where a prolonged hiss and heavy smoke event lasted about 20 seconds. In the minutes leading up to this event minimal expansion of the bottom cell was seen, but there was a quick increase in its size, between one and two centimeters, just before the first hiss. As smoke began pouring out, the expansion reduced. It appeared that the cell casing failed along its longer edge, different from the first 6.8.22 pouch hiss, where the yellow tape wrapped around the cell forced the jet of smoke out in two directions. A still-shot 5 seconds into the smoke event is shown in Figure 5-27, and the congruent IR still 5 seconds into the first hiss event can be seen in Figure 5-28. The condition of the bottom cell once most of the heavy smoke had cleared is shown in Figure 5-29, with the thermal imaging at this time seen in Figure 5-30.

Figure 5-27: ~5sec into first hiss/smoke (bottom cell) [6:15 (vid.), 335sec (data)] 6.11.22

Figure 5-28: IR ~5sec into first hiss/smoke (bottom cell) [5:54 (IR vid.), 335sec (data)] 6.11.22

Figure 5-29: Bottom cell post-hiss condition, no fire [7:44 (vid.), 424sec (data)] 6.11.22

Figure 5-30: IR bottom cell post-hiss condition, no fire [7:23 (IR vid.), 424sec (data)] 6.11.22

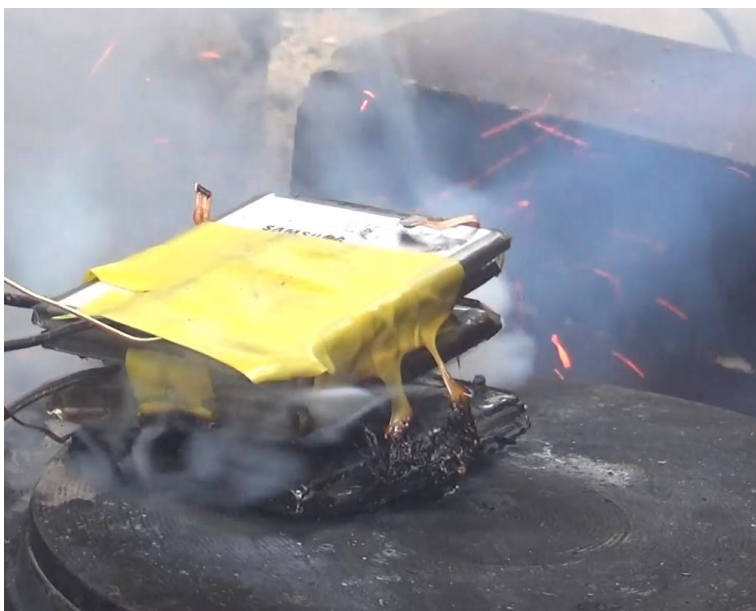
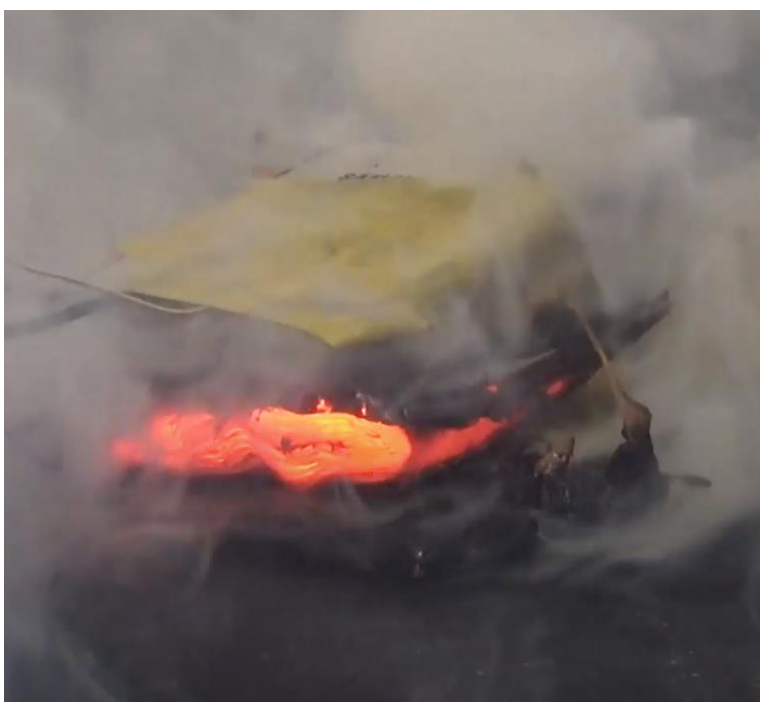
Over the next 3 minutes, the second battery expanded minimally, with light smoke, believed to be from the melting tape below, swirling about the stack of cells; until the second cell's end cap, opposite the camera view, was heard ripping open from sudden, rapid expansion. A release-of-pressure hiss immediately followed the failure of the second cell casing. Smoke did not jet out from the failure, but instead it billowed out as spark like flaming particles shot outward from within the cell. After 2 seconds the opposite end of the cell was pulled open exposing the red-hot inner contents of the cell. The progression from sparking hiss, to exposed battery layers is shown in Figure 5-31 and Figure 5-32.

Figure 5-31: Middle of 2nd hiss/expans. (2nd cell) [9:35 (vid.), 535sec (data)] 6.11.22

Figure 5-32: Red-hot innards after hiss/expans. (2nd cell) [9:38 (vid.), 538sec (data)] 6.11.22

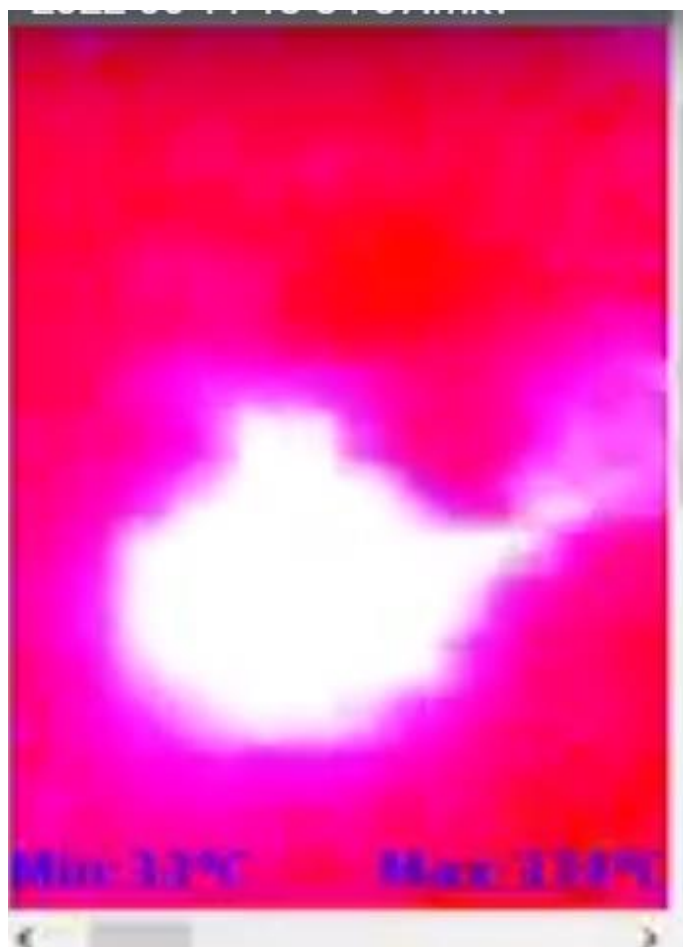
Figure 5-33: IR red innards after hiss/expans. (2nd cell) [9:17 (IR vid.), 538sec (data)] 6.11.22

There is effectively no difference in the IR image from spark-hiss to red layers since the temperature readings cannot be seen, therefore only one IR still is shown that corresponds to Figure 5-32, which is Figure 5-33.

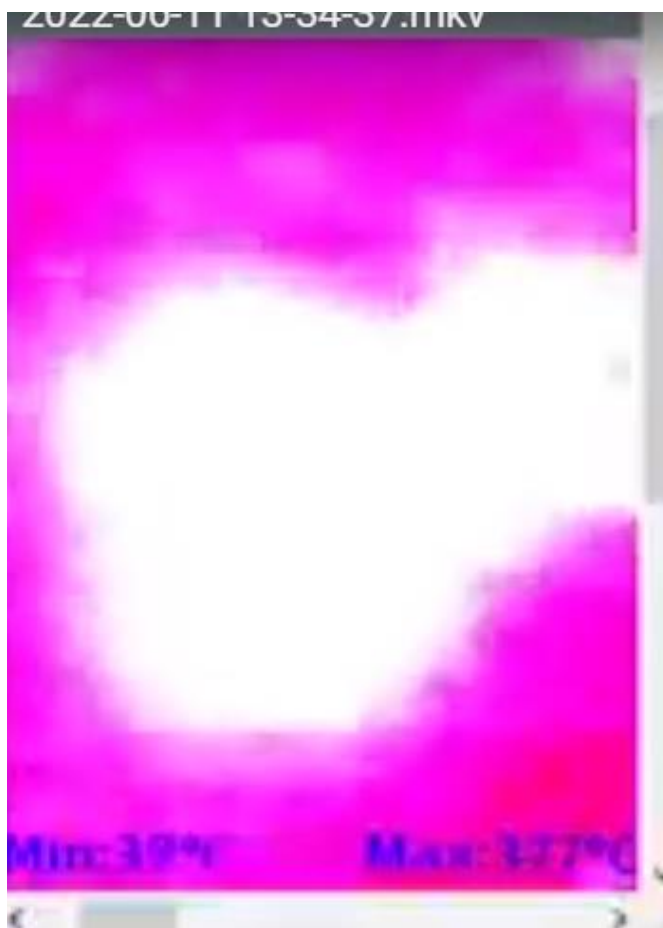
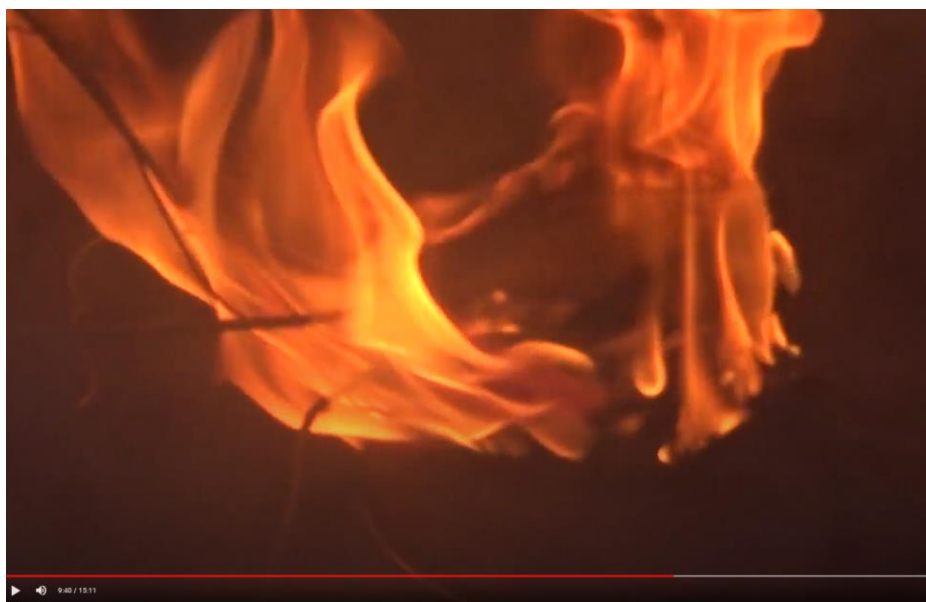
Three seconds after the exposure of the second cell's innards, flames shot out from both ends of the battery, engulfing the stack with a radius of about 4 inches. When attempting to capture the digital video moment of flame outburst, the entire view of the camera is consumed with flames for an instant; therefore, only an IR still shot, that better shows the size of the flame burst, is shown in Figure 5-34; while Figure 5-35 shows a digital video image of the flames one second later.

Figure 5-34: IR burst of flames (2nd cell) [9:19 (IR vid.), 540sec (data)] 6.11.22

Figure 5-35: 1st second after burst of flames (2nd cell) [9:40 (vid.), 540sec (data)] 6.11.22

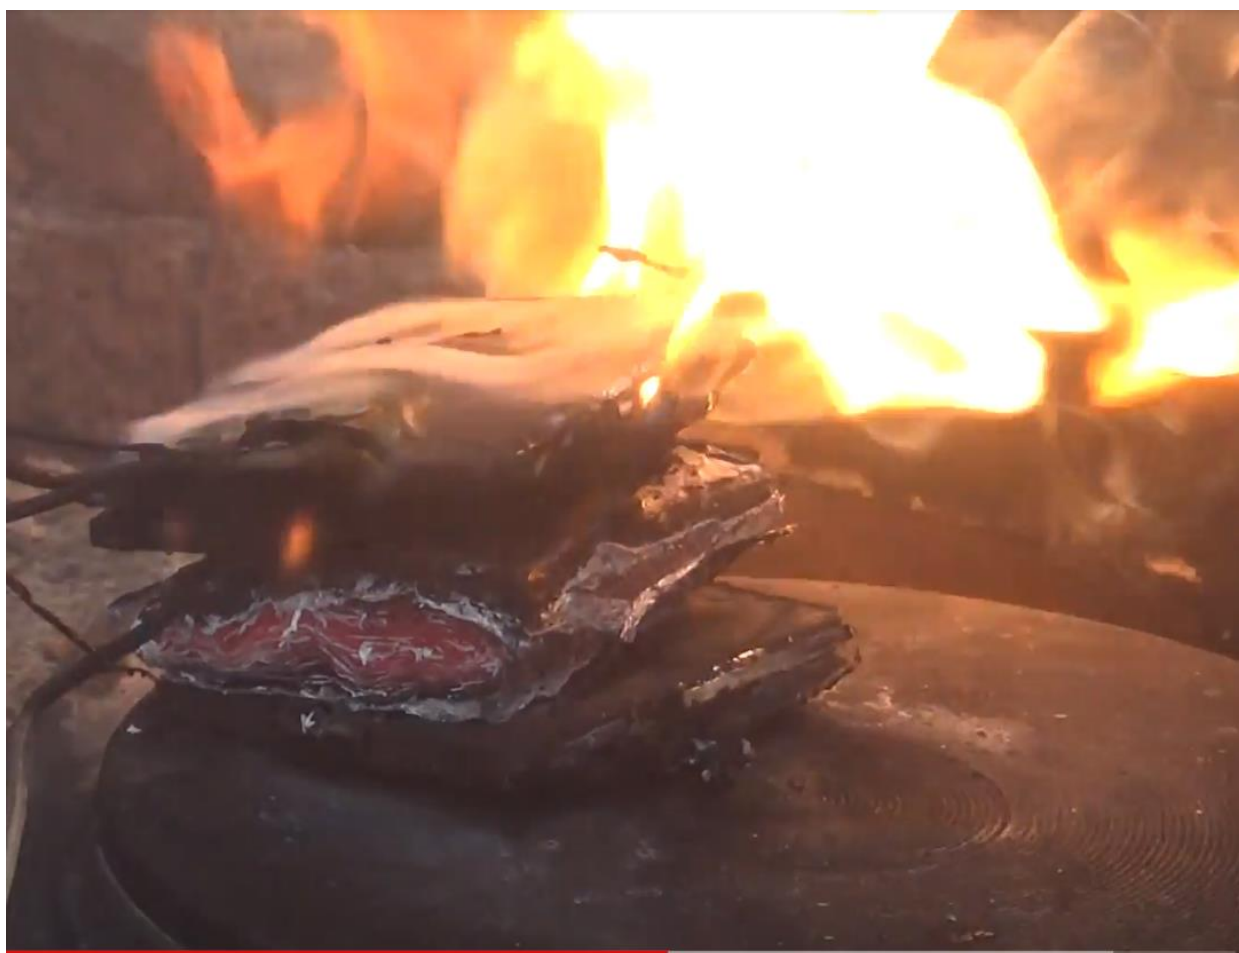
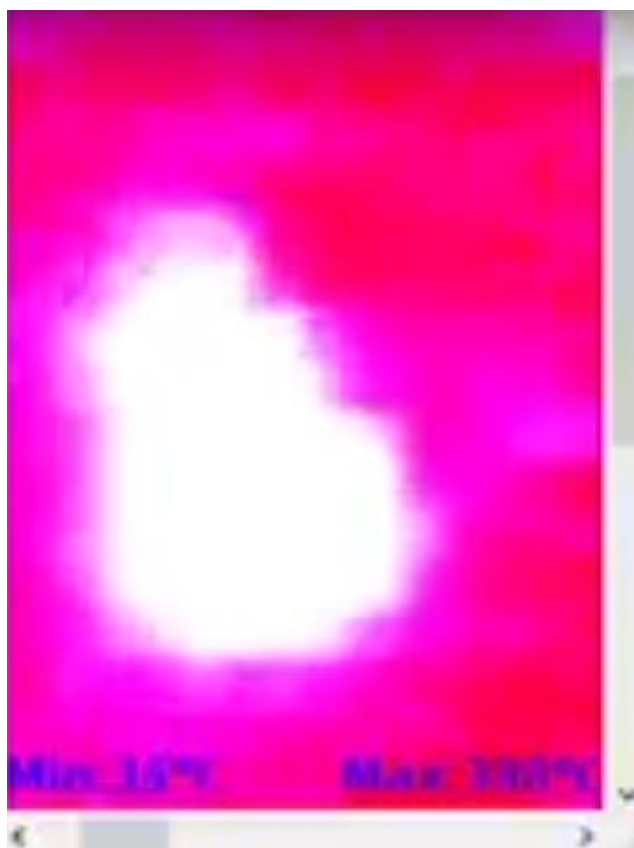
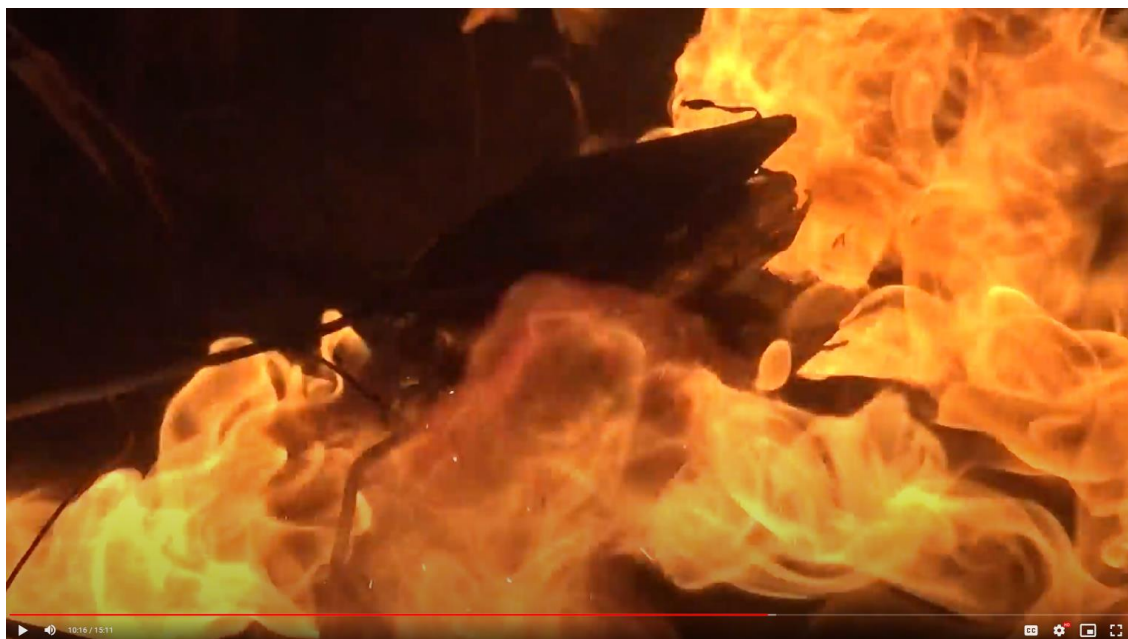
Flames were seen coming from the cell ends for about 12 seconds while tape from the cells above and below burned until the third cell reacted. The third cell underwent a rapid expansion like the second cell, but in this case, jet-flames were present immediately after the squeaking hiss of the cell casing failure. The first jet-flames from the far end of the battery, lasted just under 3 seconds before jet-flames from the opposing near end of the battery also started, which began with a similar squeaking hiss caused by the failure at the new end. Both versions (digital, IR) of the first moment of the single jet-flame can be seen in Figure 5-36 and Figure 5-37, where both versions of the dual-sided jet action are shown in Figure 5-39 and Figure 5-38

Figure 5-36: 3rd hiss w/ instant jet flames (3rd cell) [10:13 (vid.), 573sec (data)] 6.11.22

Figure 5-37: IR 3rd hiss w/ instant jet flames (3rd cell) [9:52 (IR vid.), 573sec (data)] 6.11.22

Figure 5-38: Jet flames from both ends (3rd cell) [10:16 (vid.), 576sec (data)] 6.11.22

Figure 5-39: IR jet flames from both ends (3rd cell) [9:55 (IR vid.), 576sec (data)] 6.11.22

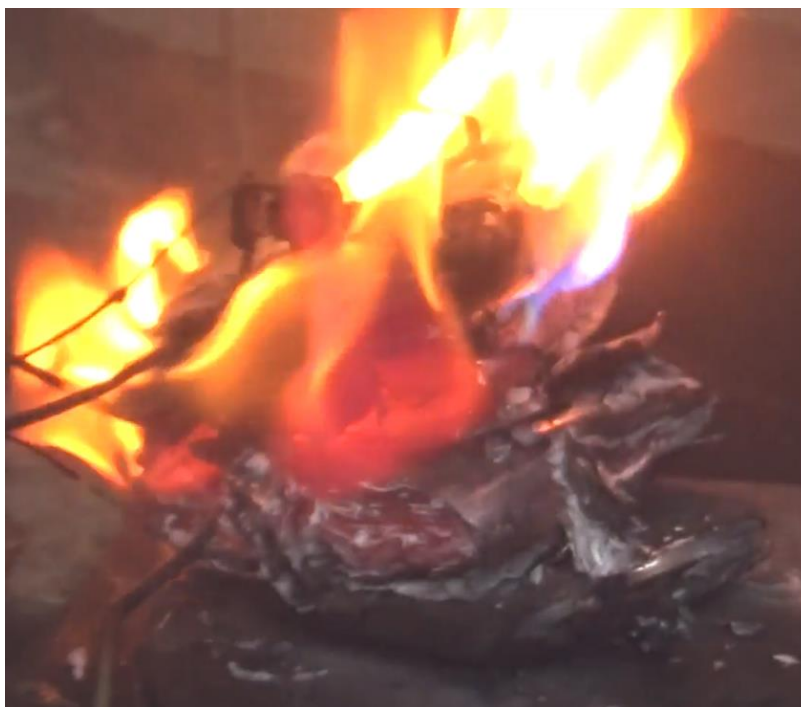
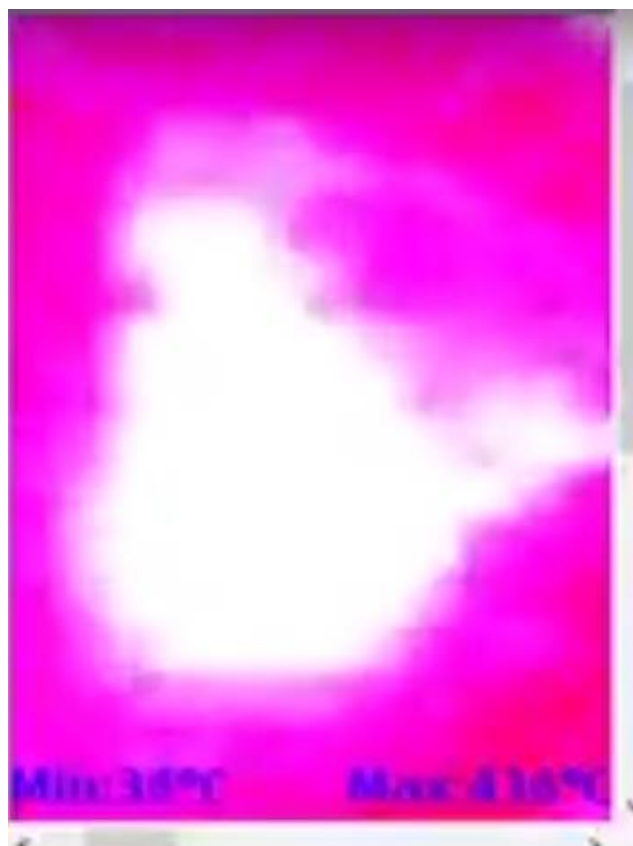
Upon cessation of the jet flames, the third cell was still engulfed in flames, along with some of the tape above. During this fire, a portion of the flames showed blue for 18 sec, which is believed to be the only test that blue flames occurred in the entire research thus far and indicated a higher temperature of the flames than other tests. At this point charring of the first two cells below had progressed to the outer layers becoming ash, which corresponds to the TC on top of the second cell reading over 900 °C, and the bottom cell TC reading over 600 °C, even without catching fire. A digital and IR still shot, 7 seconds after the jets ended, showing the blue flames can be seen in Figure 5-40 and Figure 5-41 respectively.

Figure 5-40: After jets, partially blue flame (3rd cell) [10:25 (vid.), 585sec (data)] 6.11.22

Figure 5-41: IR after jets, partially blue flame (3rd cell) [10:04 (IR vid.), 585sec (data)] 6.11.22

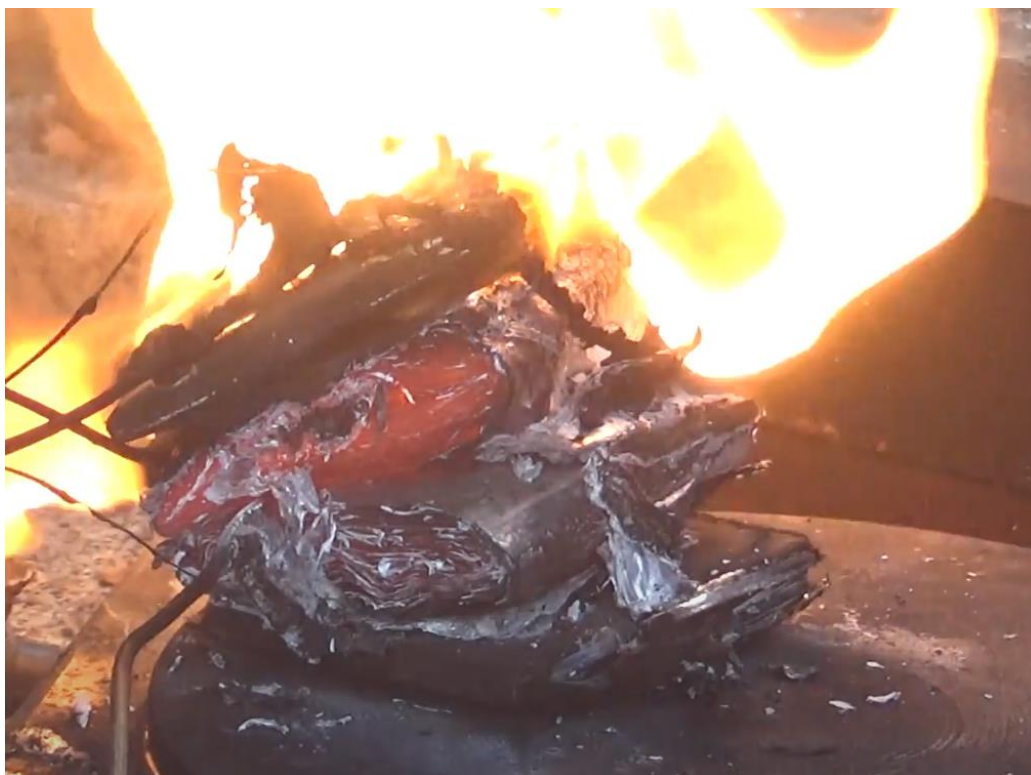
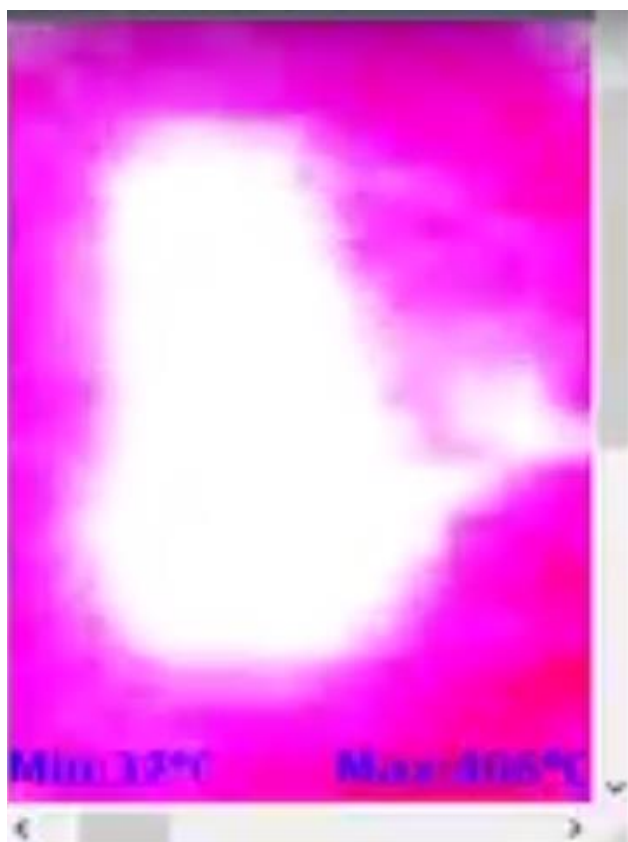
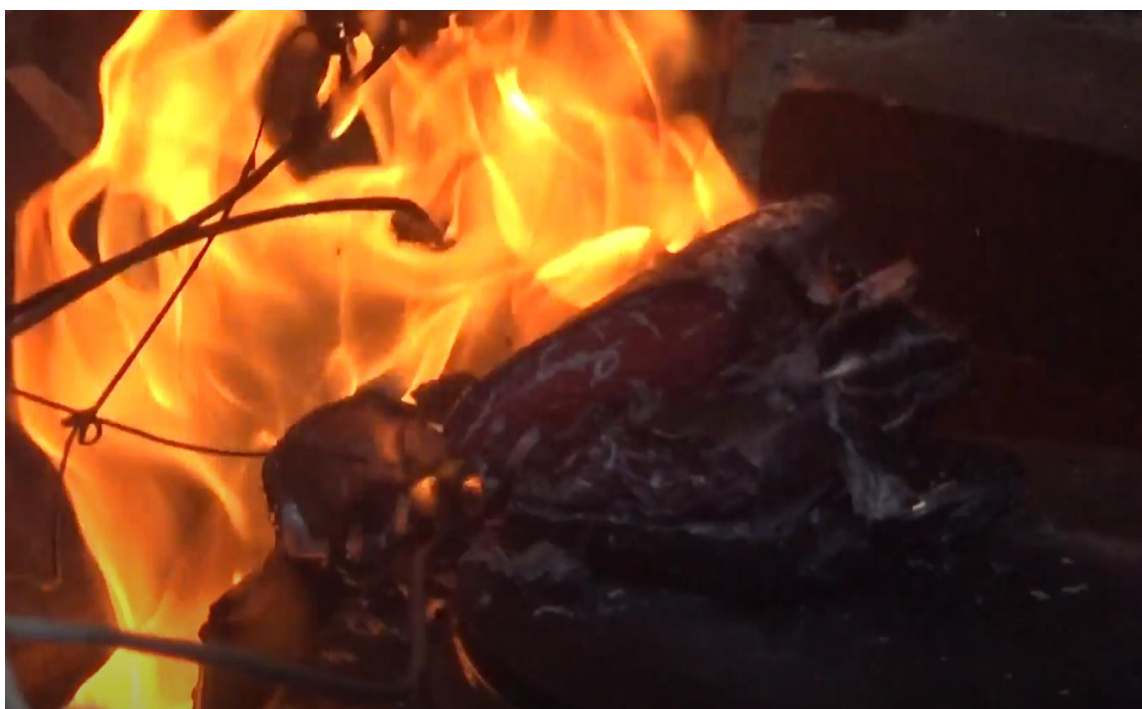
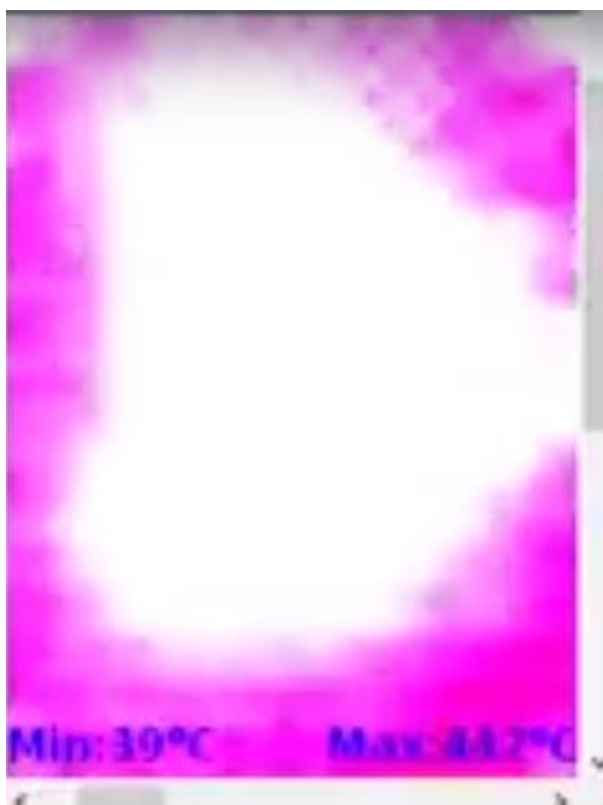
The third and final ignition, which occurred on the final top cell (fourth), appeared to start 27 seconds after the third cell's jet-flames ended. The beginning of the final fire audible sounded as if jets were about to start, but the battery fell off the stack and hot plate, which may have prevented or muffled the jets. The fourth cell slid down the side of the stack and plate coming to rest on its thin edge leaning on the left side of the hot plate. The falling cell pulled the TC between it and the third cell (Input 13) down with it, leaving the red hot third cell and other two cells still stacked in position. Upon hitting the bed of the test chamber, the largest sustained flames of the test were seen coming up from behind the plate, out of, and around the battery. Some of these flames even appeared to wrap around the corner of the plate, but due to the camera angle, it could not be confirmed if some of these flames were due to debris in the test chamber. Five seconds after the cell fell both of the top TCs and the third level TC that was still attached to the fourth cell, were seen detaching from the cell and coming to rest suspended in air a few inches above the cell, still in contact with flames. Digital and IR still shots of the top-cell fire before and after falling can be seen in Figure 5-42 and Figure 5-43 where the position of the detached TC's is seen in Figure 5-45 and Figure 5-44

Figure 5-42: Start of jet flames before falling (4th cell) [10:44 (vid.), 604sec (data)] 6.11.22

Figure 5-43: IR start of jet flames before falling (4th cell) [10:23 (IR vid.), 604sec (data)] 6.11.22

Figure 5-44: Fallen cell flames, TCs off (4th cell) [10:51 (vid.), 611sec (data)] 6.11.22

Figure 5-45: IR fallen cell flames, TCs off (4th cell) [10:30 (IR vid.), 611sec (data)] 6.11.22

It was quickly realized that the burning fourth cell was in contact with the hot plate power cord, so it was moved with the metal handling rod. This action pulled the TC between the second and third cell out from contact with the cells. The still red hot third cell had now also come in contact with the non-heating surface of the plate, so it was also removed, however the TC between the bottom and second cells remained. While the DAQ system was stopped shortly after, it was still showing real time unrecorded data on the secondary test computer. The two bottom batteries were knocked off the plate 2 minutes after the fourth cell fired and fell. One minute after this, an audible callout was made for the bottom TC that was connected to the bottom cell, still showing a reading of 300 °C (13.45 video).

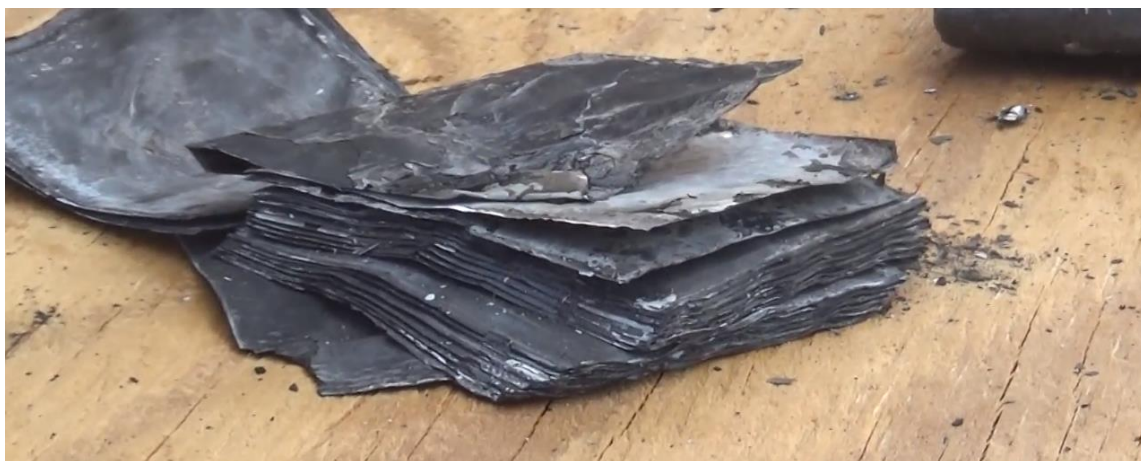
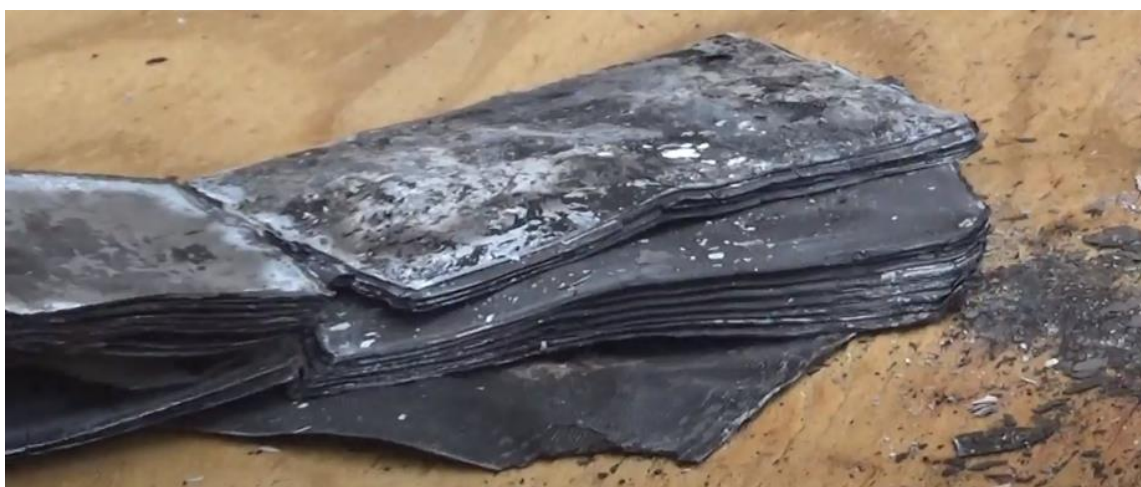
The cells were safely moved to the top cover of the test chamber for viewing and IR thermometer readings. All of the cells exceeded the 360 °C limit of the handheld FLIR gun, including in between the flipped open, separated layers of the cell shown in the video still shot Figure 5-46 and Figure 5-47, where two of the three intact cells are shown in Figure 5-48.

Figure 5-46: Hot internal cell layers (cell unknown) 6.11.22

Figure 5-47: Hot internal cell layers, flipped open (cell unknown) 6.11.22

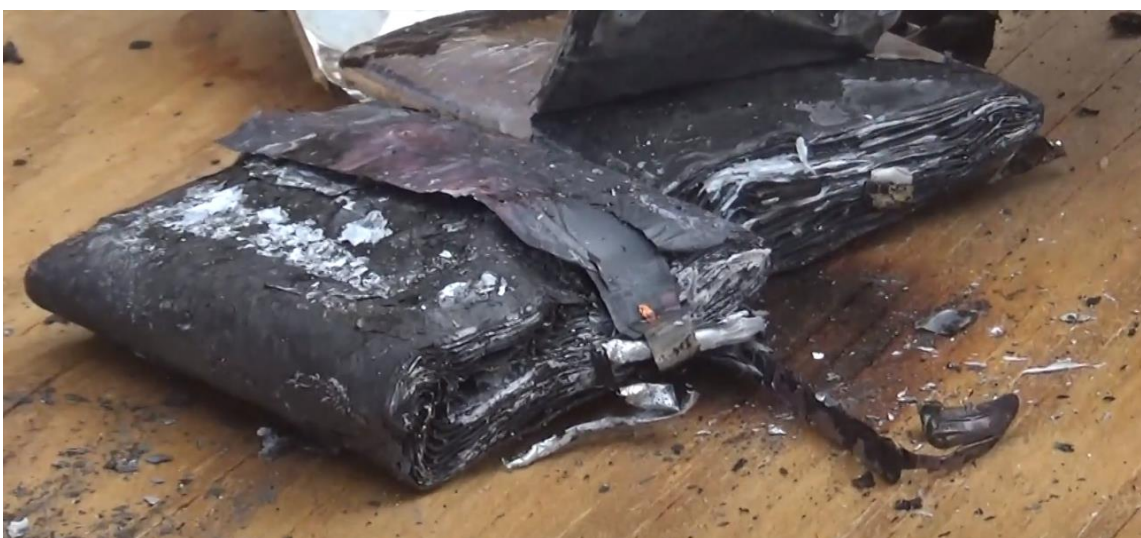
Figure 5-48: Hot intact cells (cells unknown) 6.11.22

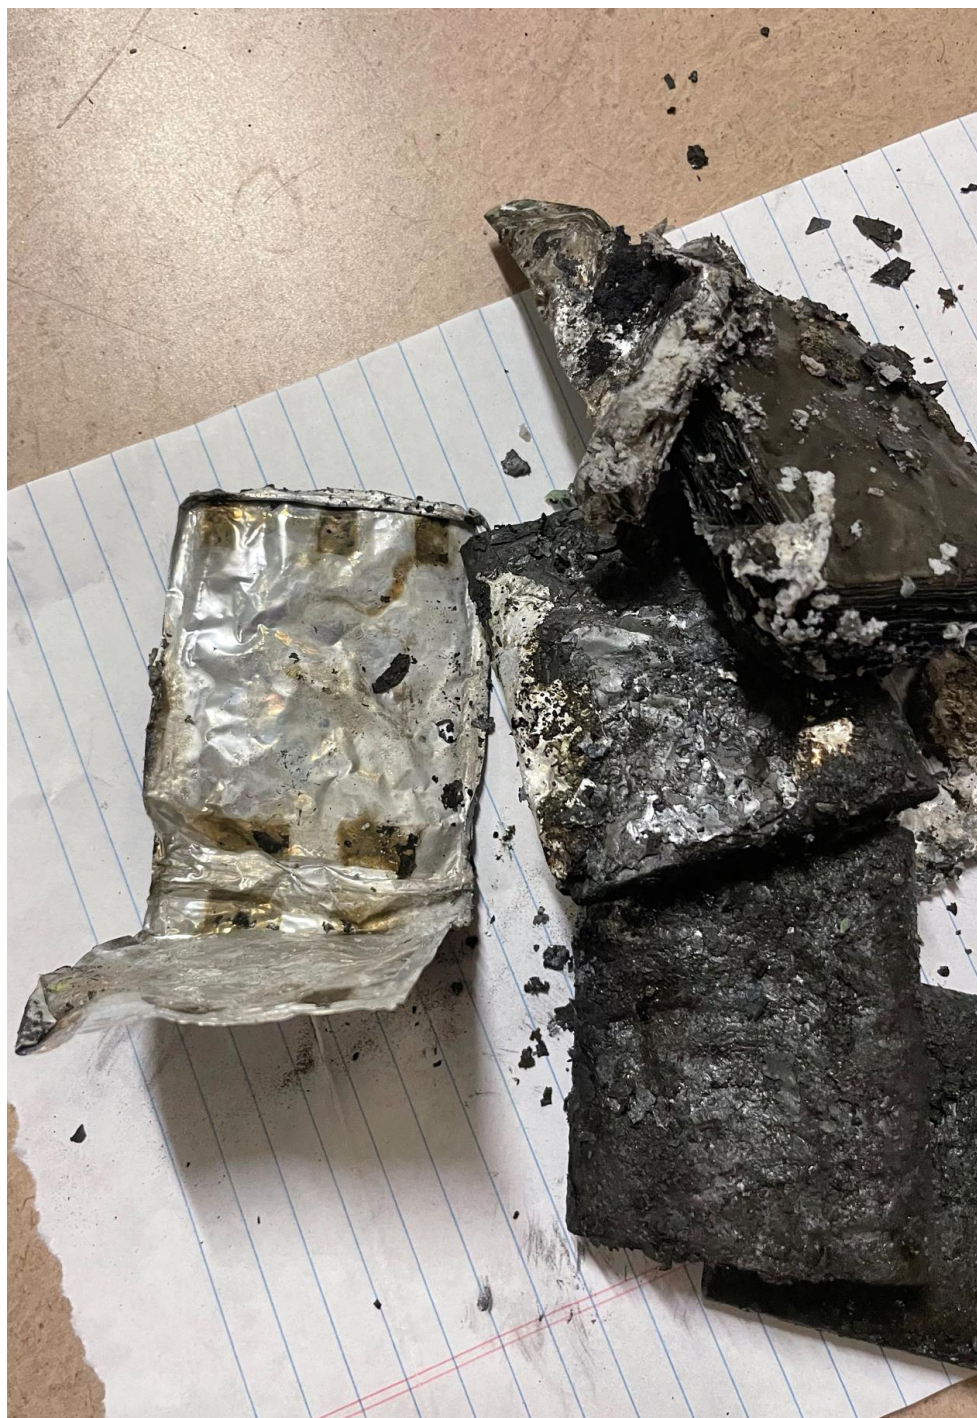
Four weeks after the test was performed, post-condition photos were taken. An outer foil casing of the layers can be seen along with crystalline formations of residue on the cells. A photo of these cells can be seen in Figure 5-49, with a zoomed in view of the residue shown in Figure 5-50.

Figure 5-49: Approx. 4-week post-test condition 6.11.22

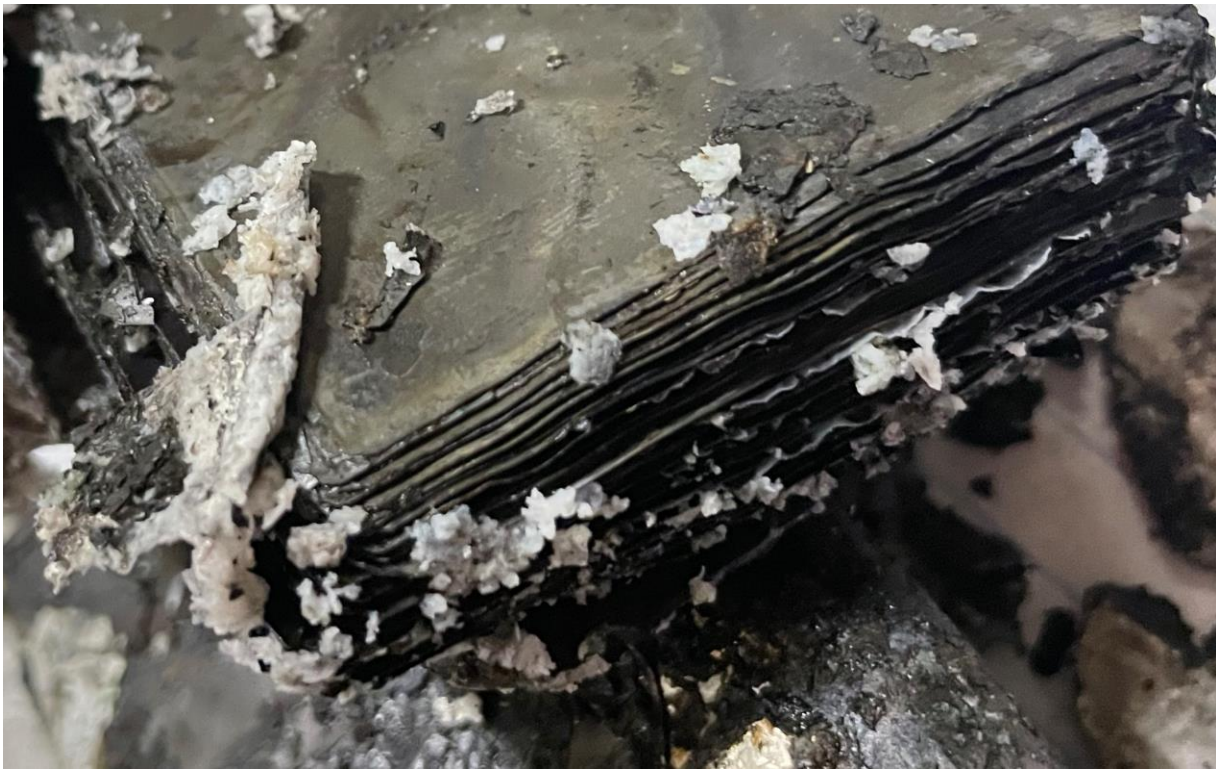
Figure 5-50: Zoomed in view of crystalline buildup, 4-weeks 6.11.22

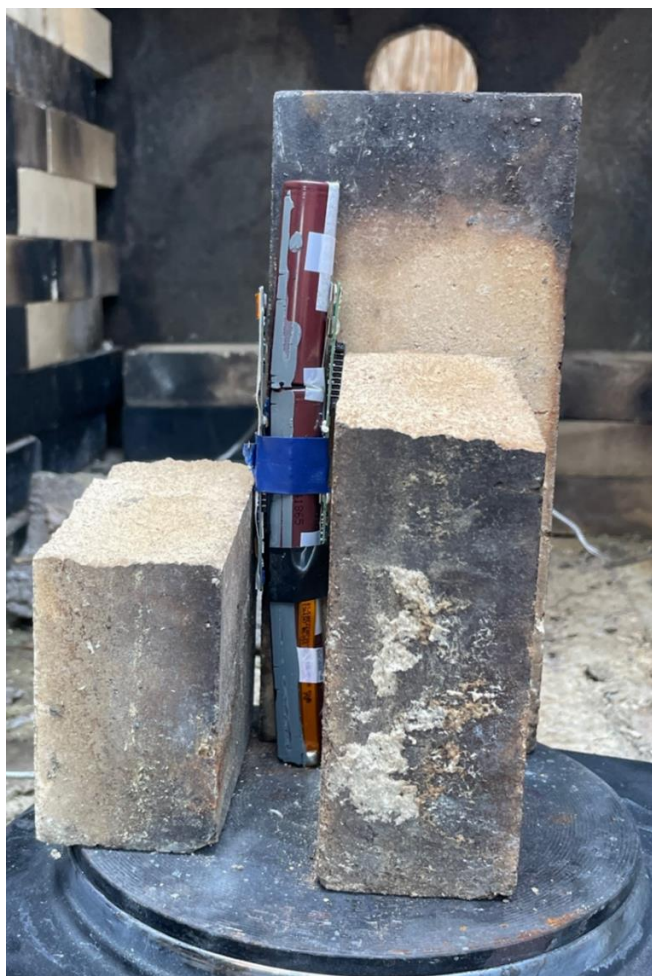
Three bricks were placed on the plate surface closely around the cell columns, exposing the viewport-facing side of the cells so they could be viewed completely by the IR camera at their level. Like the first multi-pouch test (6.8.22), the digital camera was placed on the upper rim of the test chamber giving an overhead view of the test. The column was leaned slightly toward the back brick to help the cells resist tipping over in the gap between the bricks. A snapshot of this arrangement, prior to application of the TCs, can be seen in Figure 5-51.

Figure 5-51: 6.4.22 multi-cell test setup

The TCs were also attached at different locations than the 6.11.22 multi-18650 test. Similar to all of the 18650 single-cell tests, the TCs in this 6.4.22 test, were attached at the mid-height points along the length of the cells. From bottom to top, cells one, two, and three, were attached to the SmartConnect TC, DAQ TC Input 1, and DAQ Input 15, respectively.
