EXPERIMENTAL STUDY FOR DETECTION OF THERMAL RUNAWAY, EXPLOSION,
AND FIRE IN LI-ION BATTERIES INITIATED BY HOT PLATE METHOD

A dissertation submitted to the faculty of
The University of North Carolina at Charlotte
in partial fulfillment of the requirements
for the degree of Master of Science in
Civil Engineering

2022

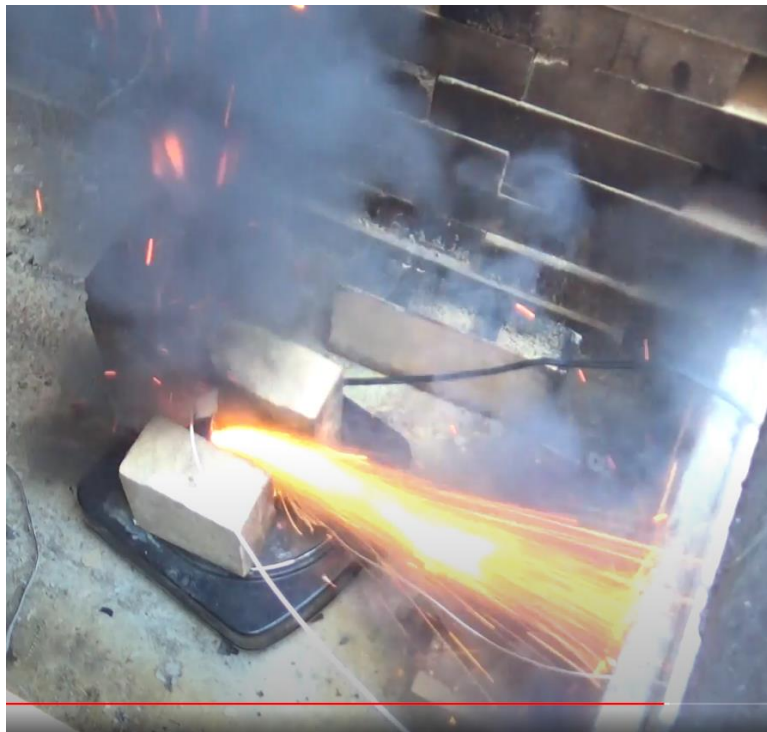
The hot plate was turned on 30 seconds after the digital camera began recording, with the DAQ and SmartConnect systems being turned on 11 seconds and 2 seconds after the plate respectively. The first 12 minutes of the digital video recording was visually uneventful, but very light smoke began to originate from the bottom of the cell column around the 12:25 timestamp. This smoke did not appear to be coming from the battery cells, but more likely the tape and adhesive residue on the cells from the module. Over the next minute of the video, the smoke transitioned between lightly visible to unseen, while the bottom TC was also detached during this time. Without warning, sparks then violently erupted from the bottom cell upwards into the cell immediately above which forced the sparks out radially in the plane of the first and second battery transition. Initially the brick surrounding only allowed sparks to travel far at the designed gap, but the sparks quickly made their way through the small gaps at the corners between the bricks. In one second the sparks were replaced by audible jet like flames expelling with the same length and trajectory. The progression from the first moment of sparks to the jet-flames can be seen Figure 5-54 and Figure 5-55.

Figure 5-54: Moment of 1st ignition bottom cell, initial sparks [13:22 (vid.), 757sec (data)] 6.4.22

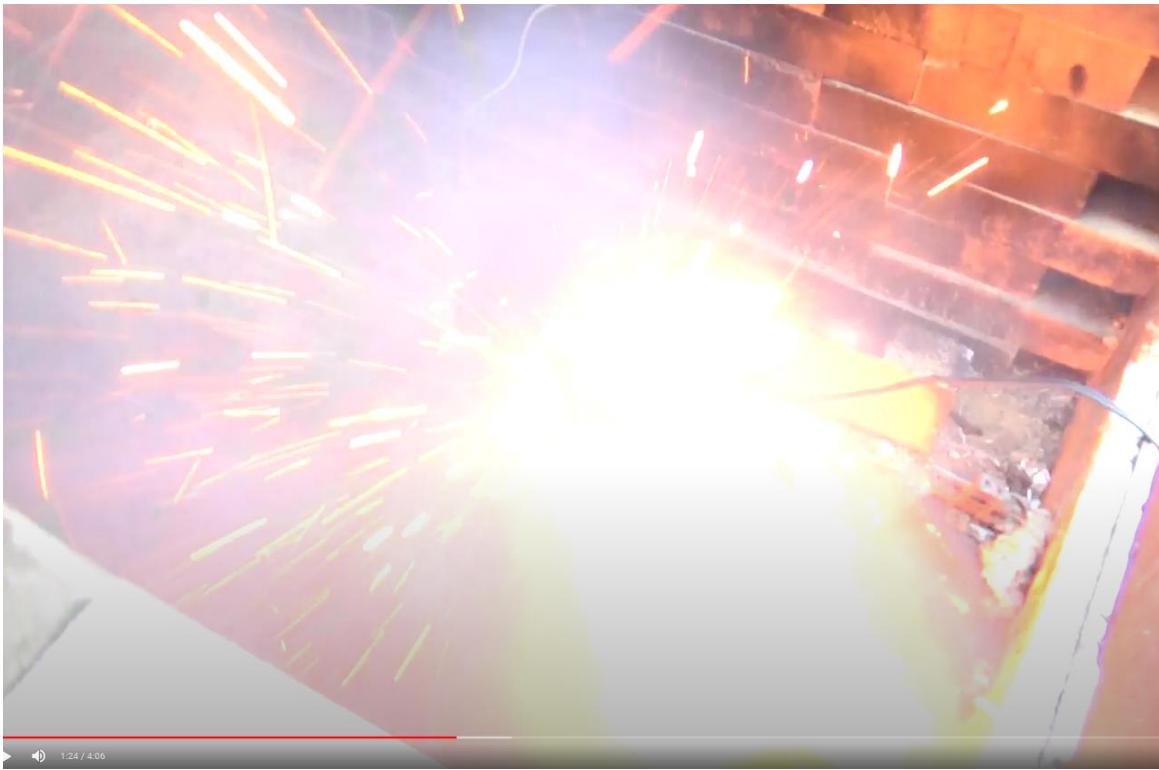
Four minutes later, the second fire occurred in the middle cell, which initially behaved like the first fire. In this fire however, the eruption of sparks quickly favored the left side of the video view which shot the column of cells to the right horizontally inside the chamber, projecting it into the wall just below the viewport opening and on top of a raised steel plate area. The video still shots from the digital camera, and the now working IR camera, of the initial in place explosion and the propulsion of the cells into the wall, can be seen in Figure 5-56 through Figure 5-59.

Figure 5-56: Moment of 2nd ignition, 2nd cell, sparks [1:24 (2nd vid.), 1061sec (data)]

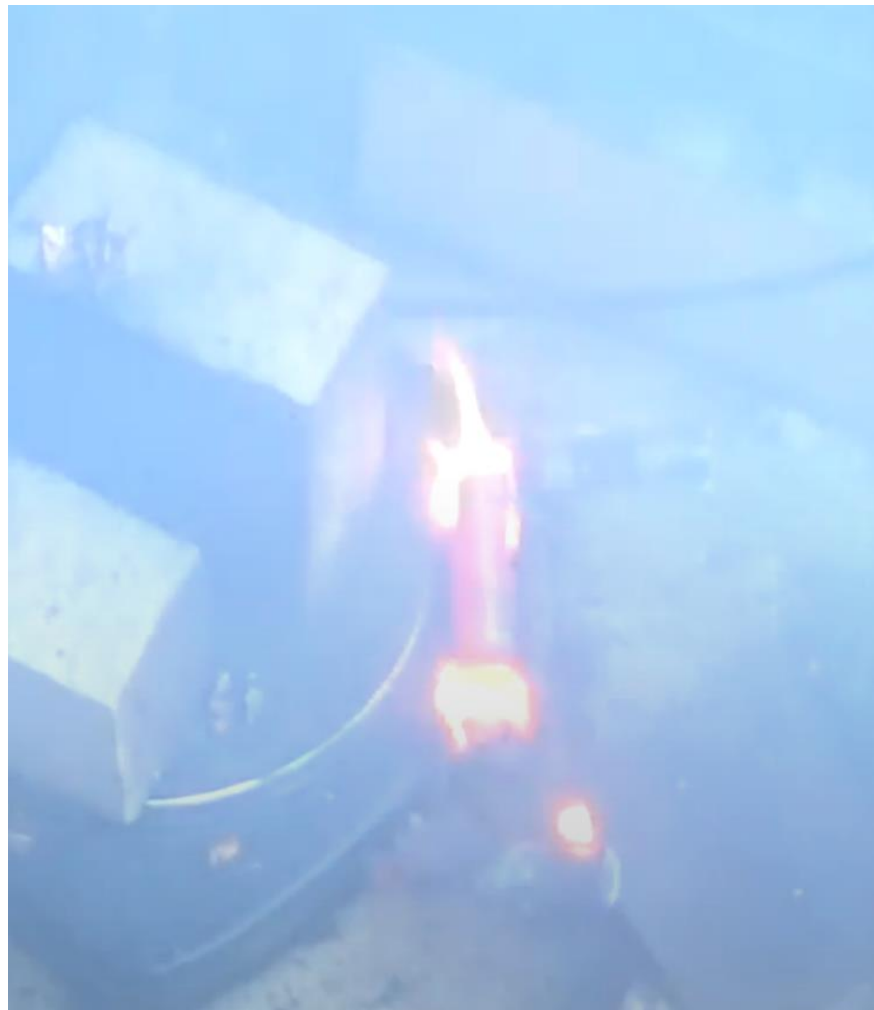
The cells hovered at the wall-plate interface for 2 seconds before an explosion of sparks, flames, and tape consumed the chamber, ending the propulsion and displacing the batteries to their final positions. The second cell, which caused the violent explosion, was red hot with small flames present at each end and had landed on the hotplate just above the temperature dial. This can be seen in Figure 5-60, and the corresponding IR view can be seen in Figure 5-61. A post-condition photo of all three cells can be seen in Figure 5-62, and a close-up photo of the middle cell failure at the negative end can be seen in Figure 5-63.

Figure 5-60: 2nd ignition, after jet, cell red-hot, dual-end flames [1:29 (2nd vid.), 1066sec (data)]

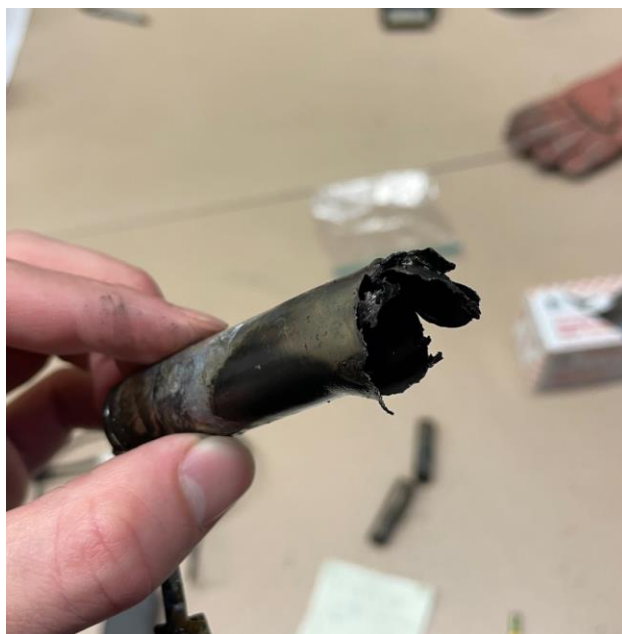
Figure 5-63: Post-condition middle cell, 6.4.22

similar, dual-end cap failure occurred in the 6.4.22 multi-18650 test; and while the brand of these cells was different (LG), the cause of this failure is theorized to be a different reason, as discussed in section 6.5.

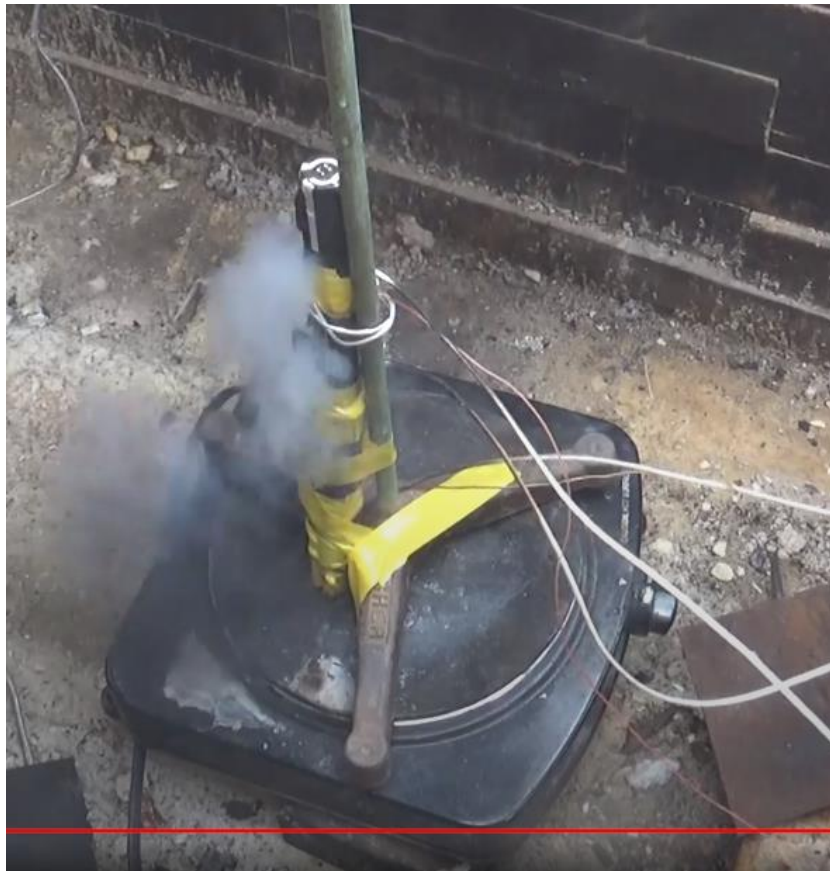
The explosion that occurred was the loudest heard throughout the course of this research, however there were no flames afterwards from or on any of the cells. There was a small flame noted partially in view at the bottom of the video that may have been burning inner layers of the bottom cell, but it could have also been a piece of tape that was ejected from the bottom cell surface, or both. This loudness of this explosion correlated to a rapid displacement of the cell column and the initial part of the explosion before displacement could only be viewed frame-by-frame at quarter speed. The still shot of the moment the explosion occurred can be seen in Figure 5-65, which is followed by Figure 5-66, showing the projectile column of cells and cloud of debris projecting radially upward from around the plate. A corresponding IR video still shot to this explosion is shown in Figure 5-67.

Figure 5-65: Explosion bottom cell, ¼ speed still shot 1 [16:40 (1st vid.), 973sec (data)] 6.11.22

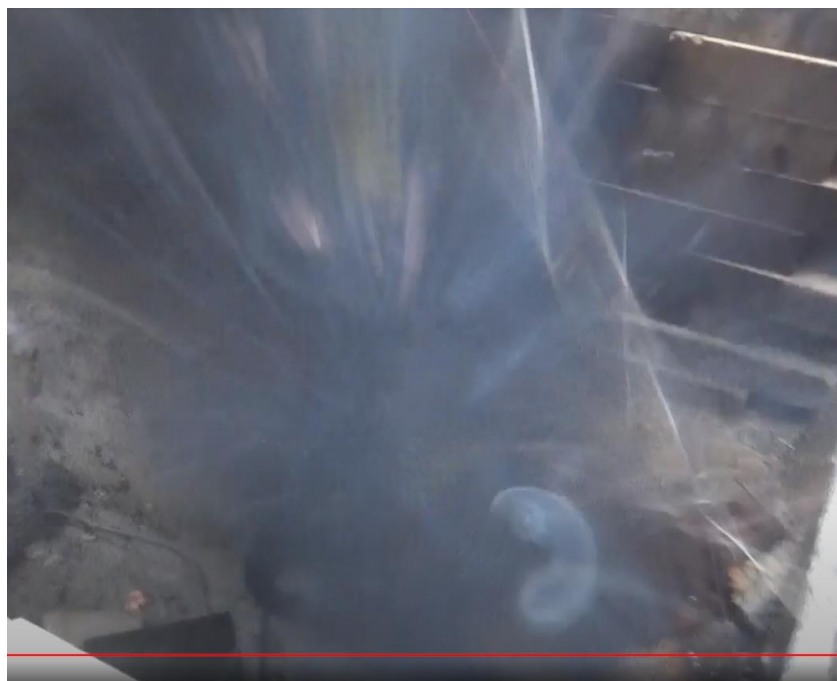
Figure 5-66: Explosion bottom cell, 1/4 speed still shot 2 [16:40 (1st vid.), 973sec (data)] 6.11.22

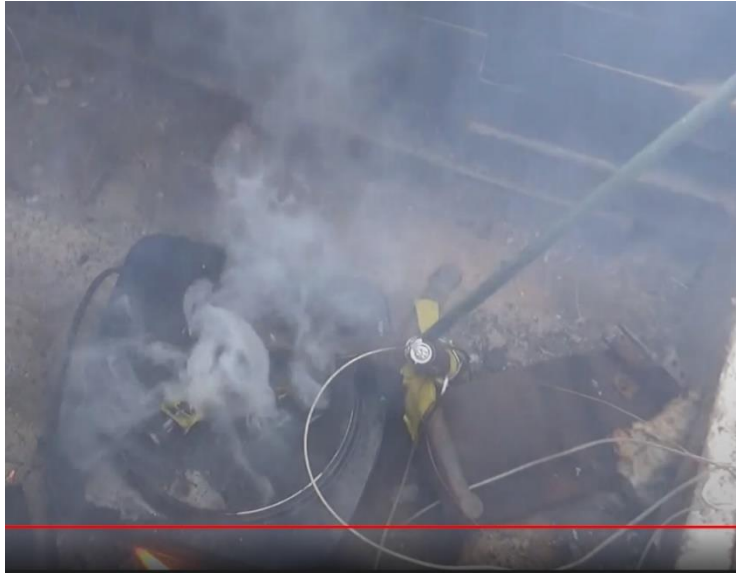
A still shot showing the position of the cells post explosion and the small flame can be seen in Figure 5-68, with a post-condition photo showing the positive end cap from the bottom cell implanted into the negative end cap of the second cell shown in Figure 5-69.

Figure 5-68: Post-explosion cell position, small flames [16:44 (1st vid.), 977sec (data)] 6.11.22

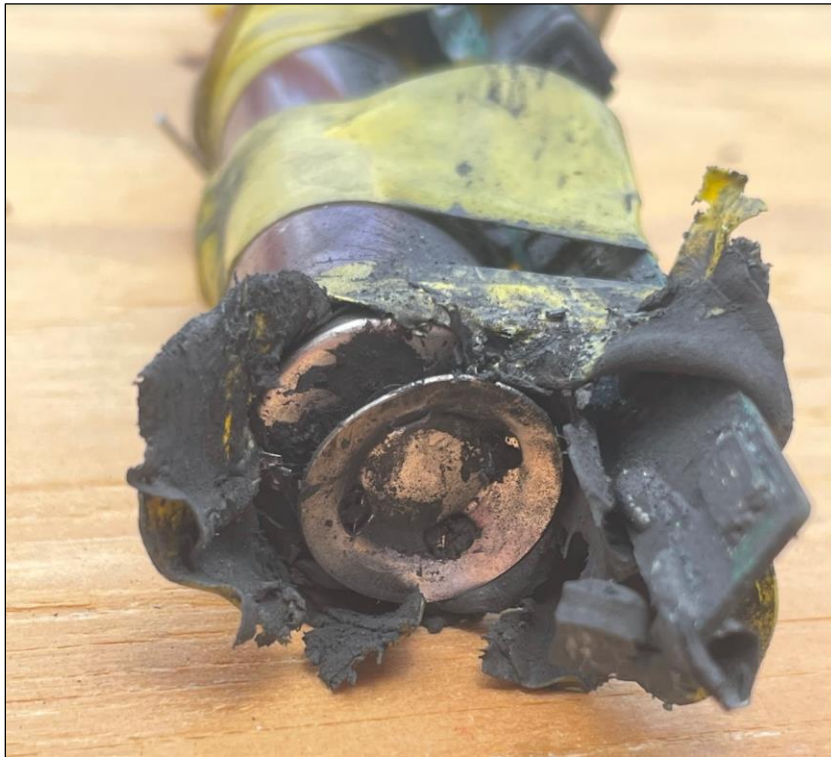
Figure 5-69: Post-condition photo, implanted (+) end cap, 6.11.22(18650)

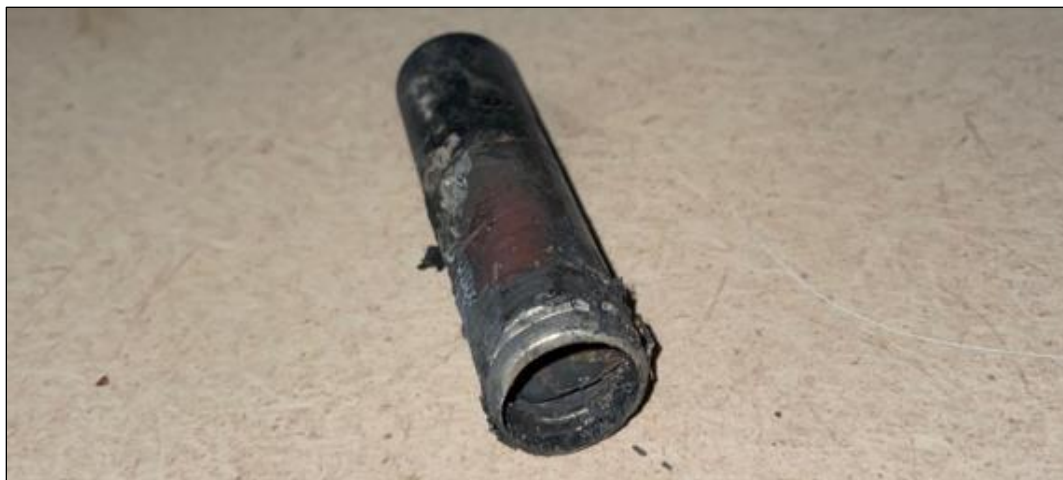
Upon complete cooling of the tested cells, further post-condition photos Figure 5-70 and Figure 5-71, were taken of the bottom cell, showing its completely emptied casing and some of the recovered inner cell layers.

Figure 5-70: Post-condition photo, emptied bottom cell, 6.11.22(18650)

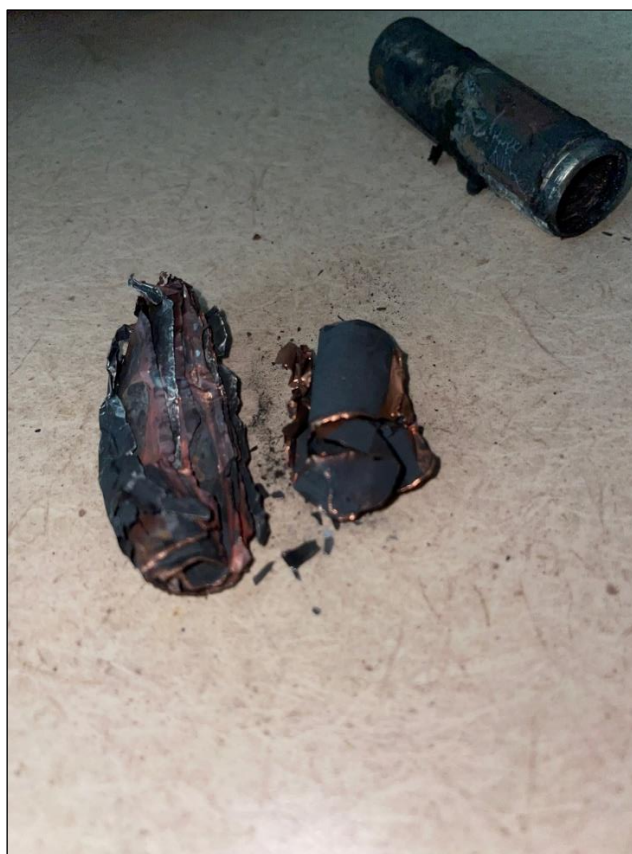
Figure 5-71: Post-condition photo, bottom cell w/ ejected innards, 6.11.22(18650)

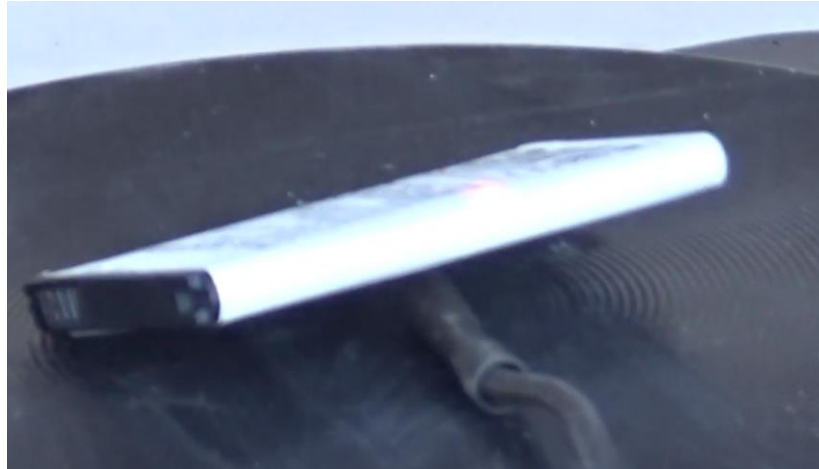
For the ICR tests, all tests on the plate used for the bulk of test events saw an explosion and fire (4.12, 4.13, 5.4.22). In the 50% SOC test, performed on the first plate which showed less heating, the explosion created so much smoke that confirmation of a fire could not be confirmed or denied. The first partially reported test on the matrix was the 3.2.22, 0% ICR, for this test instruments were still being validated and the experiment procedure was early in development. In this test the hot plate was turned to medium for a few minutes before eventually being turned to high, which is believed to cause the over 16-minute time to explosion. The cell expanded close to two inches without visible or audible failure of its casing, and sustained this shape for around 5 minutes, before an extremely loud explosion with minimal smoke occurred. This gradual buildup of pressure, demonstrated by the three phases in Figure 6-1 through Figure

Figure 6-1: Phase 1, no expansion, ICR 3.2.22

6-3, is believed to have allowed the plastic case to become more malleable, instead of being ruptured by a more rapid expansion.

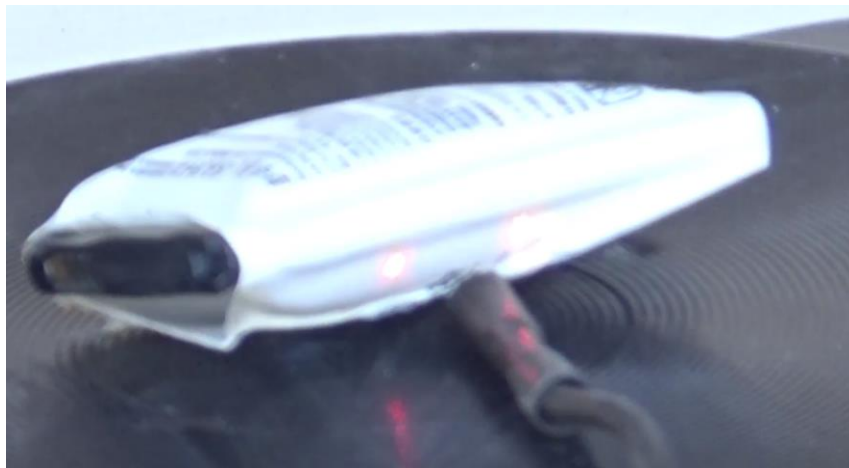
Figure 6-2: Phase 2, medium expansion, ICR 3.2.22

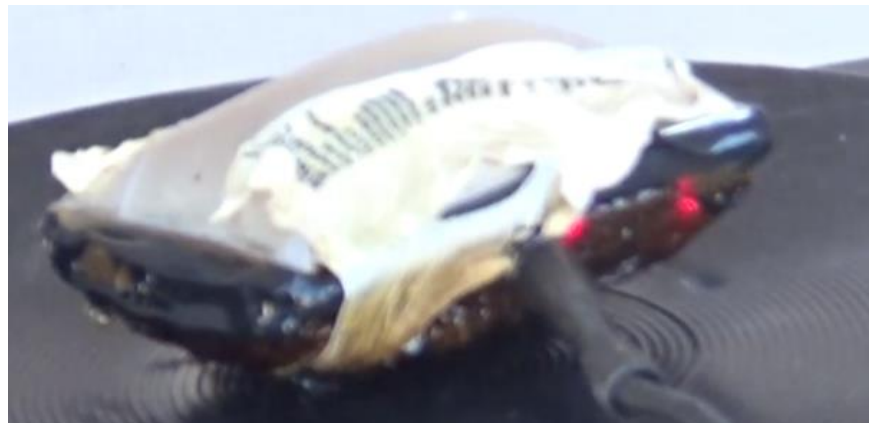
Figure 6-3: Phase 3, full expansion, ICR 3.2.22

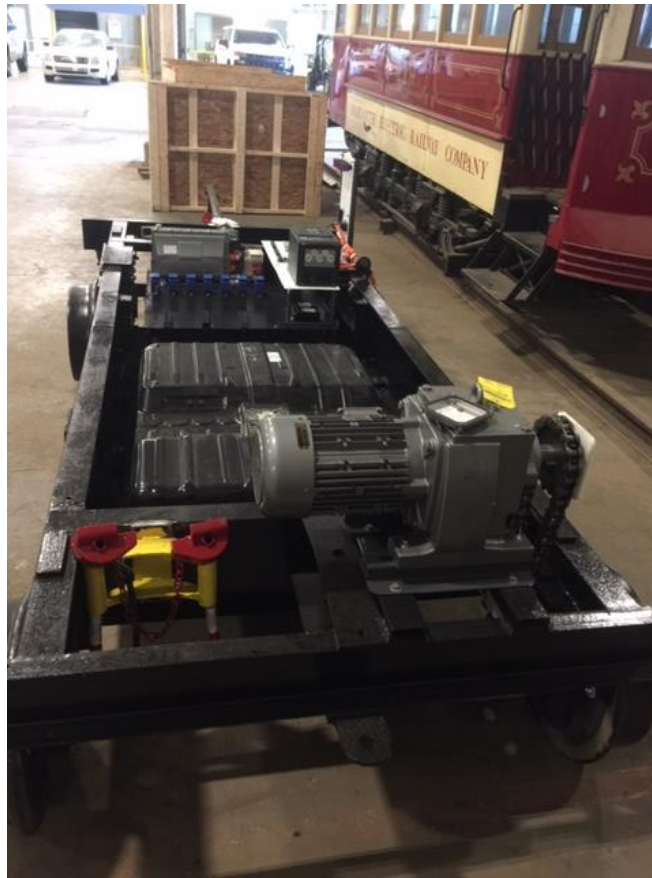
Sample designs for options 1 and 2 were discussed in detail in Chapter 2. The third arrangement has been employed for the town of Belmont, NC's installation of a new public-transit trolley. This prototypical, two-member-consist design includes a single trolley car for the operator and passengers, and a small, steel trailer that was custom fabricated for battery storage for this system. The separate trailer houses the LIB pack(s) that will externally power the electric motor in the trolley through inter-car wiring. Figure 8-2 shows the fully functional trailer car at Belmont, NC, where the trailer is holding a Nissan LEAF battery module that powers the historical trolley car (Car # 1).

Figure 8-2: Belmont battery trailer car

While currently fitted with one LEAF battery module, plans for an additional second LEAF battery module are in development, including programming logic that will allow a BMS to communicate with both modules concurrently, which will be required for charging and SOC monitoring. The trailer car will eventually be protected from rain and other types of damaging exposure.

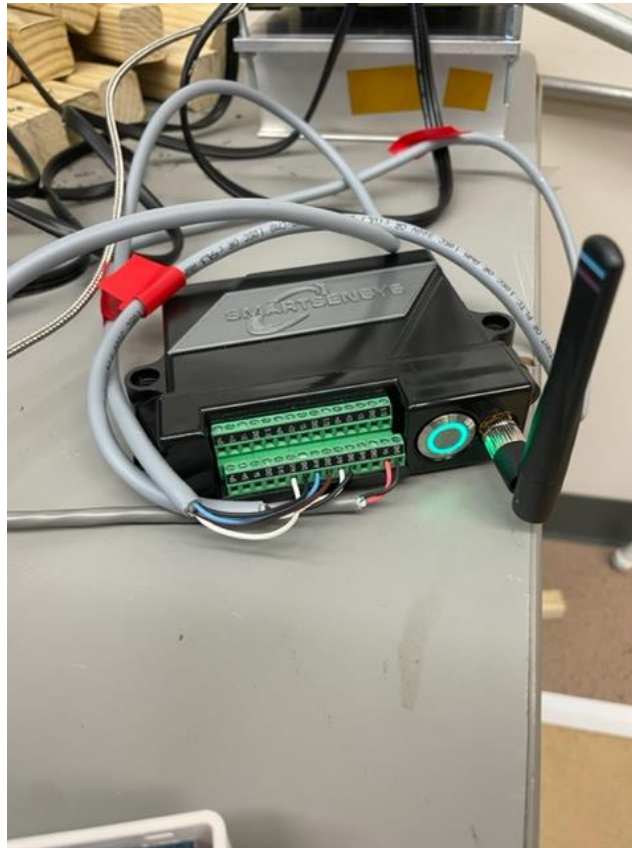
- After successfully adding base station, turn on the Node (Node 60342) with one push of the silver button. [Fig. 8] (Node light will flash green once per second when on and idle)

Figure 8- Node powered on

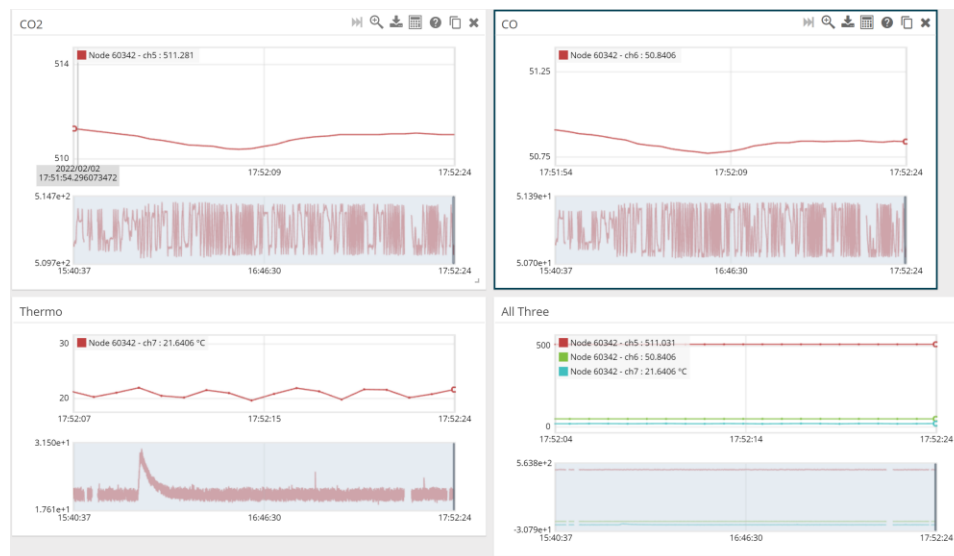
- A channel(s) must be assigned to the time series graph. [Fig. 13]
- CHANNEL 5= CO2 SENSOR
- CHANNEL 6= CO SENSOR
- CHANNEL 7= THERMOCOUPLE
- Multiple widgets can be added at one time and multiple channels can be added to a single widget. Example results are shown in [Fig. 14]

Figure 14- Sample data (single channel and combined)
