DETECTION AND CLASSIFICATION OF DEFECTS IN METAL PARTS USING
ATOS PROFESSIONAL 2019

A thesis submitted to the faculty of
The University of North Carolina at Charlotte
in partial fulfillment of the requirements
for the degree of Master of Science in
Mechanical Engineering

2022

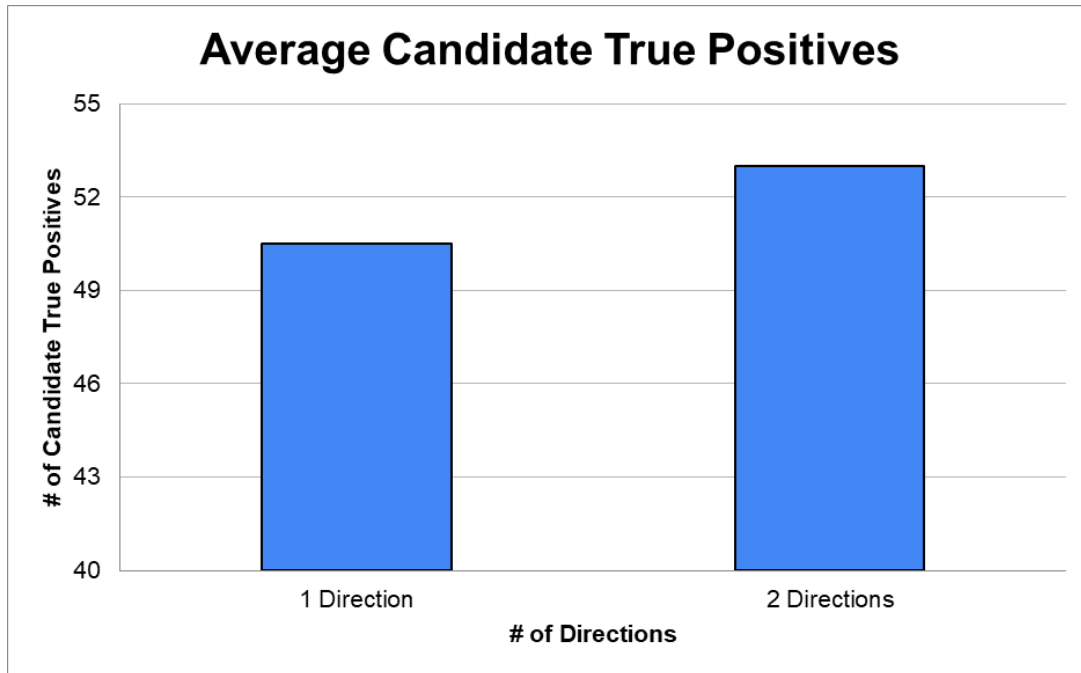
FIGURE 6-15: Average candidate true positives for Experiment 3 full mesh inspection

The largest difference existed at the top right defect again, but there were several other defects with greater than a 5% difference, such as the top left and bottom right dents. While the scratches reported very similarly across both trials, there was a notable increase in error for all the dents. A similar pattern can be seen in the candidate true/false positive data in FIGURE 6-15 and FIGURE 6-16.

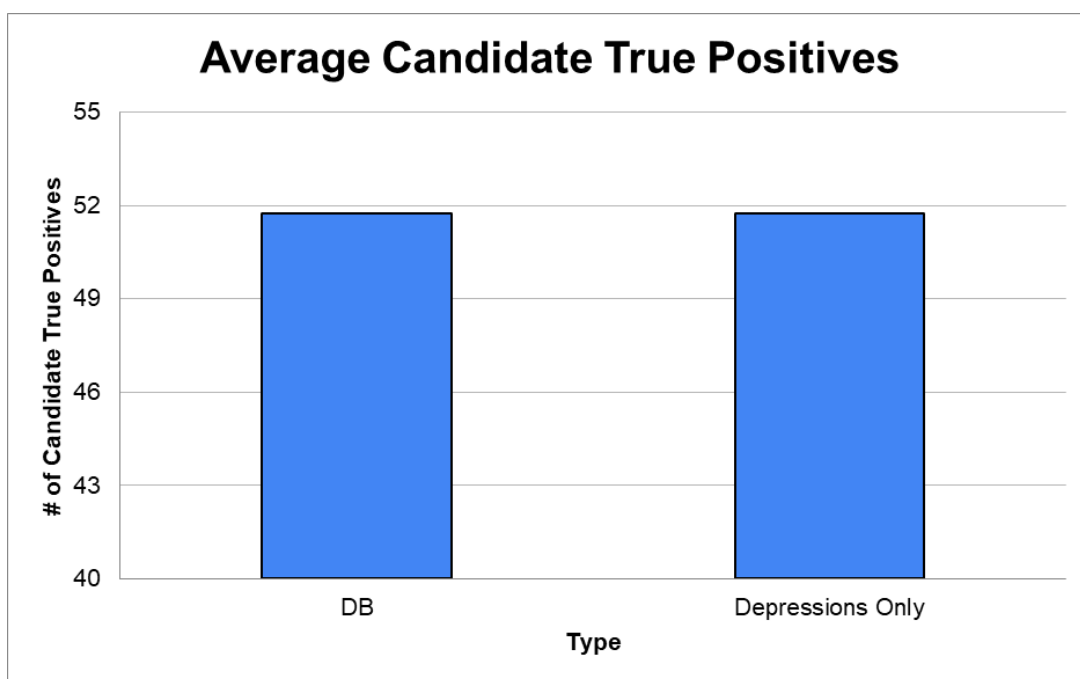
FIGURE 6-20: Average candidate true positives for Experiment 4 full mesh inspection

The scratch trials are close for both options, but the parameters that are not close are separated by almost 20% error. Across the conducted experiments, it is noticeable that the defects that register the most error are the scratches and the top right dent. This make sense for the scratches, as their geometry provides many different edges for the defect map to interpret in different ways. The only observed difference between the top right defect and the other defects is that it is the closest defect to the origin. The previously observed discrepancy between the trials that changed and the ones that didn't is even more visible in the full mesh data contained in FIGURE 6-20 and FIGURE 6-21.

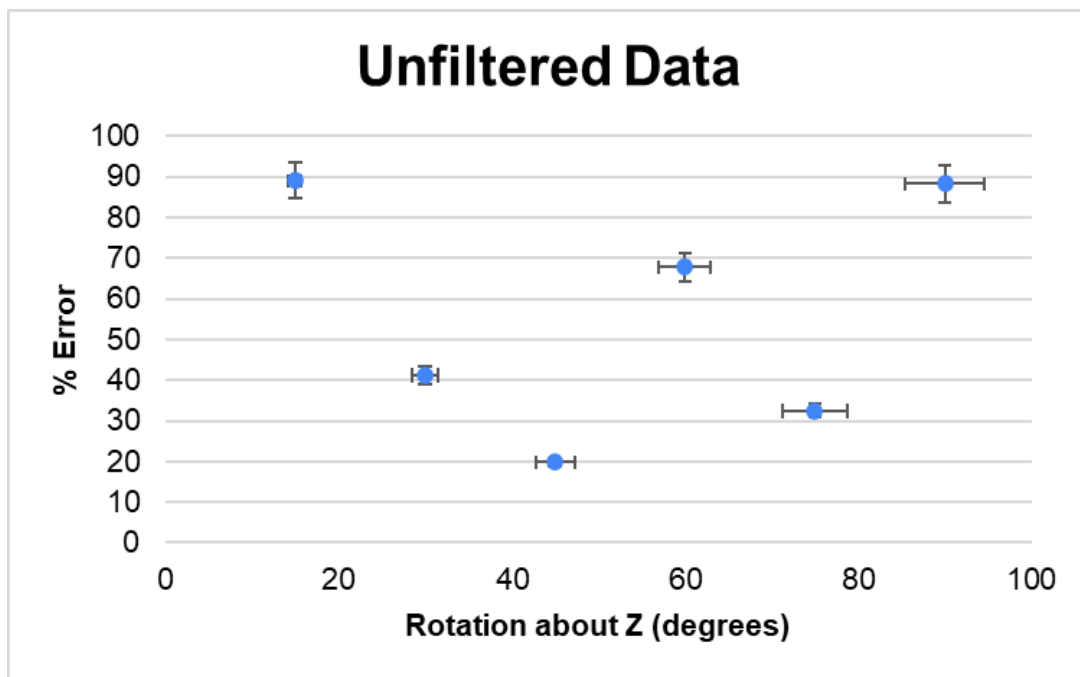
FIGURE 6-22: Unfiltered error by orientation for Experiment 5 partial mesh inspection

The partial mesh data for the orientation experiment, both unfiltered and filtered through a 2-sigma filter, can be seen below in FIGURE 6-22 and FIGURE 6-23. Due to the number of permutations needed to conduct this experiment, the max defect size line was standardized at 2.5 mm for all trials.
