EXPERIMENTAL ASSESSMENT OF THE EFFECT OF SODIUM CHLORIDE  
DEICING AND ANTI-ICING SOLUTIONS ON EXPOSED, COATED, AND  
REINFORCING STEEL IN HIGHWAY BRIDGES

A thesis submitted to the faculty of  
The University of North Carolina at Charlotte  
in partial fulfillment of the requirements  
for the degree of Master of Science in  
Civil Engineering

2014

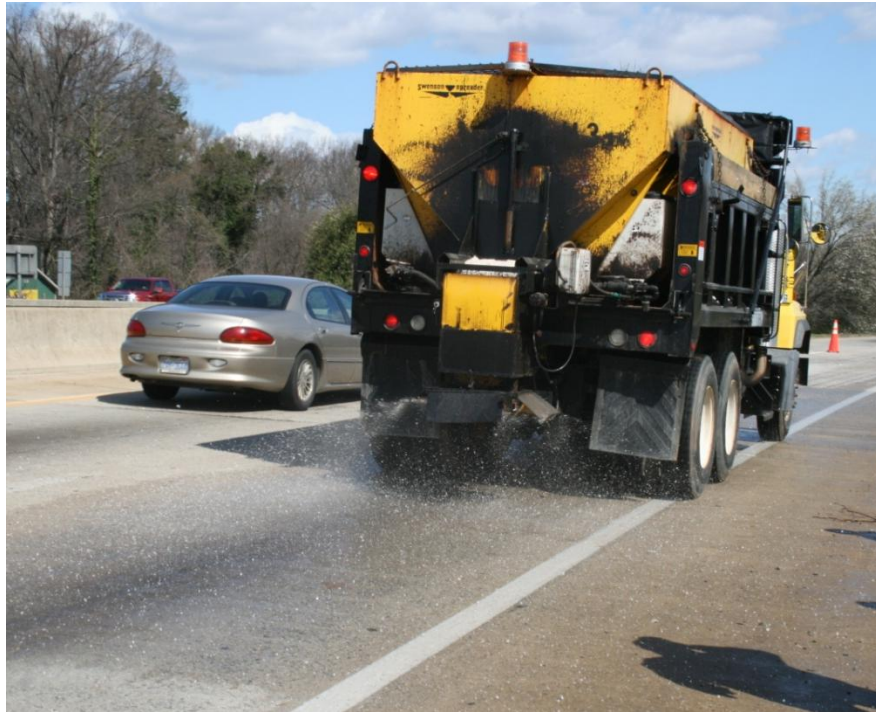
FIGURE 2.1: Granular salt application with auger type spinner

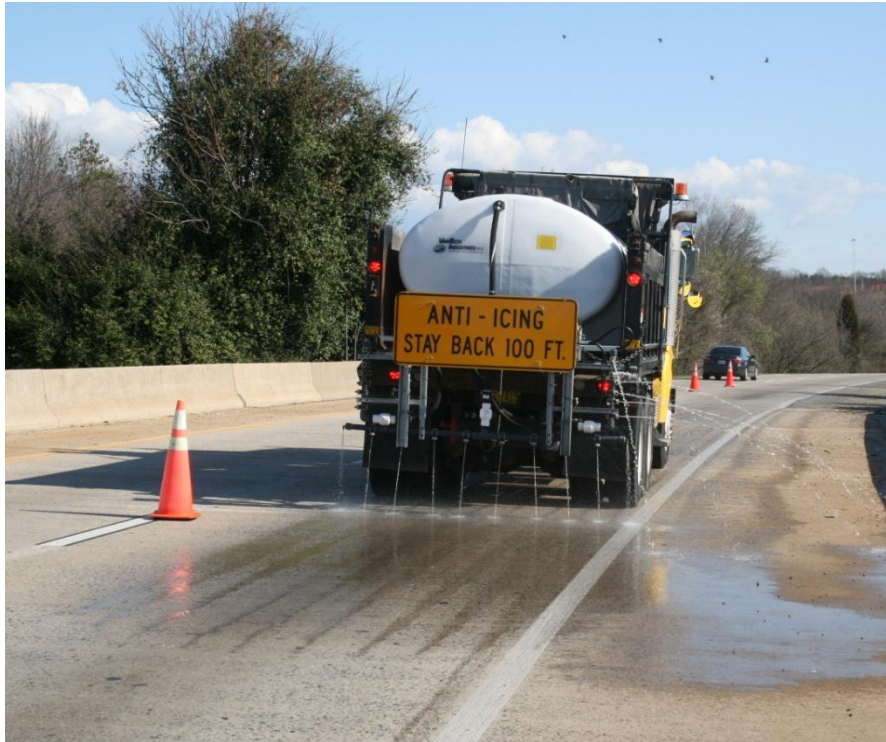
Brine is produced as the mixture of liquid and a freezing point depressant chemical such as sodium chloride, magnesium chloride, potassium chloride, or calcium chloride. The saturated concentration for sodium chloride-based brine is 23.3%, which achieves the lowest freezing temperature (Nixon, et al. 2007). Brine is typically applied by spraying a series of streams onto the deck surface (FIGURE 2.2). In bridge applications, brine may also be inadvertently applied to steel guard rails by the stream from nozzles directed to pretreat the curb or sidewalk of the bridge. Unlike granular salt applications, brine adheres to the surface when applied and is known to maintain a significant residual concentration until precipitation occurs.

FIGURE 2.2: Brine application by spraying

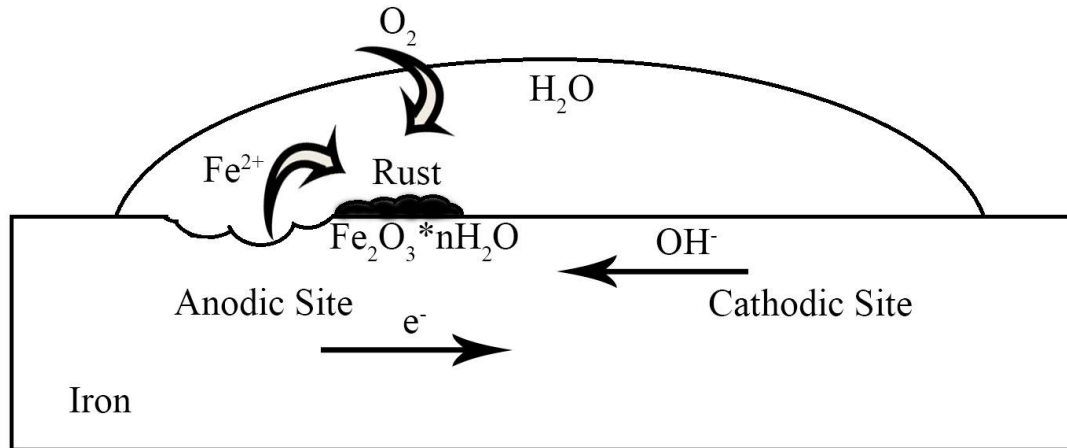
After subsequent reactions with oxygen and water, the ferrous hydroxide turns into hydrate ferric oxide, or rust (EQUATION 2.4). A schematic of the corrosion process for iron is shown in FIGURE 2.3.

FIGURE 2.3: Surface corrosion of iron

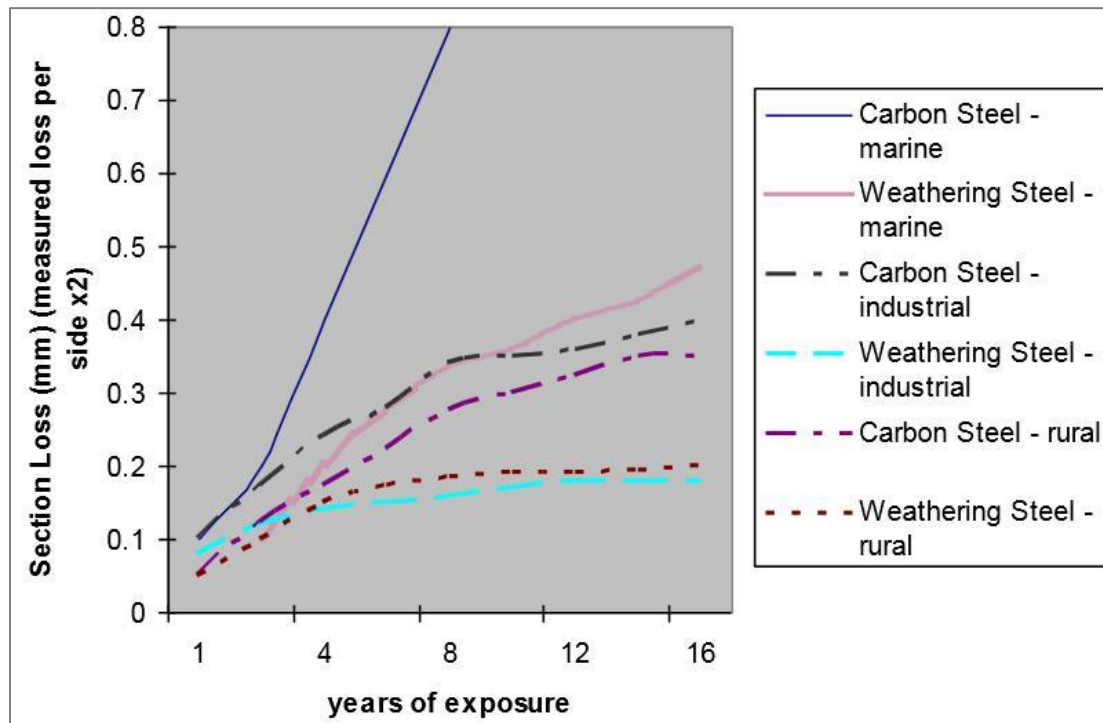
provide protection against further corrosion in rural and industrial environments. In marine environments, the corrosive loss is significantly lower for weathering steel, but does continue to progress further over time rather than stabilize.

FIGURE 2.4: Graph of corrosive for carbon and weathering steel in various environments (reproduced from (Kogler 2012))

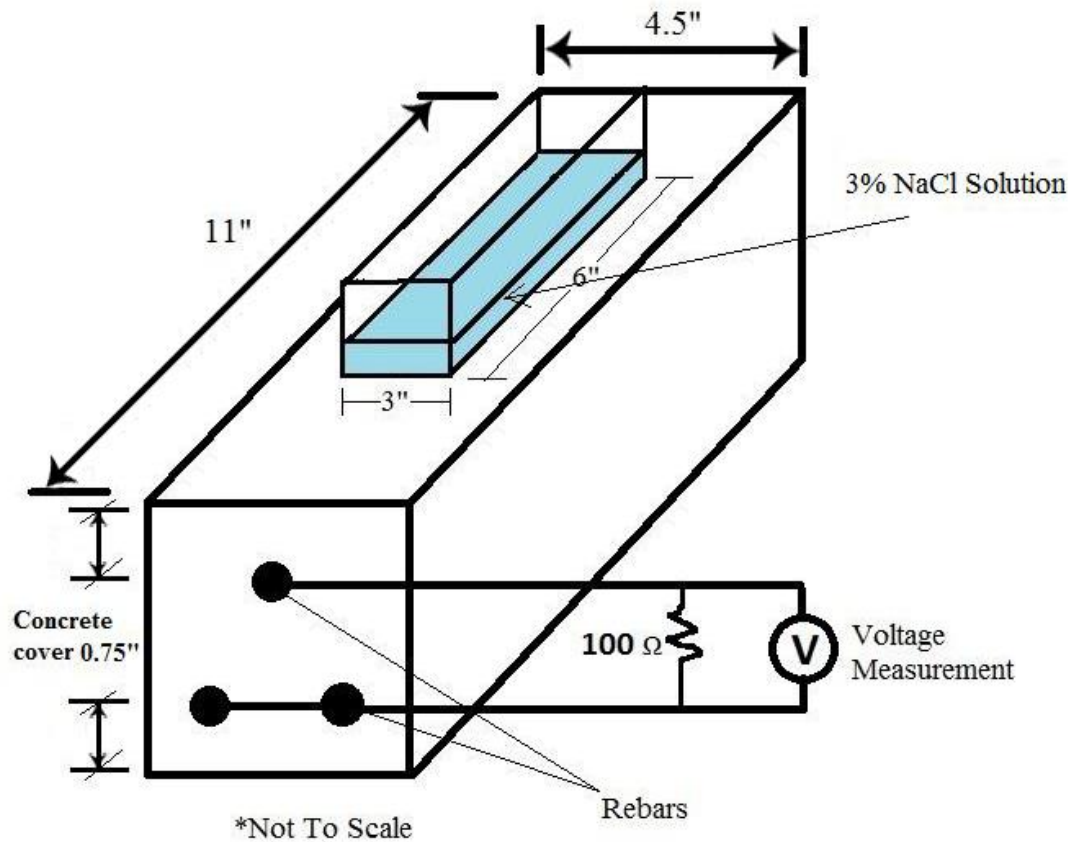
Test procedures used in this study for evaluation of different deicing strategies on reinforced concrete are based on ASTM G109 “Standard Test Method for Determining Effects of Chemical Admixtures on Corrosion of Embedded Steel Reinforcement in Concrete Exposed to Chloride Environments” (ASTM 2007). The testing setup consists of concrete samples with two embedded layers of reinforcing bars, one top rebar and two bottom rebars, that is exposed to cyclic ponding and drying of sodium chloride solution on the top concrete surface (FIGURE 2.5). Typical concrete cover for the top rebar is 0.75 inch. Electrical current flow is monitored between the two layers of reinforcement for signs of corrosion of the top rebar. Researchers using the test method indicate that the time to failure is much longer than the six months noted in the standard (Trejo, Halmen and Reinschmidt 2009). The time required for corrosion of the embedded steel ultimately depends on the rate of chloride ingress through the concrete cover and the amount of chloride required to initiate active corrosion at the reinforcement. Study on the critical chloride content show scattered results that depends on interconnected and time-dependent variables for the quality of steel-concrete interface, the pH of pore solution, and the electrochemical potential of the steel (Angst and Vennesland 2009).

FIGURE 2.5: Specimen setup for ASTM G109 test method

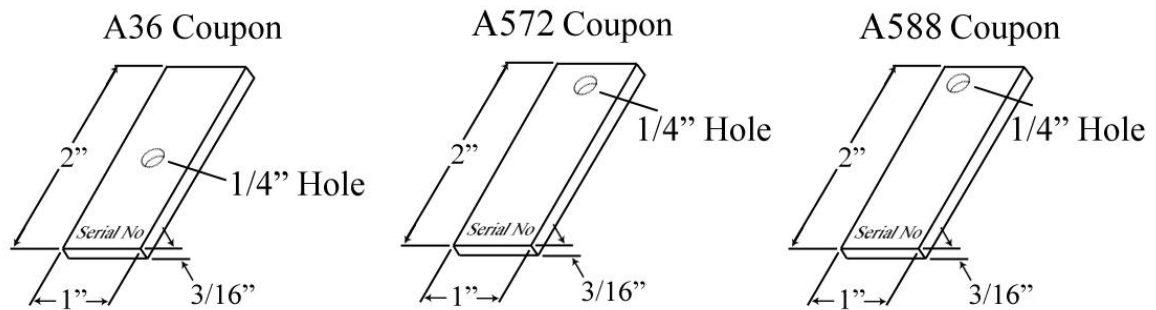
The ASTM G31-72 recommendation was followed by using sacrificial steel specimens with large surface-to-mass ratio and small ratio of edge area to total surface area to minimize the area of exposed end grain (ASTM 2004). Also, careful dimensional measurements were made to permit accurate calculation of exposed area. A band saw was used to cut each 3/16 inch thick specimen into 1 inch by 2 inch dimensions. To identify each steel grade, a hole of 1/4 inch diameter was drilled into each specimen using a metal drill press at unique locations. Each coupon was also stamped with a unique serial number using a hammer-stamp tool. FIGURE 3.1 shows the dimensions and layouts for each steel grade.

FIGURE 3.1: Test coupon layouts for each steel grade

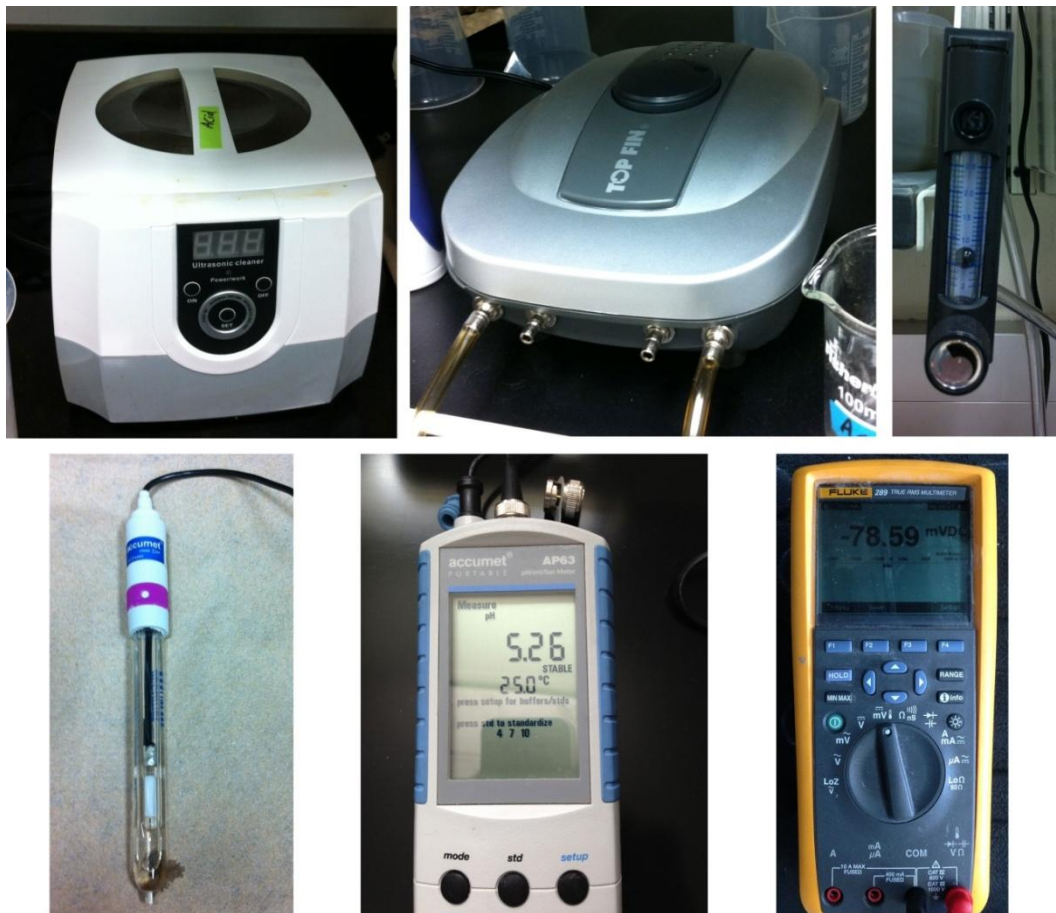
- 1) Fishing line: for hanging metal specimen in each test cell.
- 2) Insulated electrical wire: for connecting the test electrode to the voltmeter.
- 3) Brass screws and nuts: for attaching electrical wire to the test electrode.
- 4) Silicon sealer: for sealing the electrical wire to the test electrode.
- 5) Test cell container: 2.5 quart plastic container to hold the deicing solution.
- 6) Test cell lid: for covering of test solution and hanging of the metal specimens.
- 7) Air Tubing: for directing air to each test cell.
- 8) Sodium chloride and deionized water: for preparing test solutions.
- 9) Magnetic stirrer: for dissolving salt into solution

FIGURE 3.2: SHRP test equipment: cleaner, air pump, flow meter, electrode, and meters

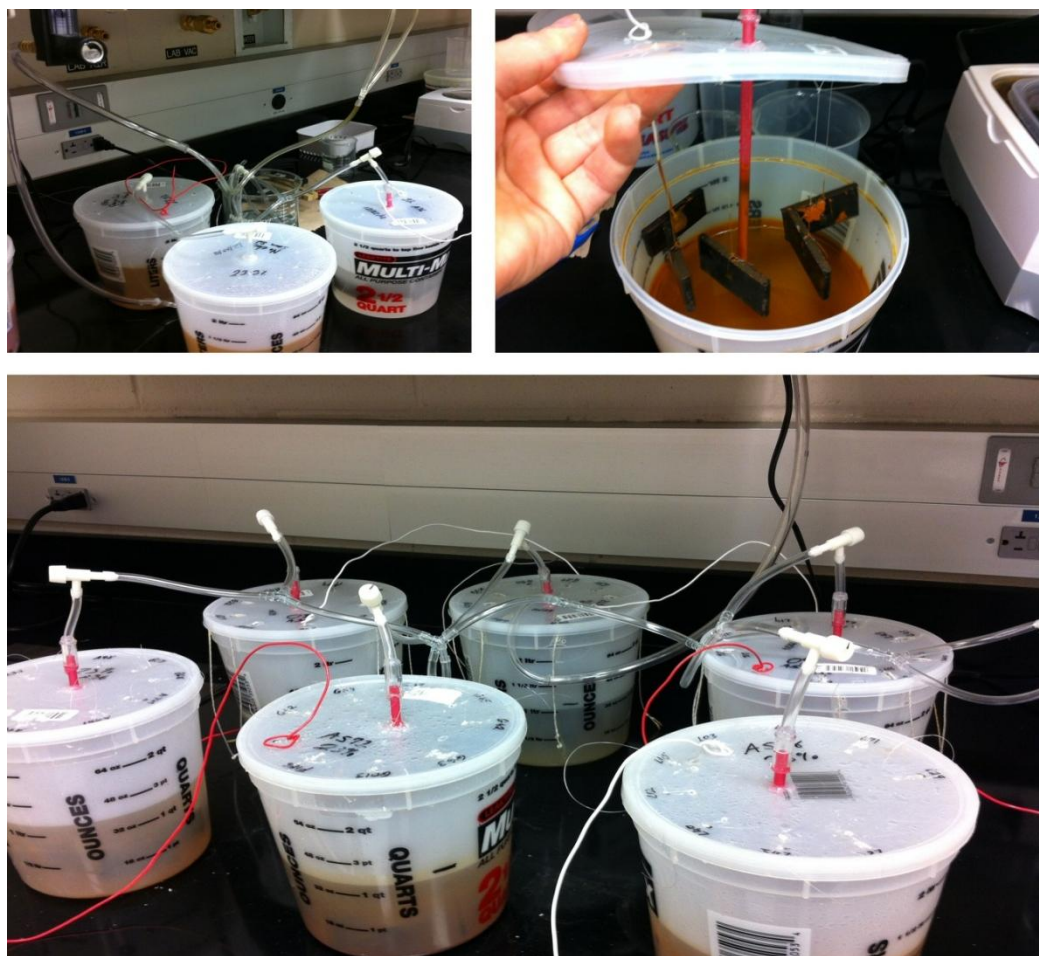
acetone, air dried, and weighed to the nearest 0.1 mg as the initial weight. A nylon string was tied to each test specimen at the  $\frac{1}{4}$ " hole to allow the specimens to be suspended inside the test cell. "Electrode" specimens were prepared by attaching an insulated electrical wire to a single metal specimen using screw and nut. The electrical connection at the screw was sealed using silicon to prevent development of a cathodic surface at this connection. Test cell lids were punched with nine hanging locations around the circumference for hanging of the specimens and a center hole to attach the air tubing. FIGURE 3.3 shows the setup for the immersion test.

FIGURE 3.3: SHRP H-205.7 test setup with specimens submerged in solution

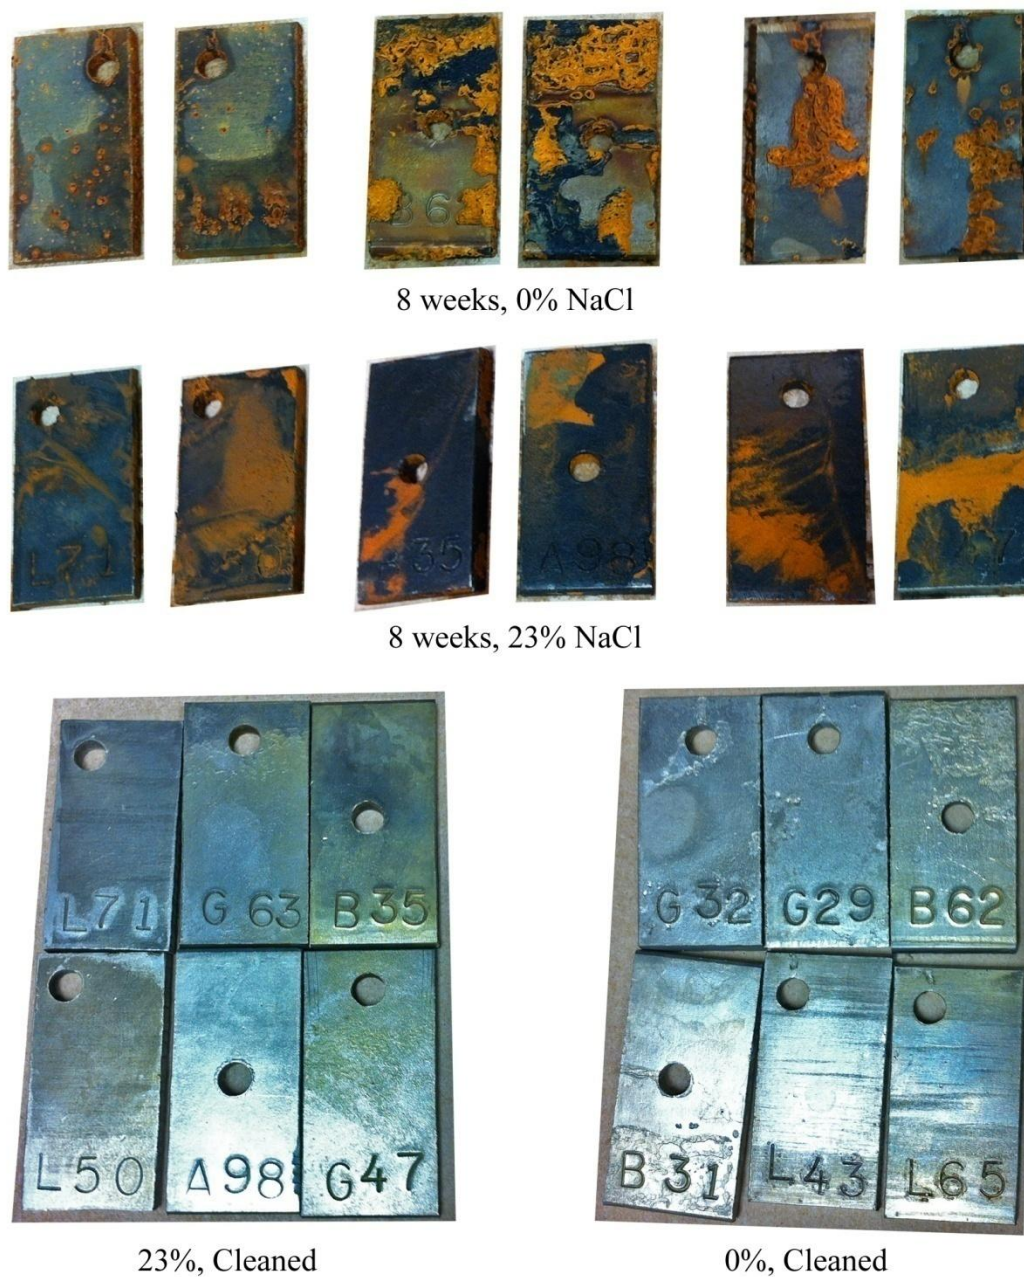
FIGURE 3.4: Corroded specimens after 8 weeks of exposure before and after cleaning

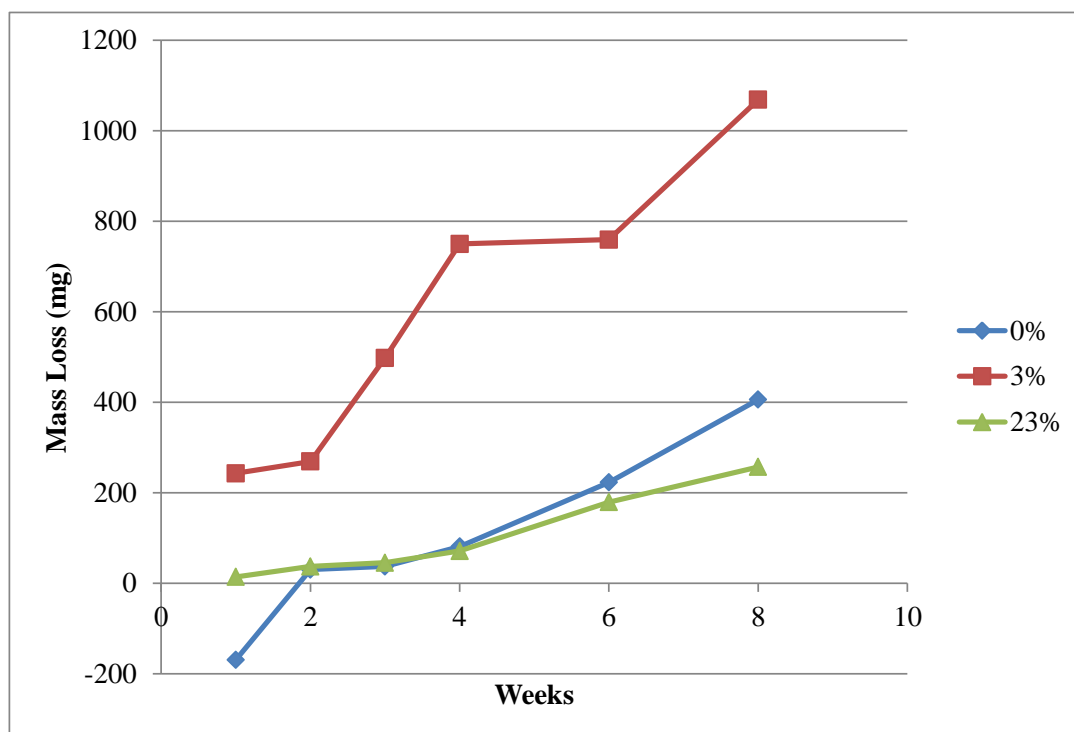
FIGURE 3.5: Results for A36 Steel using SHRP test method

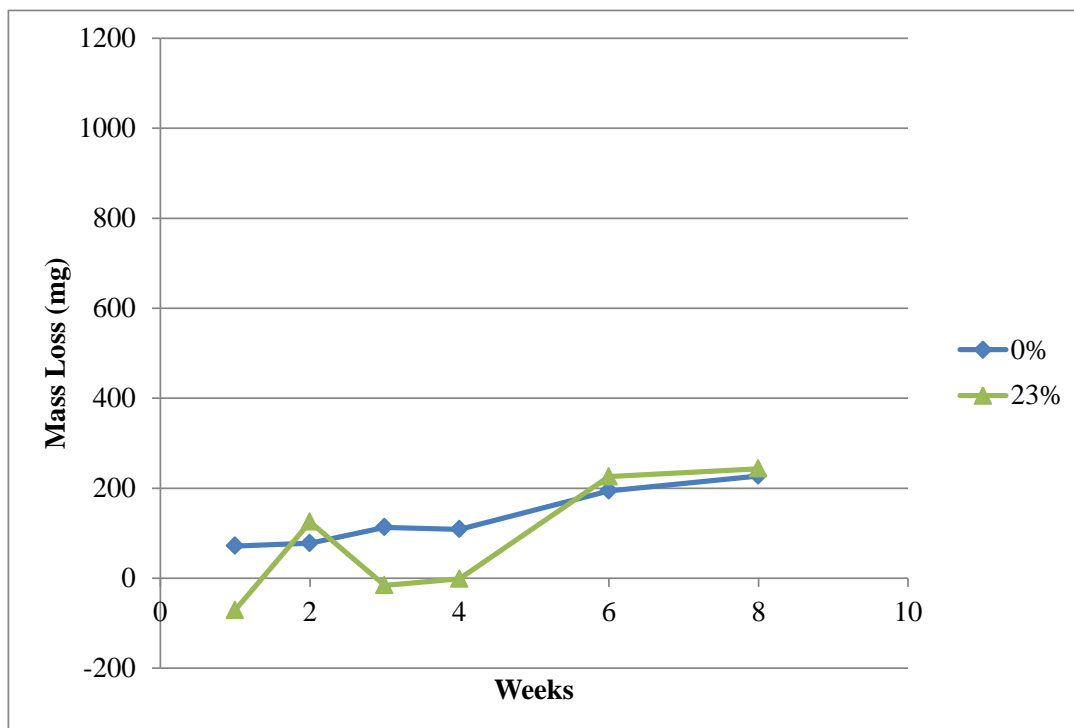
FIGURE 3.6: Results for A572 Steel using SHRP test method

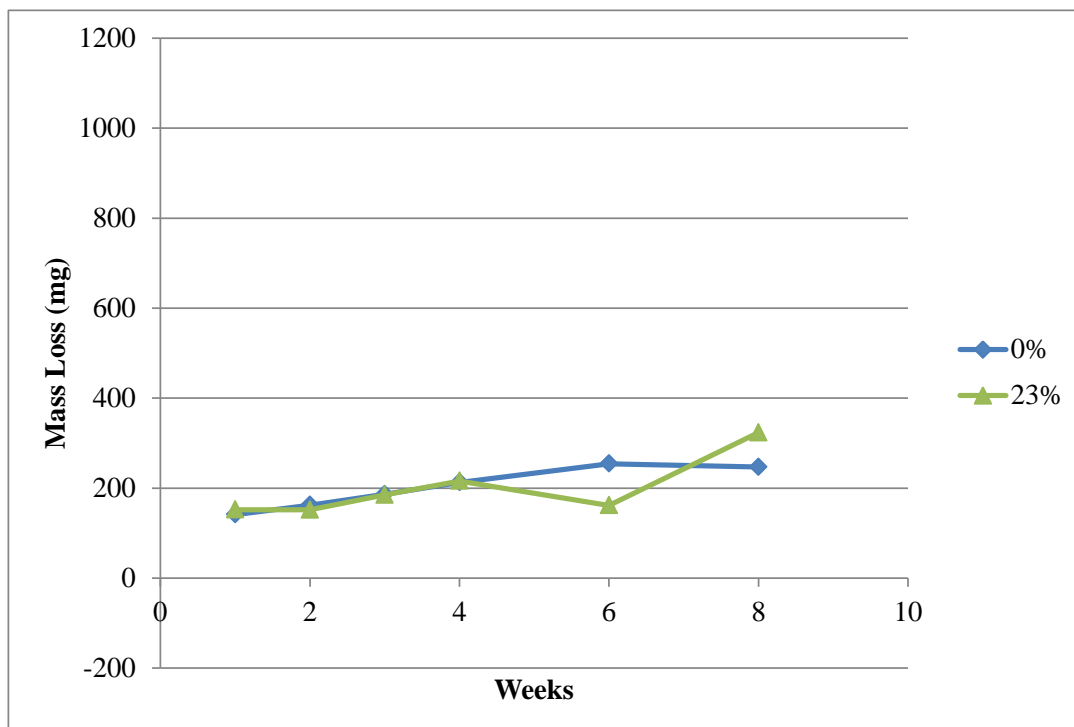
FIGURE 3.7: Results for A588 Steel using SHRP test method

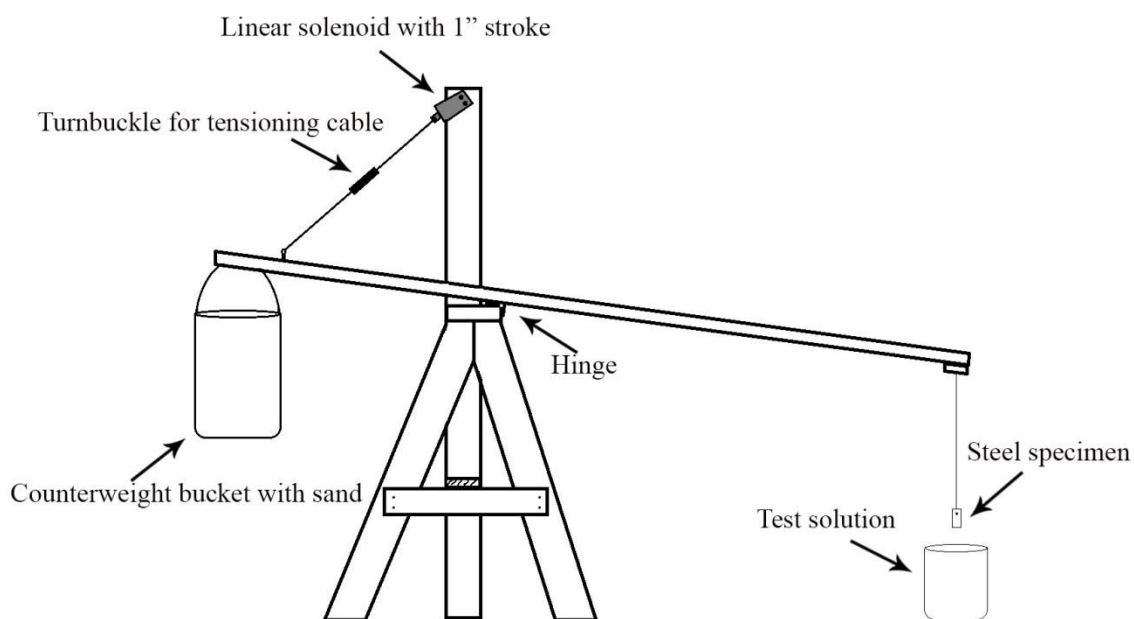
the specimen end into placed containers with testing solution. After two minutes, power was switched off releasing the solenoid and bringing the specimens out of solution due to the slightly heavier counter-weight end. The test set up used two lever arms, each supporting 112 specimens. FIGURE 3.9 shows a photograph of the test setup used for the cyclic corrosion test.

FIGURE 3.8: Schematic of dunking apparatus

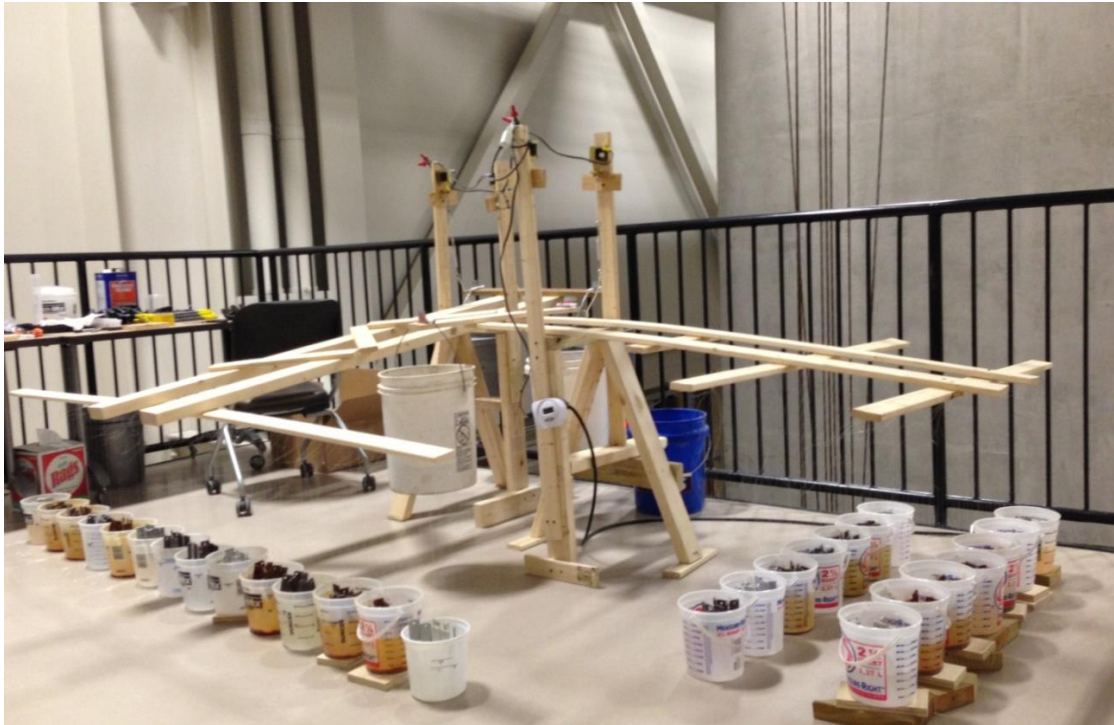
FIGURE 3.9: Fixtures used for dunking motion in cyclic corrosion test

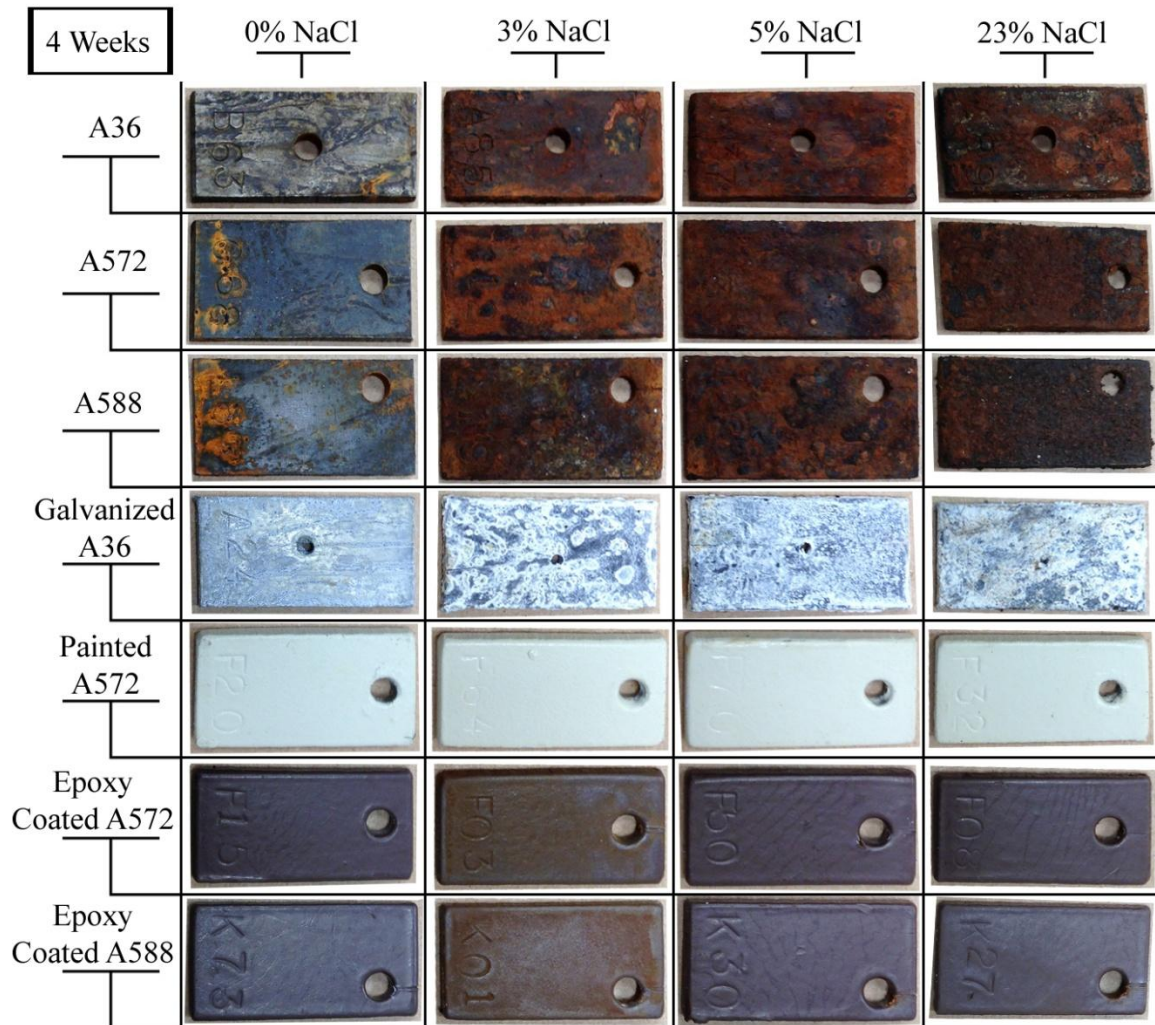
FIGURE 3.10: Test specimens with 4 weeks exposure before cleaning

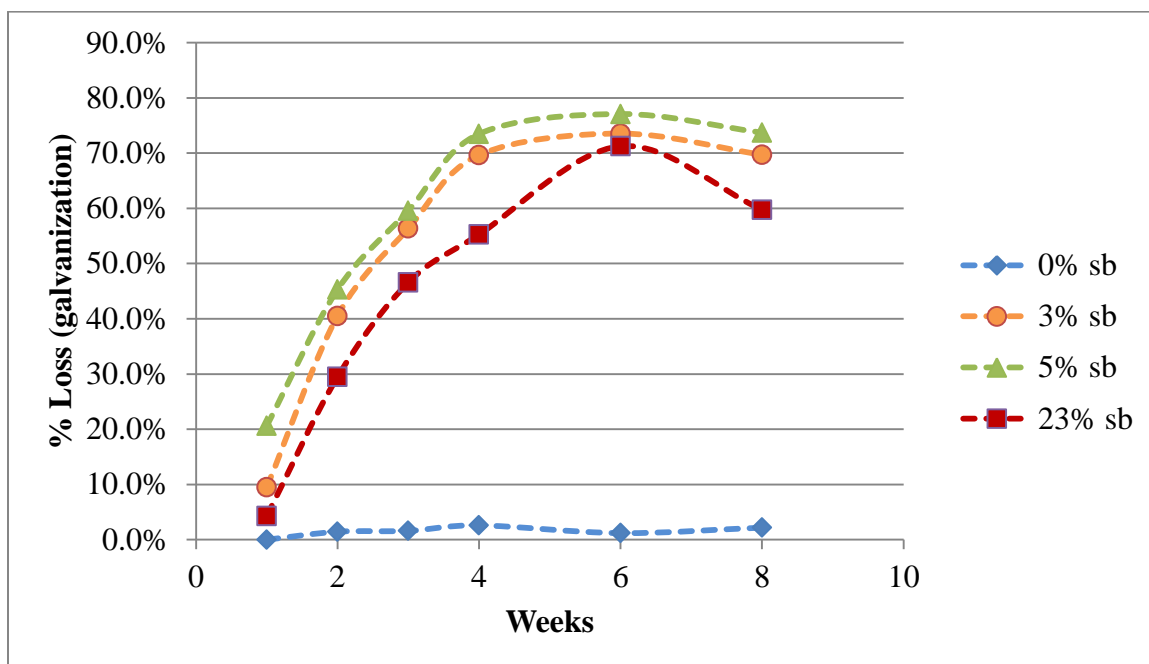
remainder of the test program. Galvanized specimens exposed to 5% NaCl concentration exhibit the highest mass loss follow by 3% while those exposed to 23% exhibit the lowest.

FIGURE 3.11: Percent loss of galvanized layer in NaCl solutions

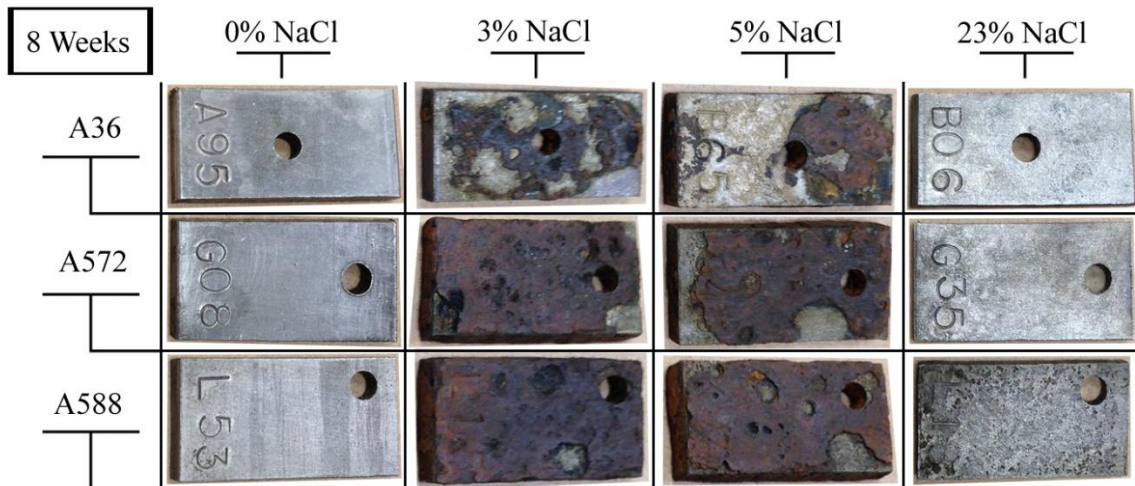
FIGURES 3.12 and 3.13 show the 8 week bare steel test specimens exposed to 0%, 3%, and 23% NaCl concentrations after acid cleaning and sand blasting, respectively. Specimens exposed at 5% sodium chloride concentration were visually similar to those exposed at 3%. As seen in FIGURE 3.12, acid cleaning alone was not effective in removing all corrosion byproducts in heavily corroded specimens. Plots showing mass loss results for acid cleaning alone and after sand blasting can be seen in FIGURES 3.14, 3.15, 3.16, and 3.17. In the higher corrosion cases, as seen for 3% and 5% concentrations, sand blasting results show a more reasonable trend, where higher corrosion is observed with longer exposure. Also potential unwanted sandblasting effects were minimized, as seen in the 0 and 23% concentration results. Final corrosive losses of test specimens after acid cleaning, sandblasting and adjusting for loss due to cleaning are shown in TABLE 3.7.

FIGURE 3.12: Test specimens after acid cleaning

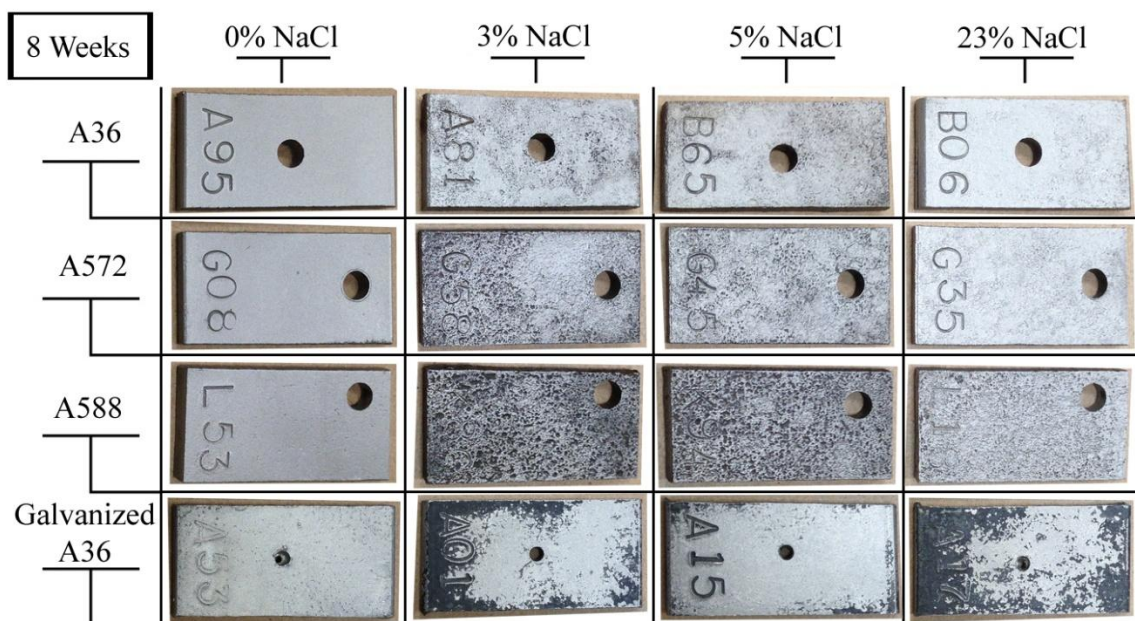
FIGURE 3.13: Test specimens with 8 weeks exposure after sand-blasting

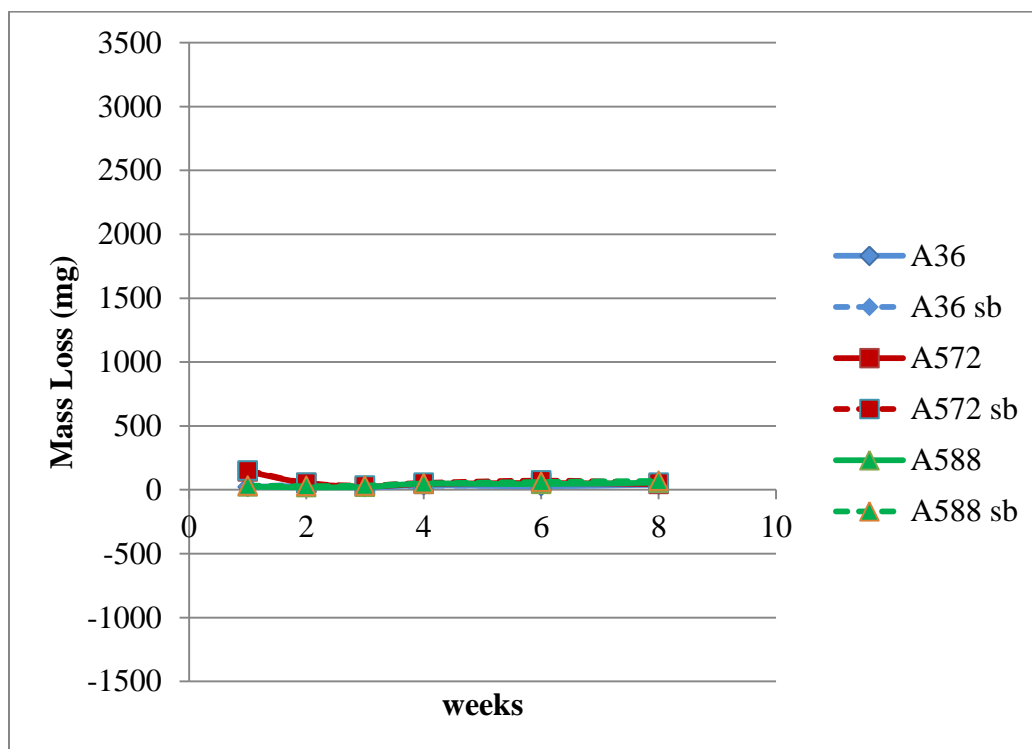
FIGURE 3.14: Mass loss result for specimens after acid clean and sandblasting (sb), at 0% NaCl

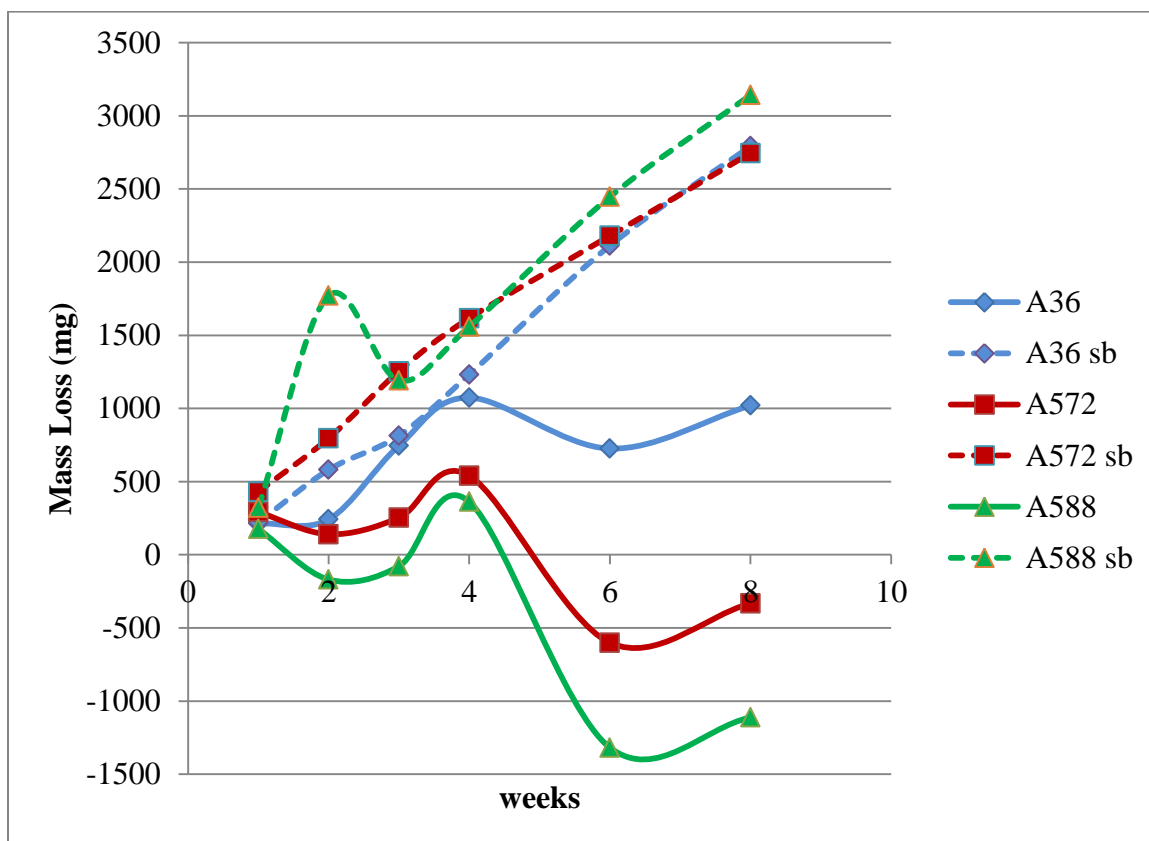
FIGURE 3.15: Mass loss result for specimens after acid clean and sandblasting (sb), at 3% NaCl

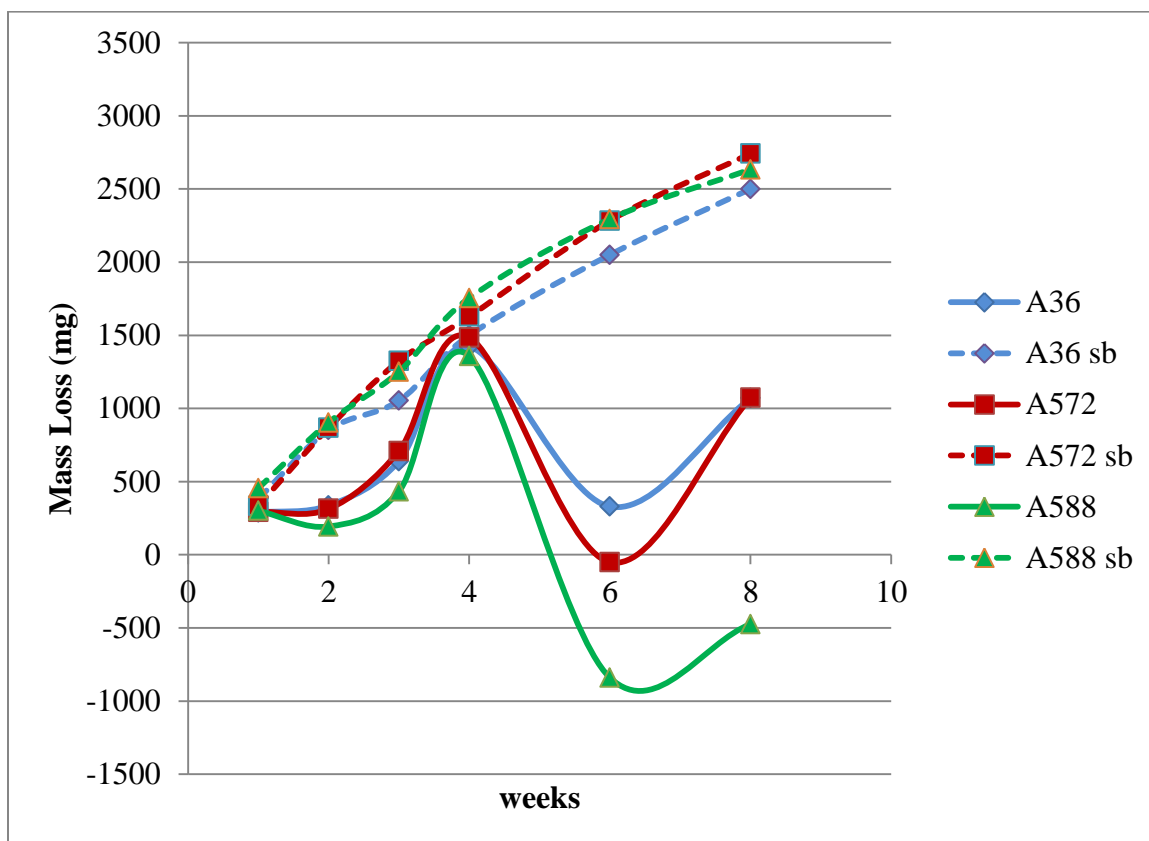
FIGURE 3.16: Mass loss result for specimens after acid clean and sandblasting (sb), at 5% NaCl

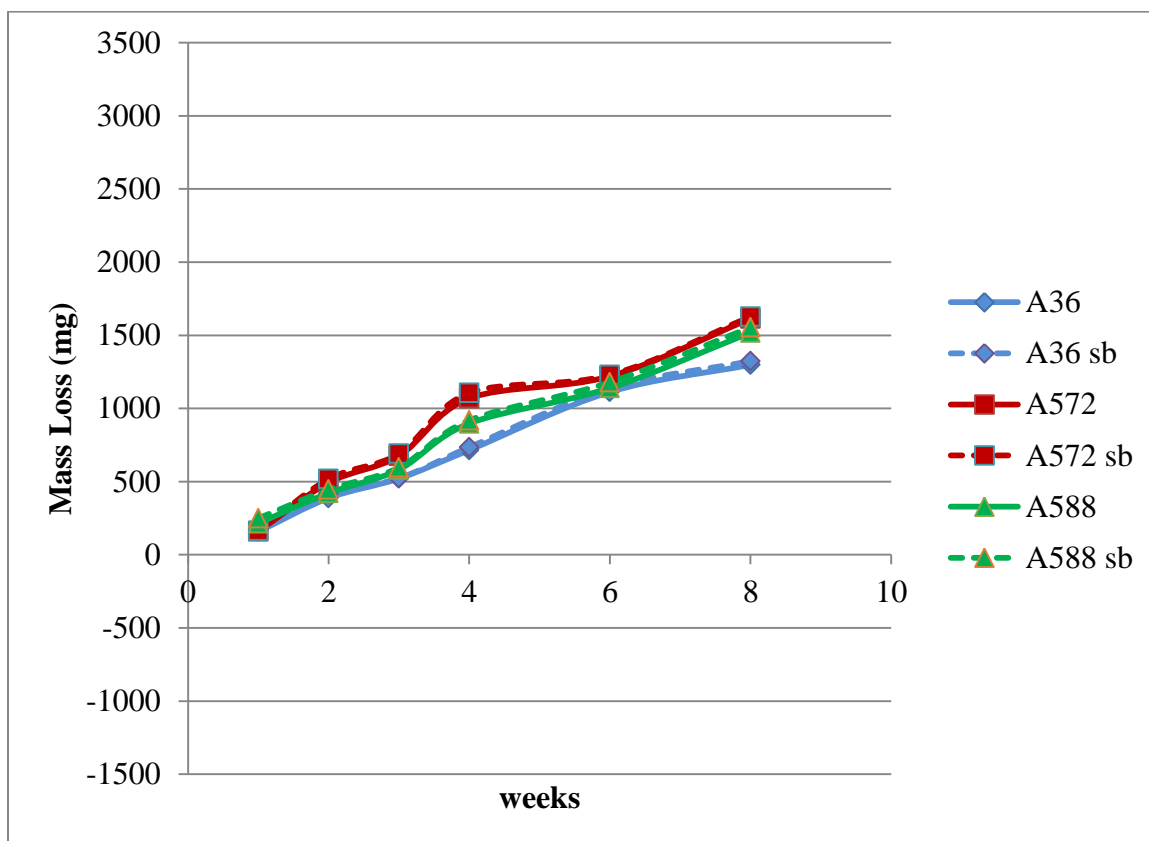
FIGURE 3.17: Mass loss result for specimens after acid clean and sandblasting (sb), at 23% NaCl

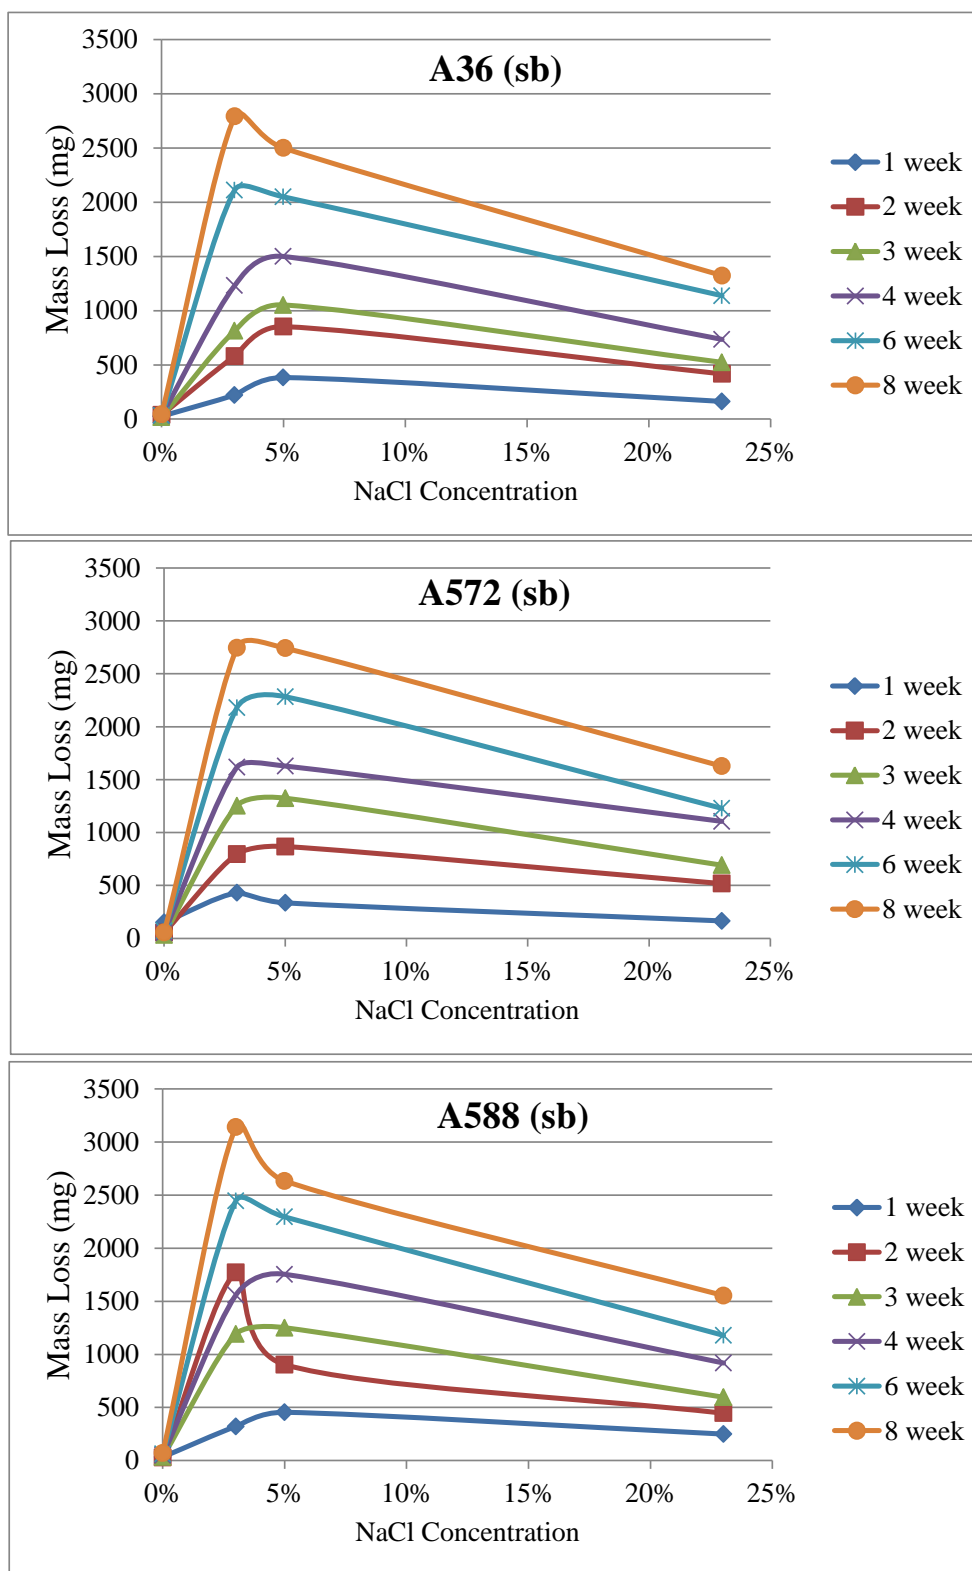
The average corrosion rate was calculated for each concentration and metal type based on the formula in EQUATION 3.1. TABLE 3.8 shows the average corrosion rate in mils per year for each metal type at each concentration. An average mass loss for steel type A588 at 2 weeks with 3% exposure was not included in the average corrosion rate calculation due to an unexpected high value within the plotted trend, as indicated in FIGURE 3.14. Results after sand blasting exhibit expected increases in corrosive losses with time for all steel types. A36 steel shows slightly less corrosive loss compared to A572 and A588 steel. A572 and A588 steel exhibited comparable corrosive loss across all tested salt concentrations. Similar corrosive loss is seen for 3% and 5%, while specimens subject to 23% solution exhibited less corrosion across all three steel types. Plot of mass loss against solution concentration for each steel type helps to identify this trend, as seen in FIGURE 3.18.

FIGURE 3.18: Comparison of corrosive losses measured as a function of solution concentration

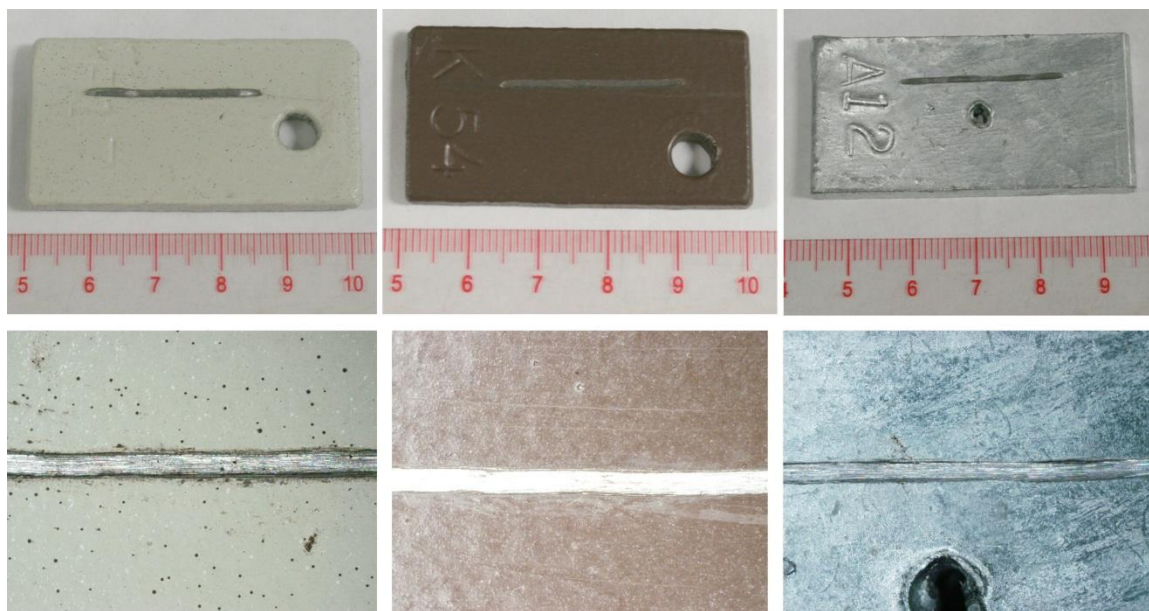
Coated specimens were scribed using a motorized circular blade. A Dremel tool with 1 mm thick circular blade was used to scribe each specimen along its length. Each scribe line was cut by positioning the blade at 90 degree angle penetrating the coating and scratching the bare metal surface. Scribe lines were approximately 3 cm in length positioned clear from the specimen edge or hole. FIGURE 3.19 shows scribed specimens for each coating type.

FIGURE 3.19: Scribed painted, epoxied, and galvanized specimens, from left to right
