EXPERIMENTAL ASSESSMENT OF THE EFFECT OF SODIUM CHLORIDE  
DEICING AND ANTI-ICING SOLUTIONS ON EXPOSED, COATED, AND  
REINFORCING STEEL IN HIGHWAY BRIDGES

A thesis submitted to the faculty of  
The University of North Carolina at Charlotte  
in partial fulfillment of the requirements  
for the degree of Master of Science in  
Civil Engineering

2014

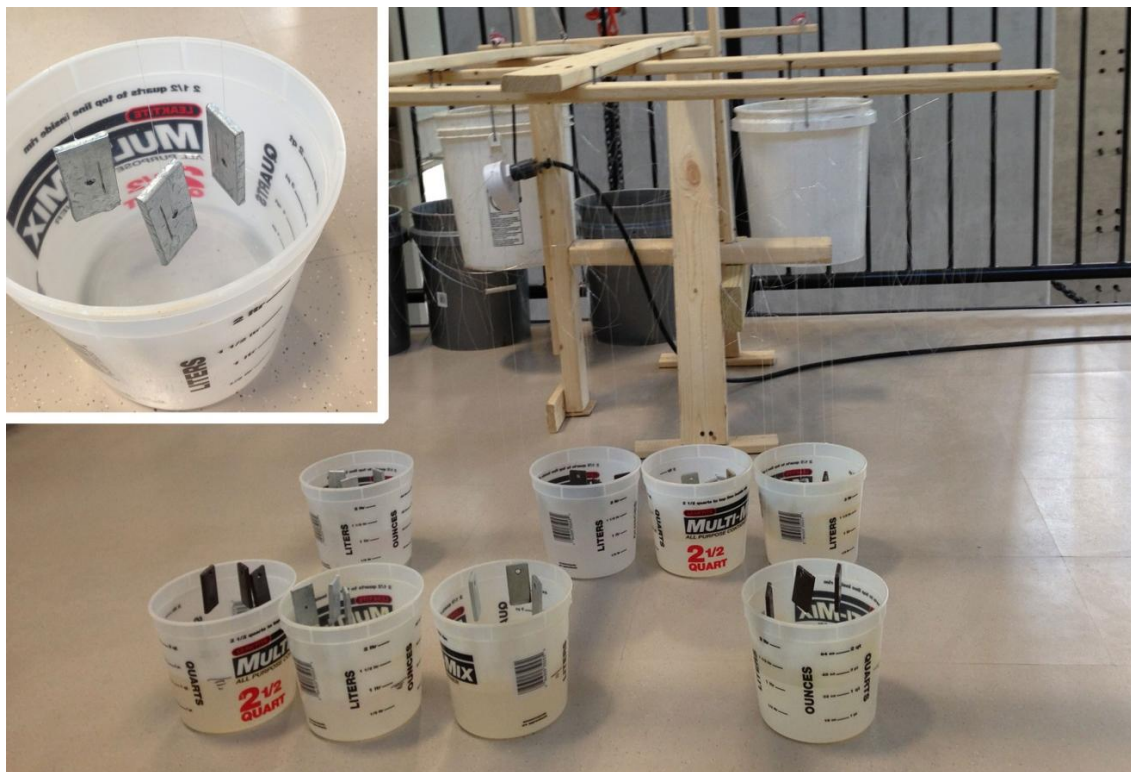
FIGURE 3.20: Scribe test set-up for cyclic wetting and drying corrosive exposure

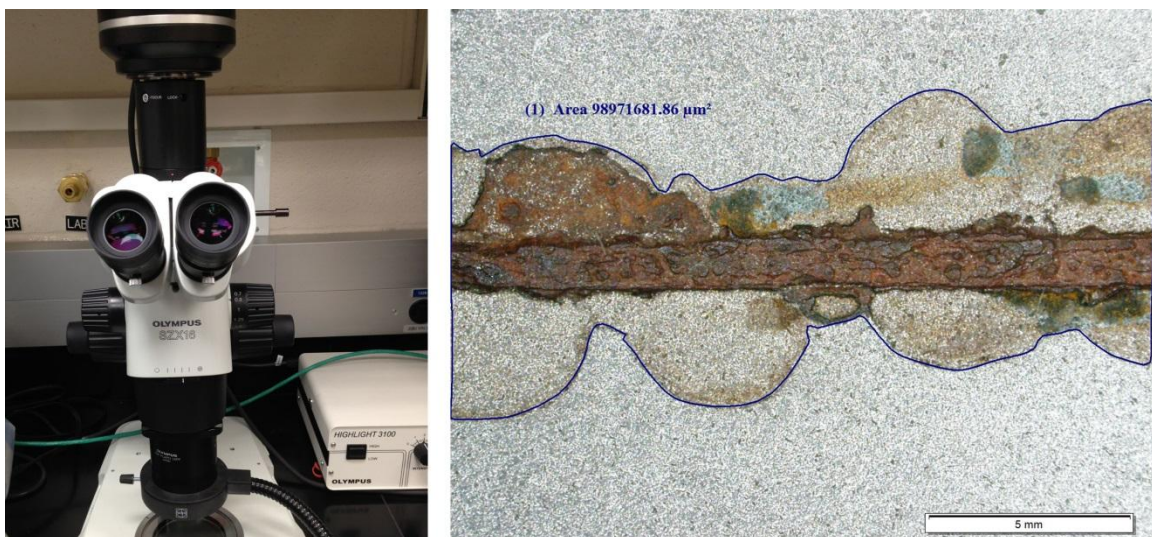
Rating of undercutting at the scribe line for each coating system was determined based on areas of the substrate that were discolored due to corrosion. The software package used features the capability to capture and examine an area of 17.5 mm by 13 mm, which was the area used to examine the test specimen. Before capturing images of corroded specimens, the software was calibrated using a known length at a particular zoom of the microscope. Images of corroded specimens were captured at the calibrated zoom from a mounted camera on the microscope. The captured image was then imported to the software for analysis. Rust creepage areas were determined for each specimen by tracing the discolored corroded area around the scribe line and using the software to calculate the total area. The area calculated included the original area of the scribe line. FIGURE 3.21 shows the microscope and a screen shot of the tracing method used.

FIGURE 3.21: Corroded area determination using microscope captured image

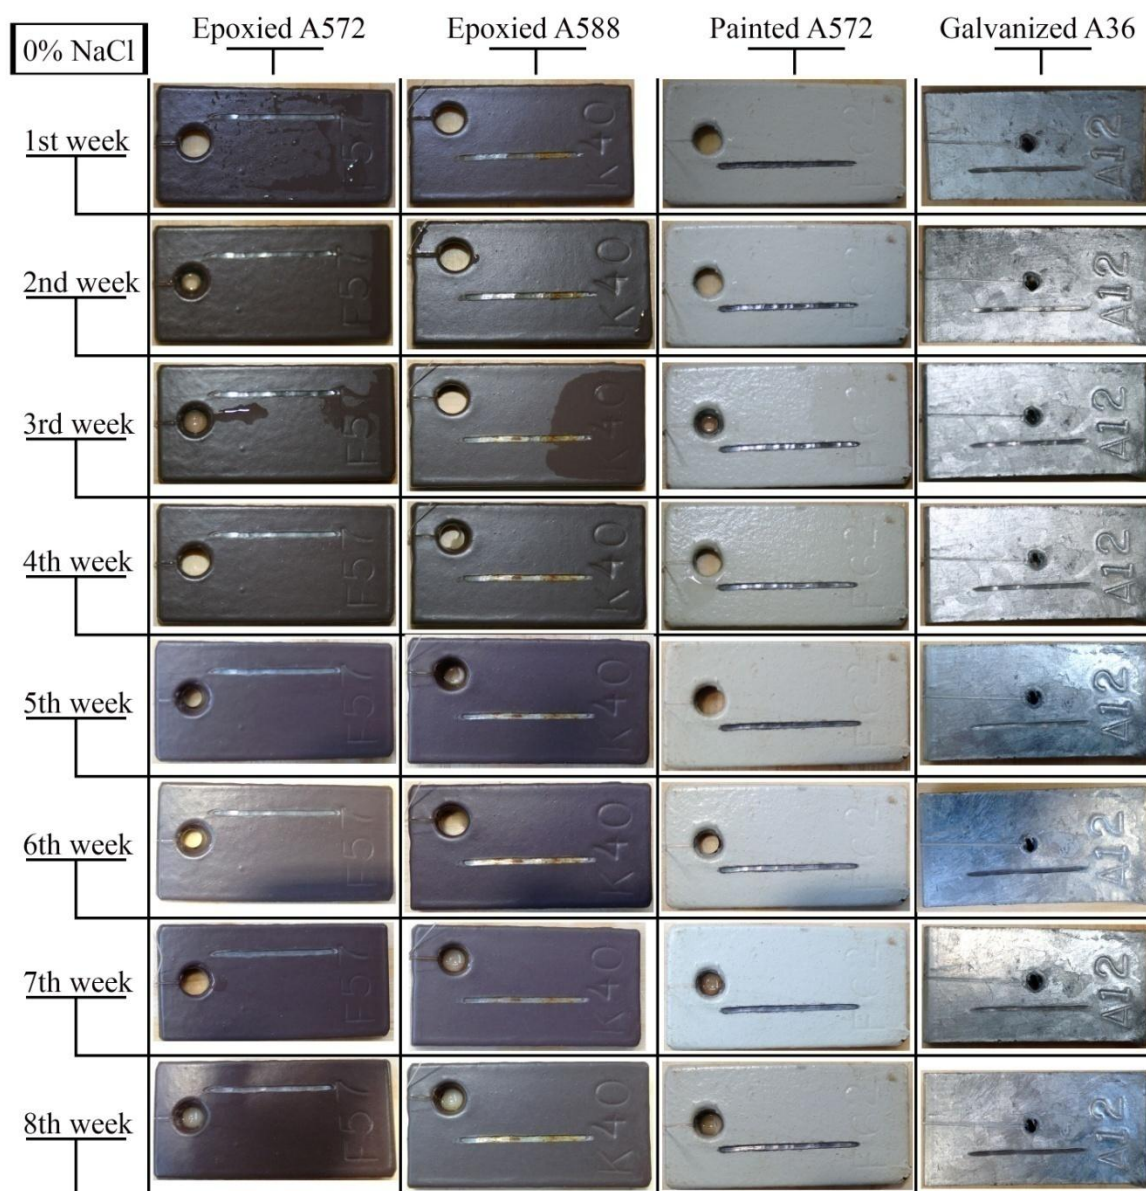
Weekly images of the specimen after exposure to the test solutions are presented in FIGURES 3.21 and 3.22 for 0% and 3% sodium chloride concentrations. Images selected for the figure were of the visibly worst specimen condition out of the three replicates. Similar corrosion progression was observed for the remaining two replicates.

FIGURE 3.22: Weekly images of coated specimens in deionized water

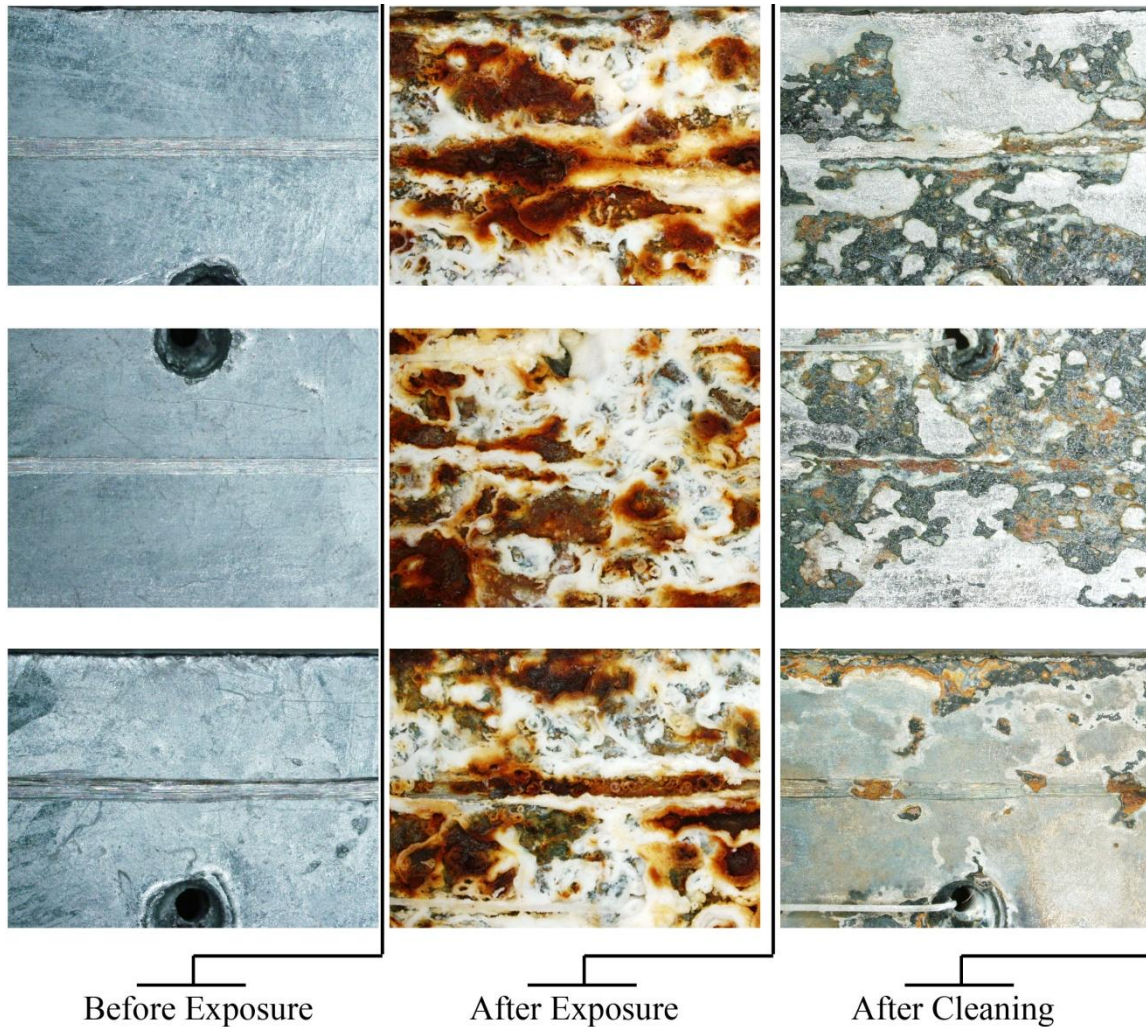
Unlike the epoxied and paint specimens that show corrosion only occurring around the scribe line, galvanized A36 specimens experience a wider area of corrosion across the galvanized surface. Since the galvanized coating is a zinc metal layer, it is designed to naturally corrode as a sacrificial coating. Image results of galvanized specimens show a clear progression of corrosion on the galvanized layer with time. The image also indicates that more corrosion occurred toward the upper end of the specimen where more brownish discoloration can be seen. Unlike the upper end, the bottom end experienced more exposure to the test solution with longer wetting period due to gravitational flow from the upper end. Build-up of white byproducts can also be seen concentrated toward the bottom end of the specimen. The build-up of insoluble products that form are a potential combination of crystalized salt and zinc patina or corroded zinc byproducts. The build-up of byproducts creates an impervious layer that slows the corrosion of the zinc, which could explain why the bottom end is less corroded. FIGURE 3.24 shows microscope images at the scribe line of three galvanized specimens at the end of eight weeks exposure. With the galvanized layer removed, little corrosion is seen on the scribe line; instead most of the corrosion occurred on the zinc layer with remnants of corrosion products throughout the specimen surface. Due to the protective galvanized layer, little to no corrosion is seen on the base metal surface outside of the scribe line.

FIGURE 3.24: Microscope images of galvanized specimens

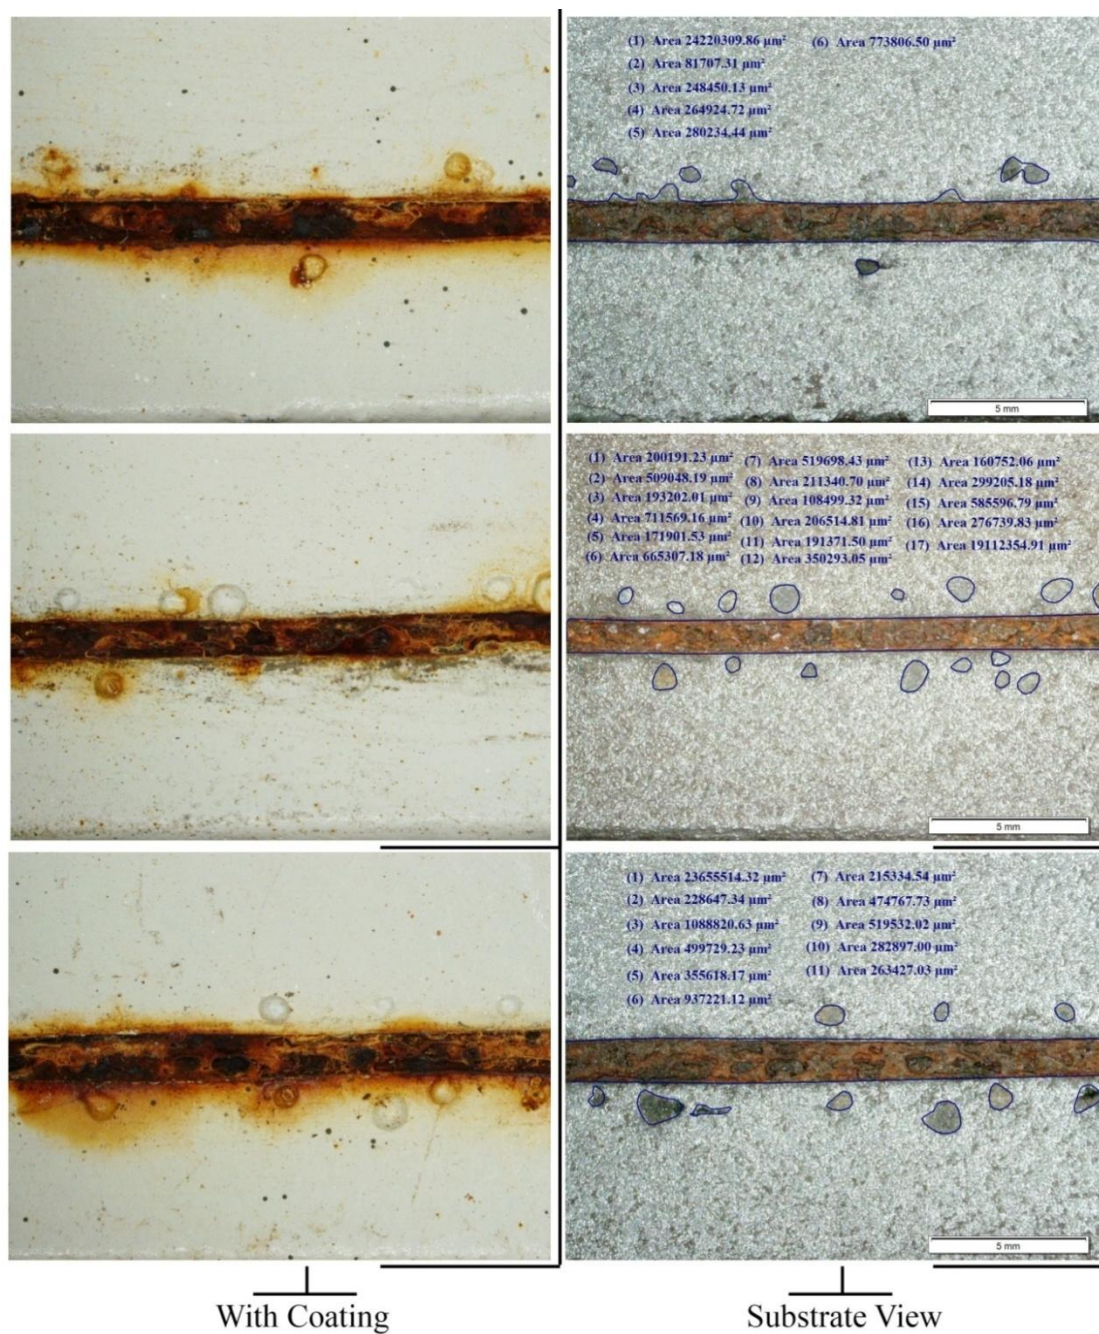
the coating. Rating numbers were consistent for all three specimens with painted A572 having the highest coating performance with a value of 8 follow by epoxied A572 at 6 then epoxied A588 at 5.

FIGURE 3.25: Microscope images of painted A572 specimens

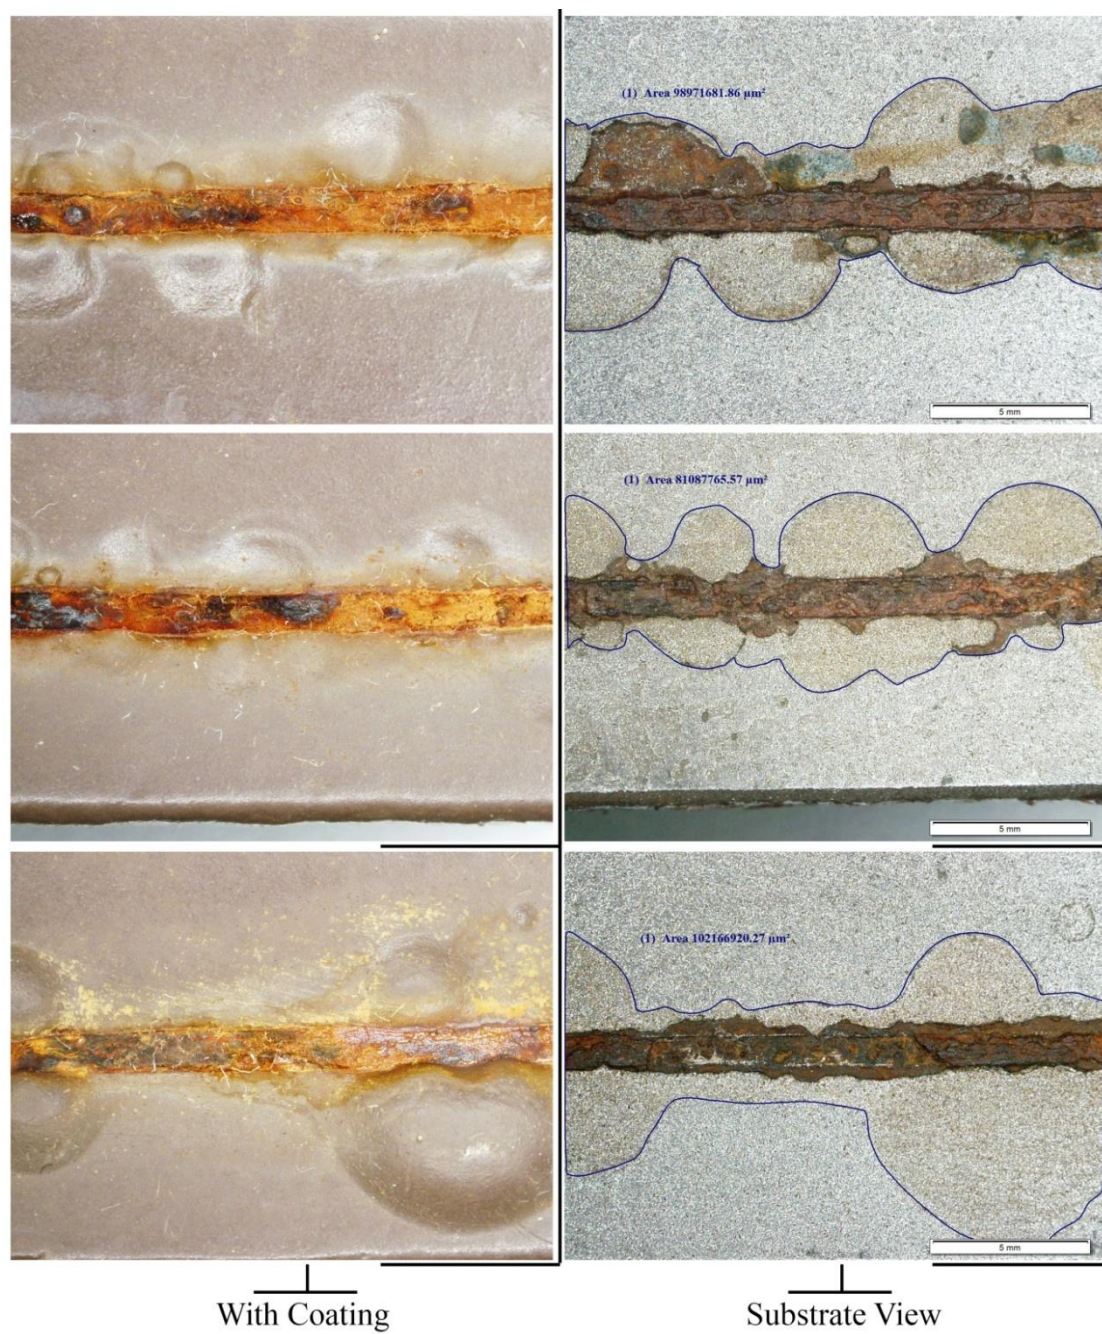
FIGURE 3.26: Microscope images of epoxied A572 specimens

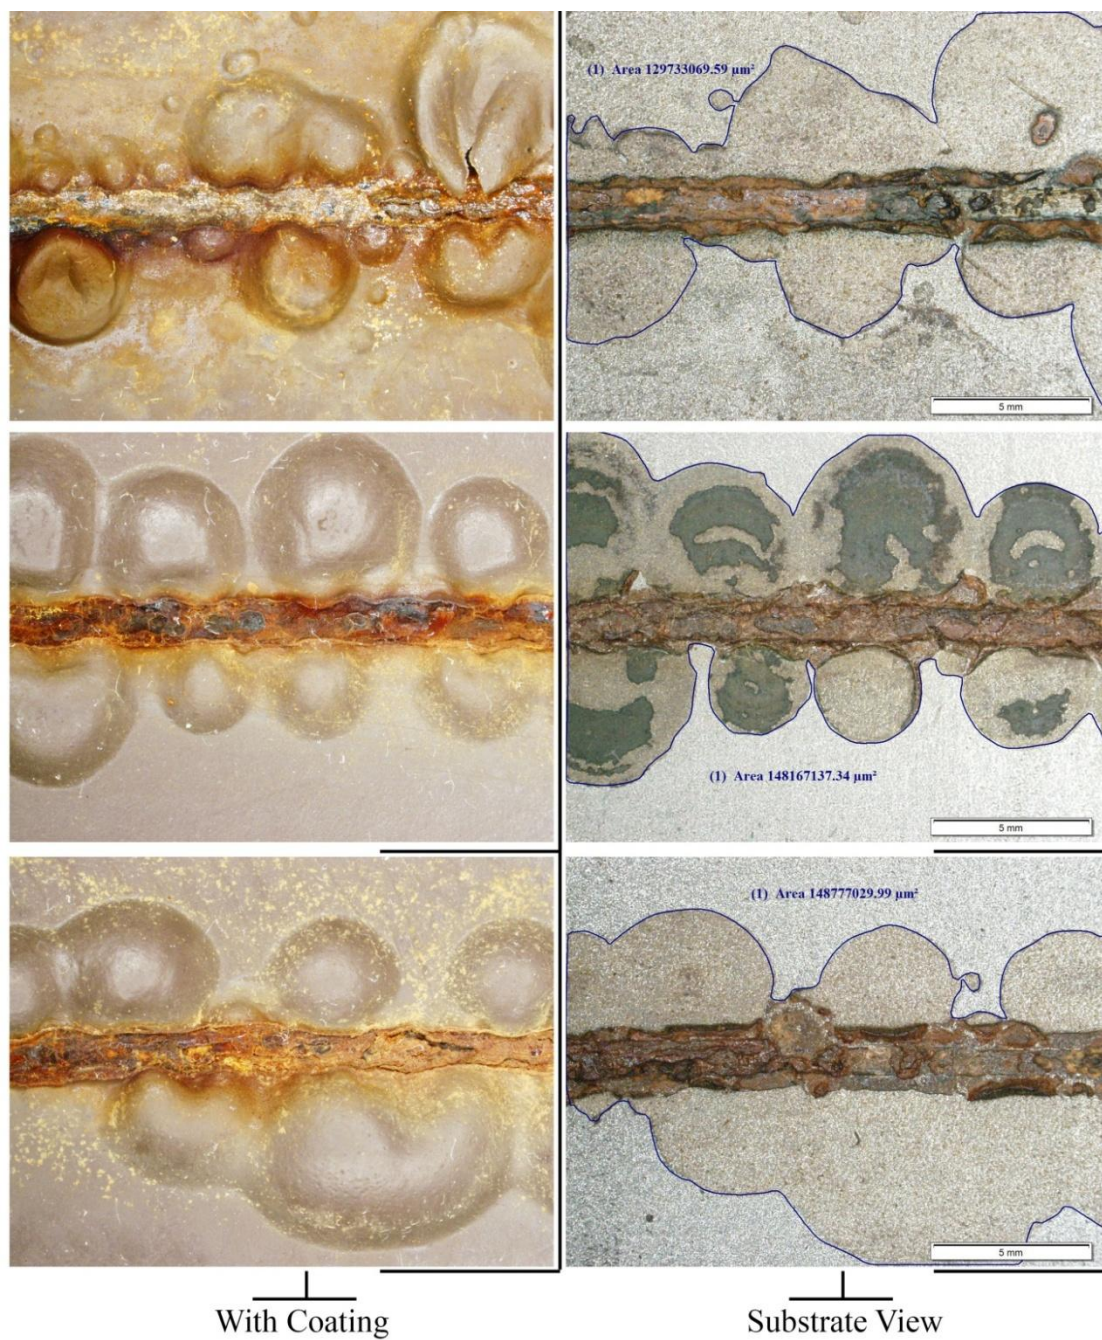
FIGURE 3.27: Microscope images of epoxied A588 specimens

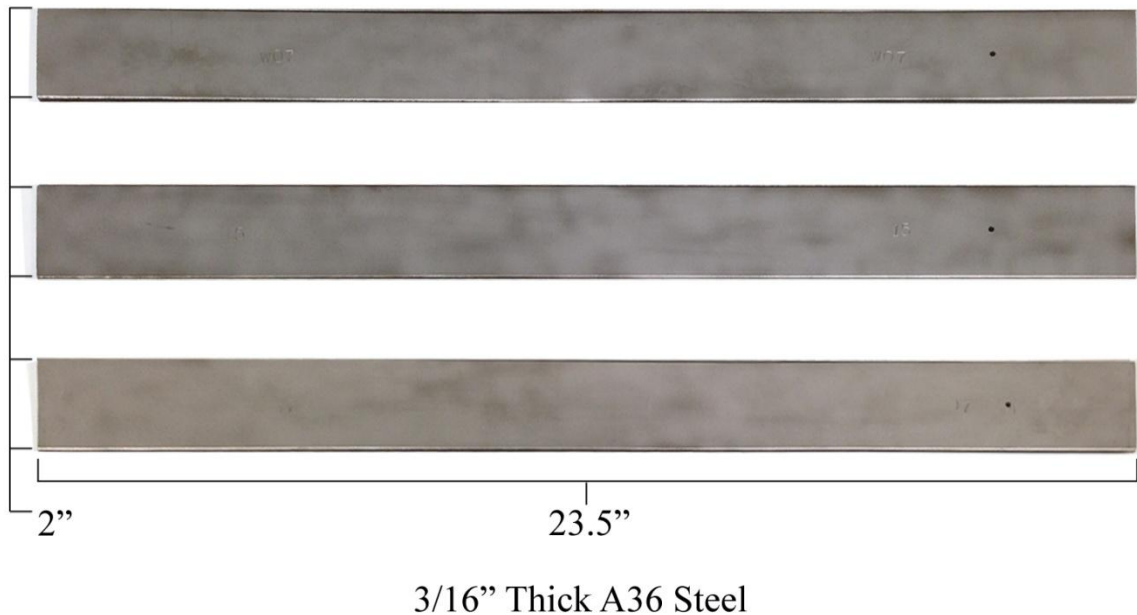
contaminants. The samples were weighed to the nearest 0.01 gram prior to installation in the field.

FIGURE 4.1: Steel specimens prepared prior to installation on bridge girders

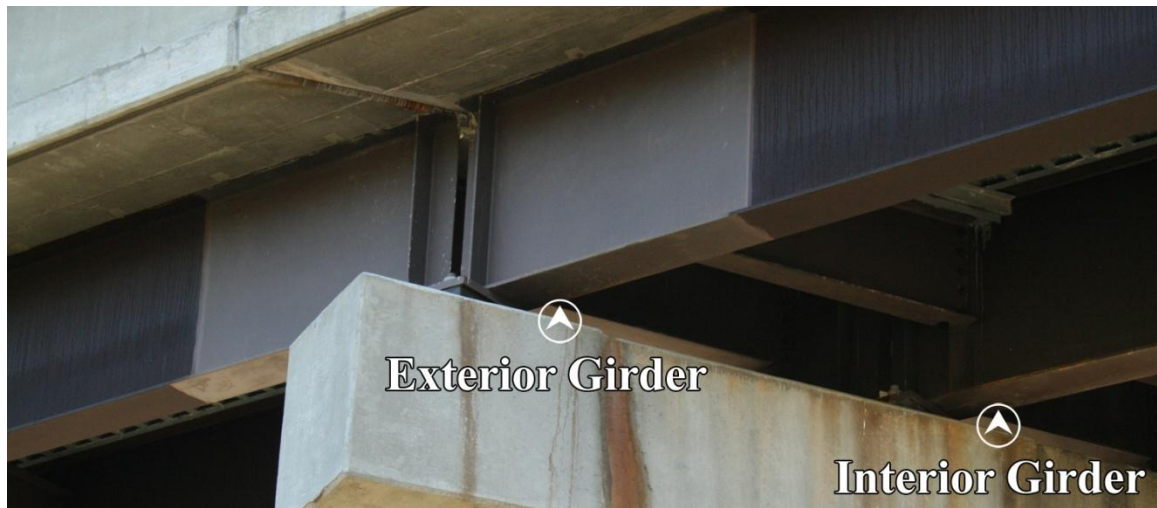
Field installation sites were selected at both exterior and interior girders (FIGURE 4.2). At each exterior and interior girder location, sample specimens were mounted on both the web and bottom flange of the girders, designated as exterior for exposure toward the outside and interior for exposure on the inside under the bridge deck (FIGURE 4.3).

FIGURE 4.2: Testing sites for atmospheric exposure of metal coupons

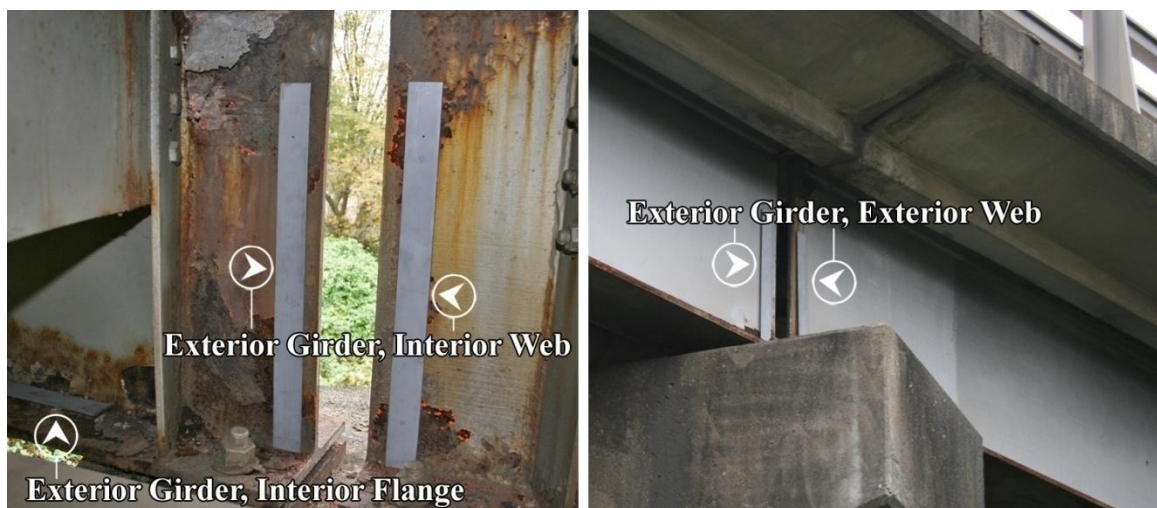
FIGURE 4.3: Coupons placement and location for atmospheric exposure

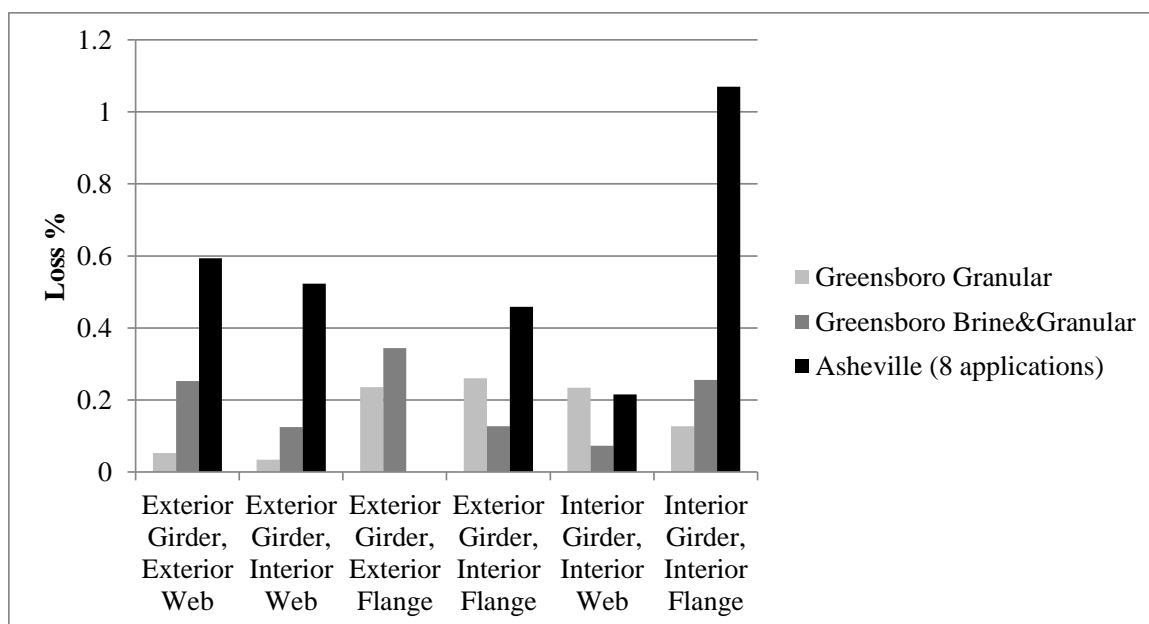
FIGURE 4.6: Average percent losses for girder locations and treatment types

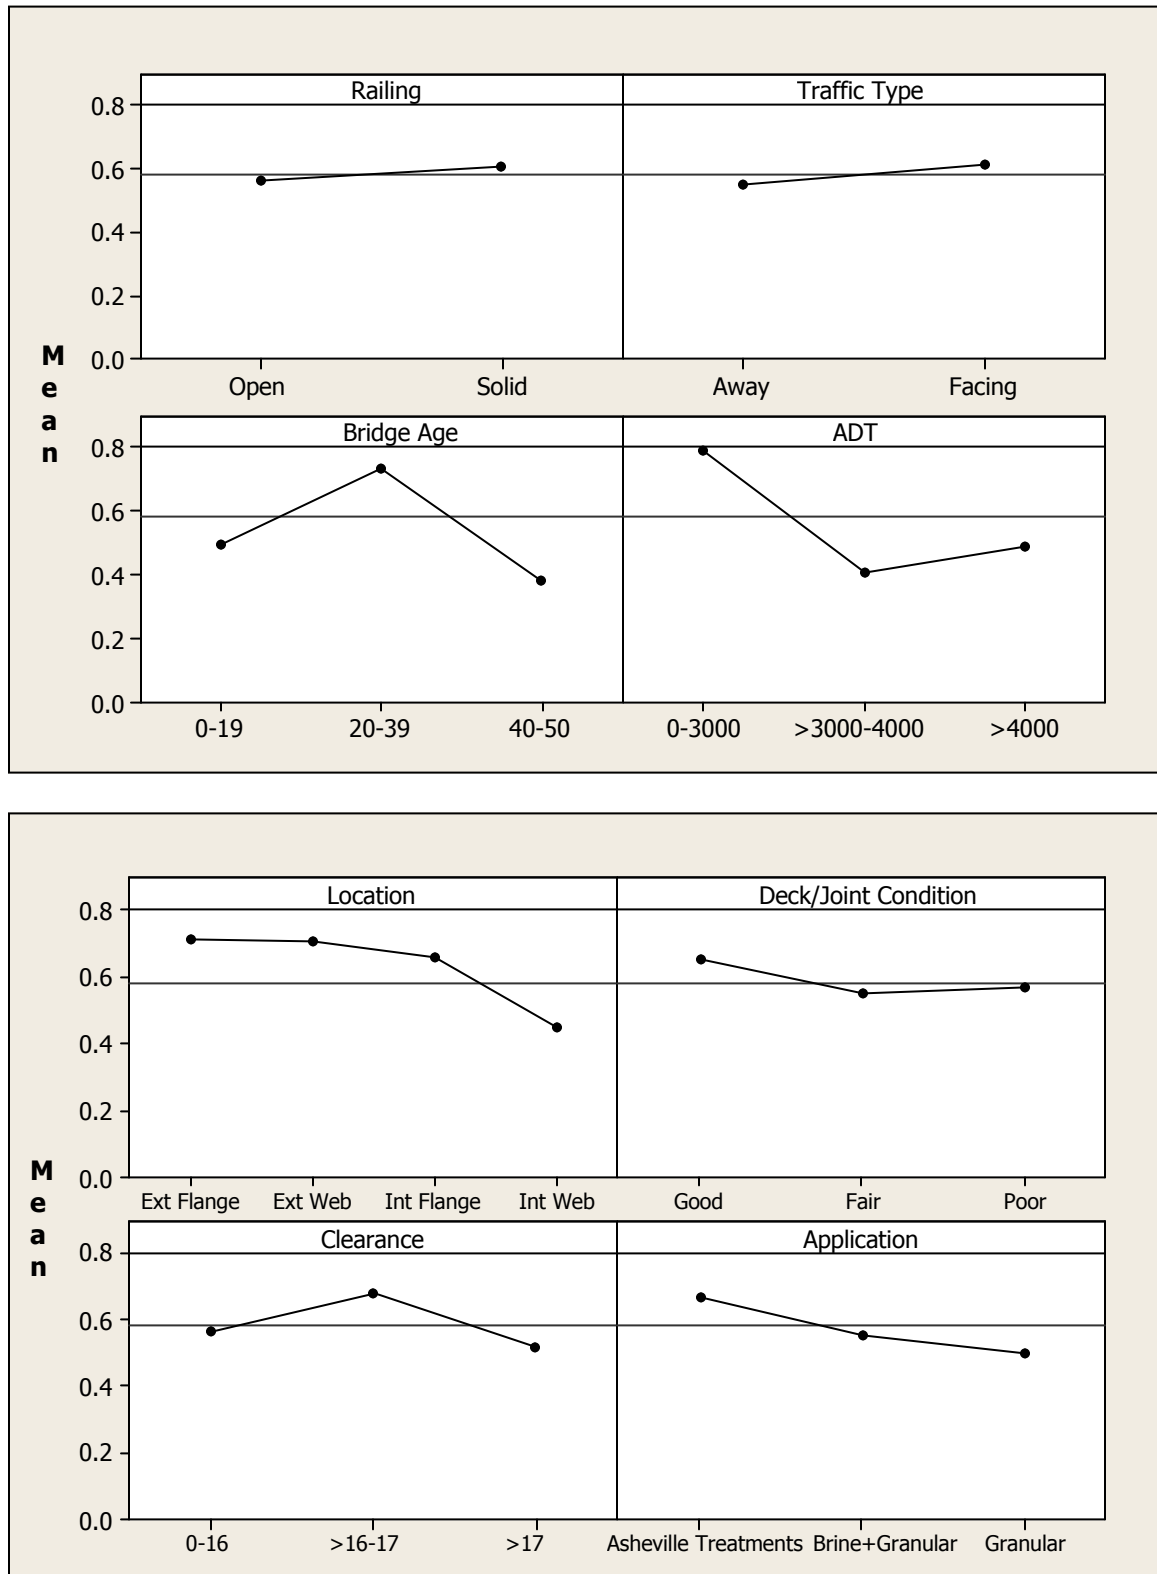
FIGURE 4.7: Main effects plots for explanatory factors on mean corrosive loss in grams

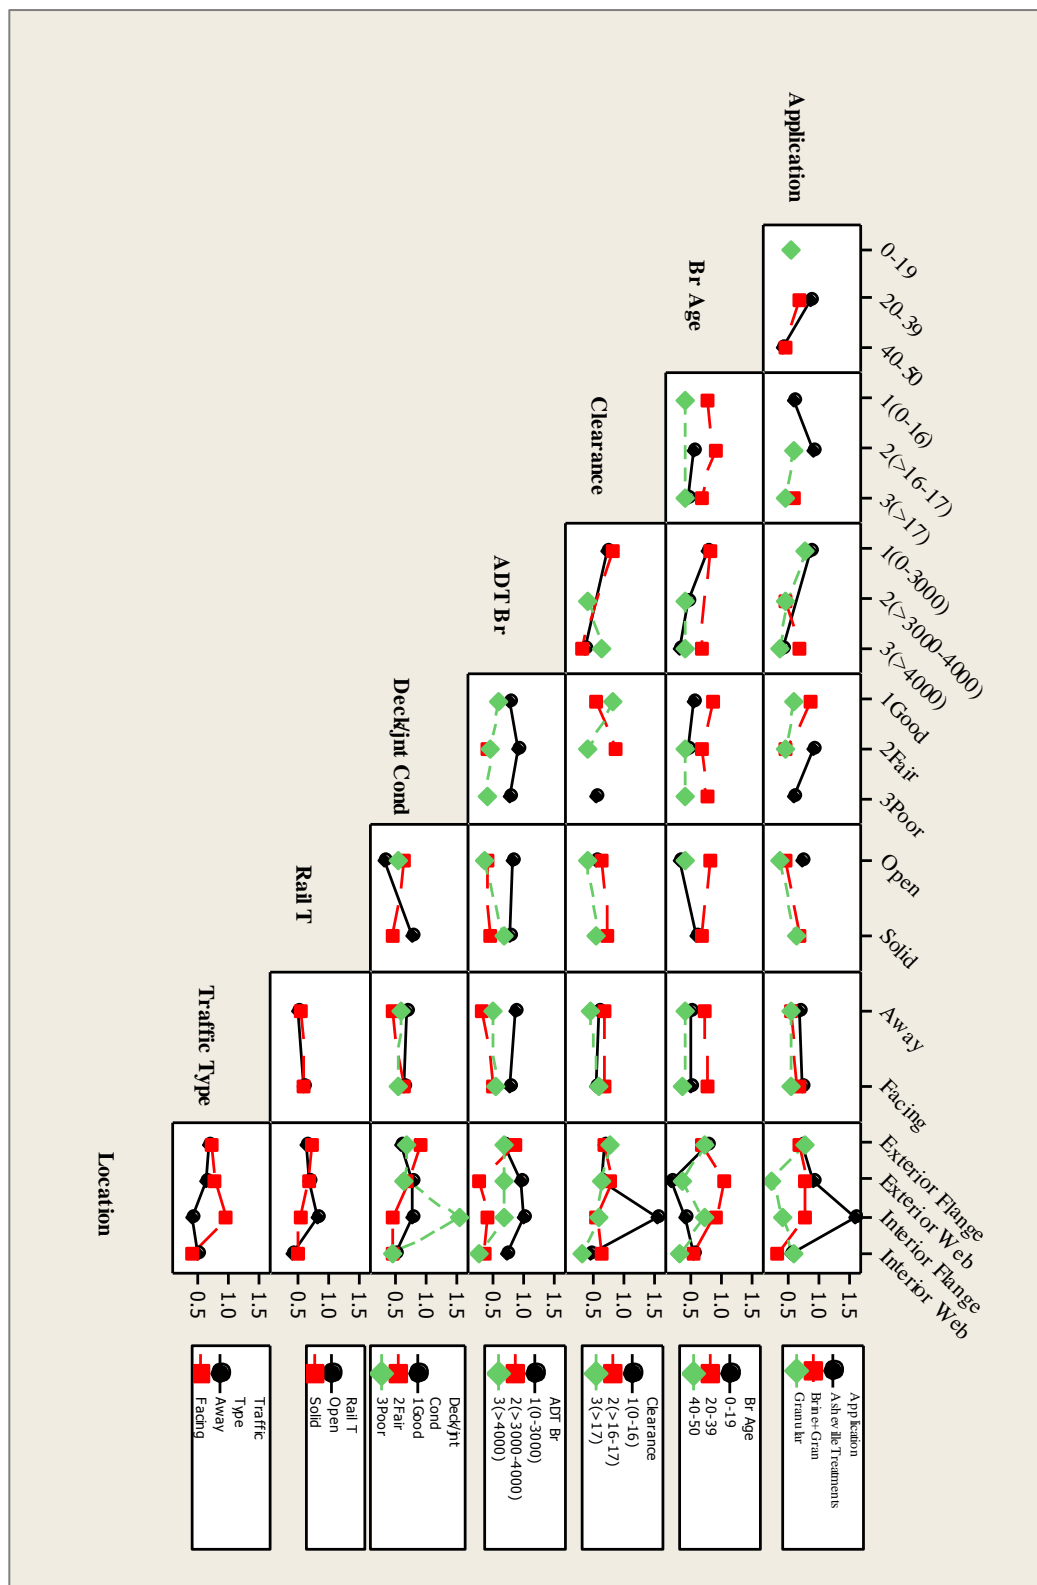
The interaction effects model was developed to take into consideration the effect of multiple factors and how those factors act together to influence the corrosive mass loss. The matrix of resulting interaction effect plots is presented in FIGURE 4.8. An interaction plot is also useful in separating out the more influential variables in instances where several significant effects interact producing a main effects plot that can be misleading, especially when the differences in individual effects is large. There are no interaction effects between two factors when the plot shows relatively horizontal lines from one condition to another within a factor plotted against another factor. The horizontal lines indicate that the main effect is neither increasing nor decreasing for each condition. Due to limited collected data, certain interaction plots are incomplete for particular conditions where the data is too sparse and thereby determination of a comprehensive analysis of interaction was not possible.

FIGURE 4.8: Interaction effects of explanatory factors on mean corrosive loss in grams

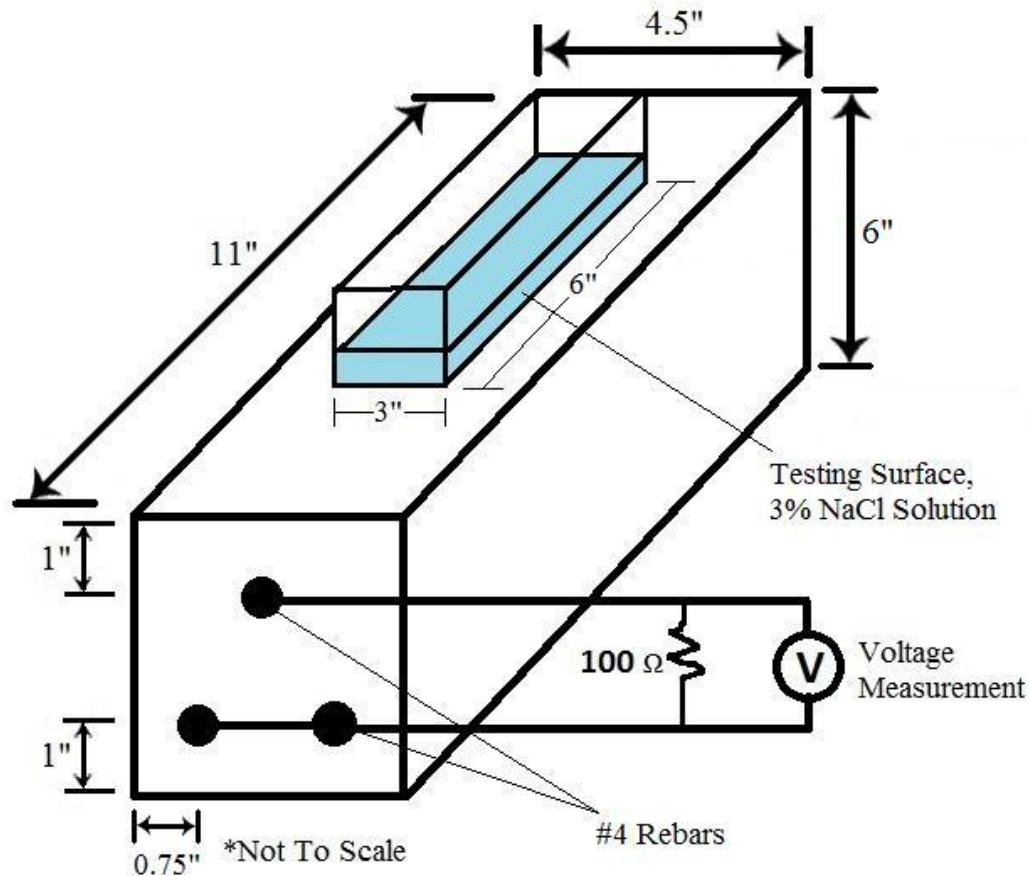
(RCT) of the concrete over various depths was performed to analyze chloride content at the end of the protocol.

FIGURE 5.1: Schematic of testing setup for reinforced concrete block

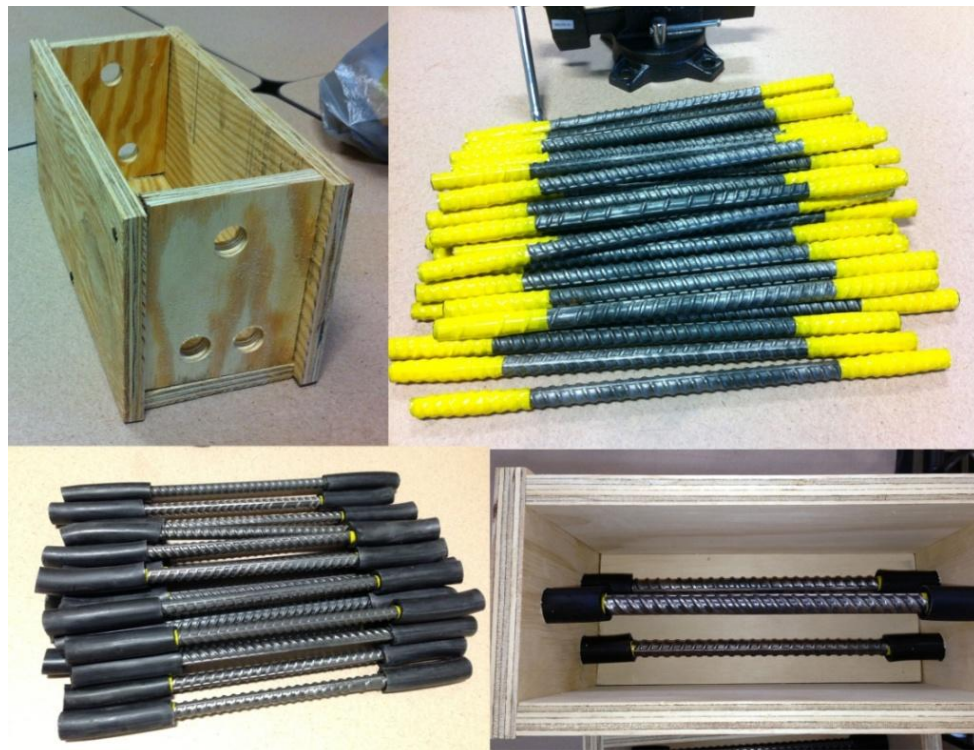
and nut for the electrical connection. Electroplater tape was used to cover the end of each bar leaving a middle portion of 8 inches in bare steel. In addition, 3.5 inches of neoprene tubing was used to cover the ends of each bar over the taped portion. The process exposed about 8 inches of steel within the concrete to be tested and electrically isolated the steel surface at the end of each bar. The protruded tubing at each end was sealed with silicone. Wood molds were prepared for each specimen with holes positioned to support the rebars in place during casting. FIGURE 5.2 shows preparation of the bar and mold. A special specimen was prepared to measure the internal temperature fluctuations within the concrete specimens. A mold that did not contain reinforcing bars was also prepared to be cast with temperature sensors placed along the height of the specimen, as shown in FIGURE 5.3.

FIGURE 5.2: Preparation of reinforced bars and wood molding

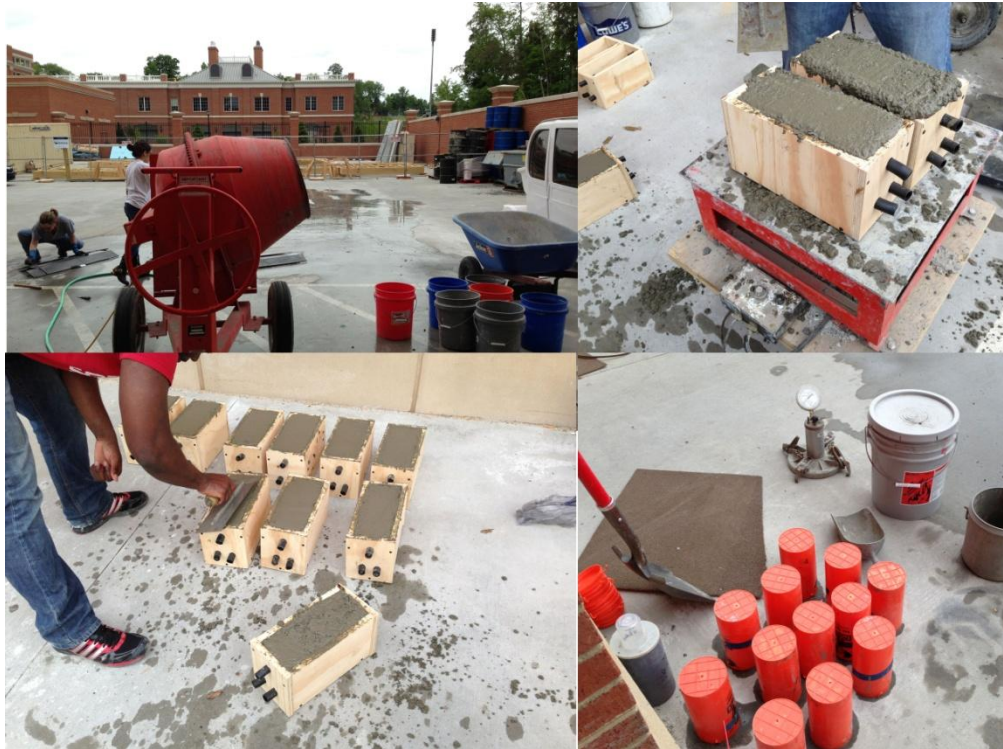
were 0.5” and 6 %, respectively. To help consolidate the concrete, a vibration table was also used when filling the wood mold (FIGURE 5.4).

FIGURE 5.4: Pouring of concrete specimens

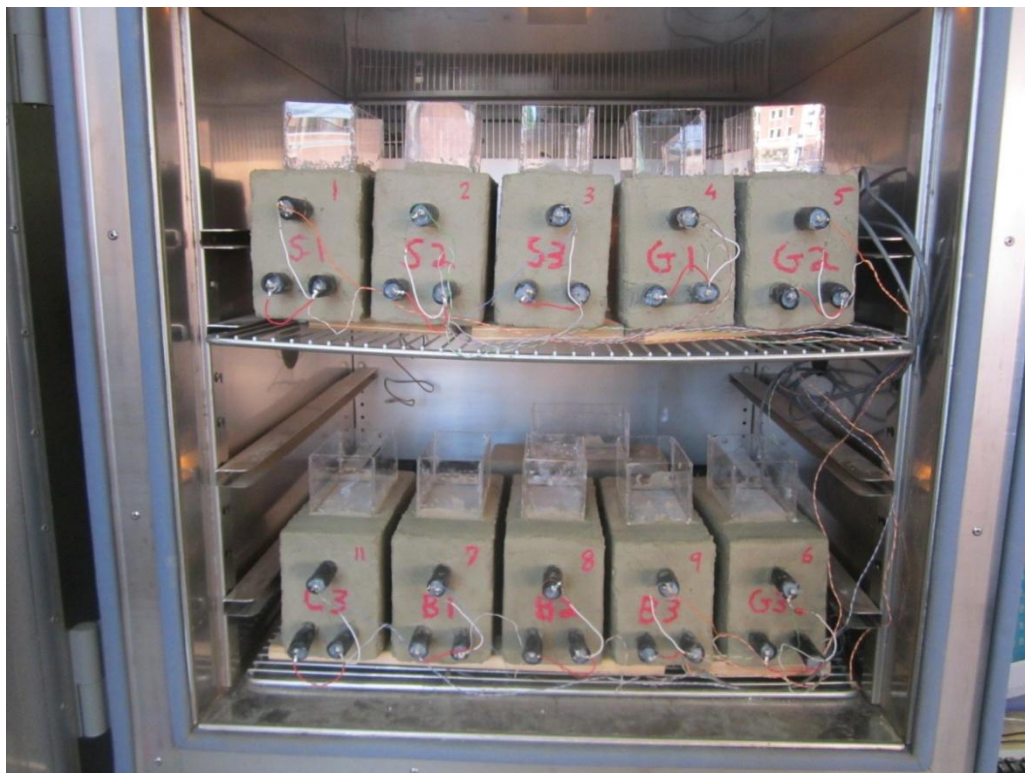
FIGURE 5.5: Finished specimens with attached wires and resistors

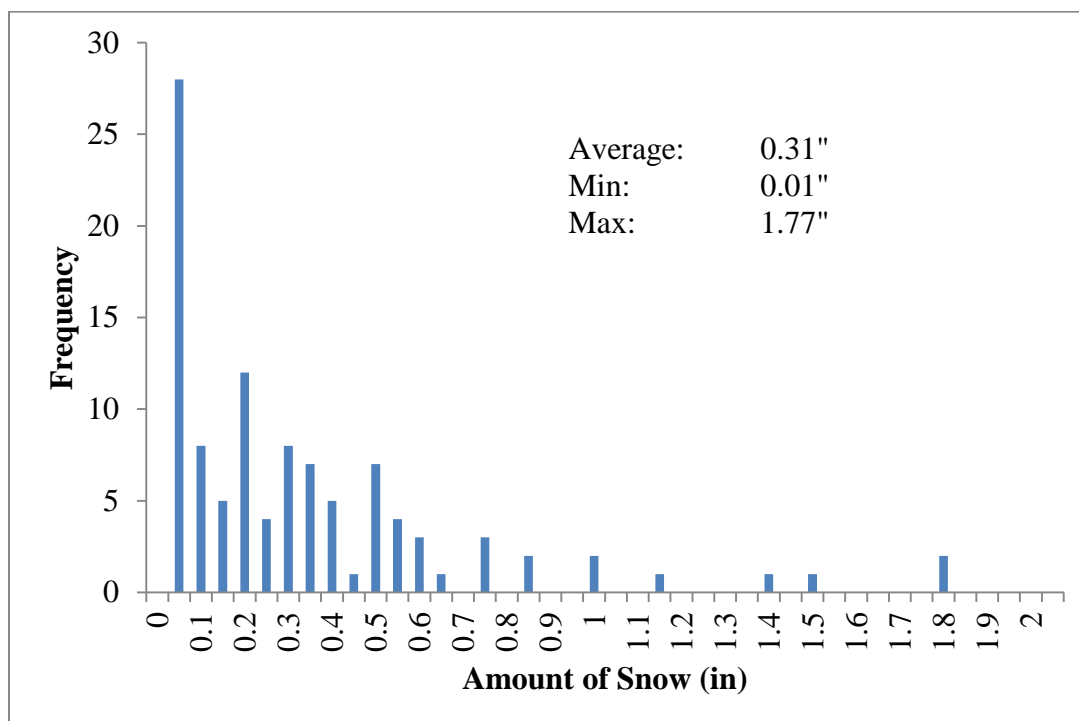
The test program attempted to simulate field exposure on concrete bridge decks during a typical winter season in North Carolina. Weather features considered when preparing the program included: temperature cycling, above and below freezing temperature (freeze-thaw action), precipitations (rain and snow with wet-dry action), and deicing treatments (brine, granular salt, and salt-sand mix). To create an exposure regimen representative of North Carolina winters, weather information and winter deicing practices were considered. Weather information was obtained from 1991 to 2011 for the city of Asheville, NC through Weather Underground, a weather data service (Weather Underground 2013). The study examined winter seasons over the months of November through March over the 20 year period. The average amount of snow precipitation for one snow event was found to be 0.31 inches (FIGURE 5.6). Average temperatures were found to be  $-0.13^{\circ}\text{C}$  ( $31.76^{\circ}\text{F}$ ) for the daily minimum and  $11.31^{\circ}\text{C}$  ( $52.36^{\circ}\text{F}$ ) for the daily maximum over the entire selected winter season. Out of the 3,019 days in the study, 1,557 days have a minimum temperature that is below freezing and a high that is above freezing temperature. Temperatures on days that indicated a snow event have an average minimum of  $-4.44^{\circ}\text{C}$  ( $24^{\circ}\text{F}$ ) and a maximum of  $3.33^{\circ}\text{C}$  ( $38^{\circ}\text{F}$ ). Further studies of weather information were performed for the first 10 winter seasons (1991-2001) from the 20 years of weather data. The average number of snow or ice and rain events per season is shown in TABLE 5.3.

FIGURE 5.6: Amount of snow precipitation per event for 1991-2011 in Asheville, NC

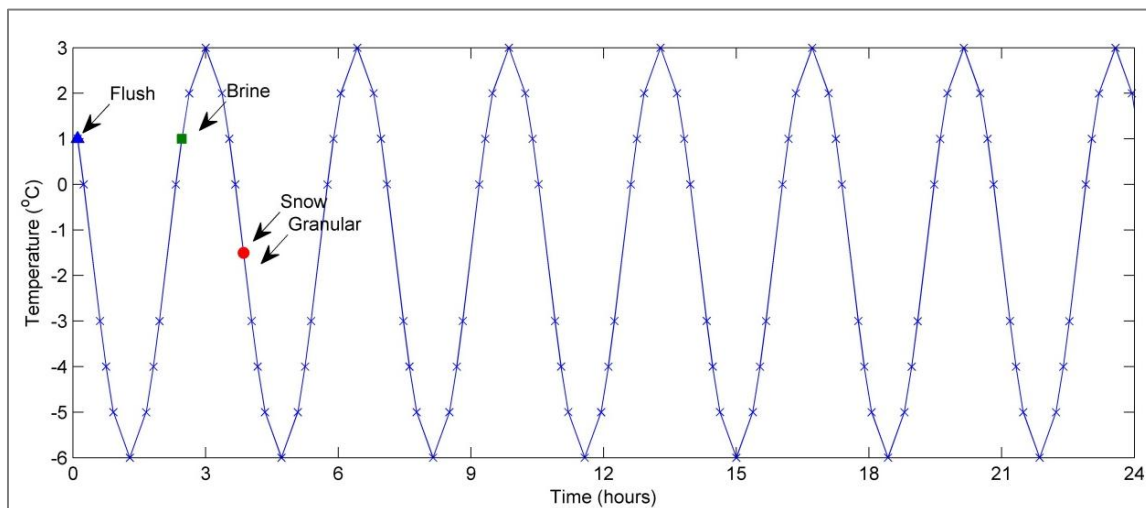
The cycle was set up to repeat during a 24 hours period for Monday through Friday, which included flushing with water (as by rain), deicing applications, and snow precipitation. FIGURE 5.7 shows the full one 24 hours cycle for the test program. The temperature was set to cycle between -6°C and 3°C (21.2°F - 37.4°F) in a sinusoidal wave pattern. The temperatures selected were lower than the average daily low for days that indicated a snow event to account for temperature lag on the concrete surface and ensuring adequate freeze-thaw actions. Each daily cycle consisted of seven freeze-thaw actions. The test program ran over 70 days. According to Asheville weather data, for a typical 20 years there are 1,557 freeze-thaw cycles; with a total of 490 simulated freeze-thaw cycles the approximate amount of years is 6.29. The total number of simulated snow events is 70, which can be approximated as 6.67 years based on the historical analysis of the average number of snow fall annually. The whole test program can be summarized as having an average simulated time of 6.5 winter seasons with three times the normal deicing application rate.

FIGURE 5.7: Environmental chamber setup for one cycle

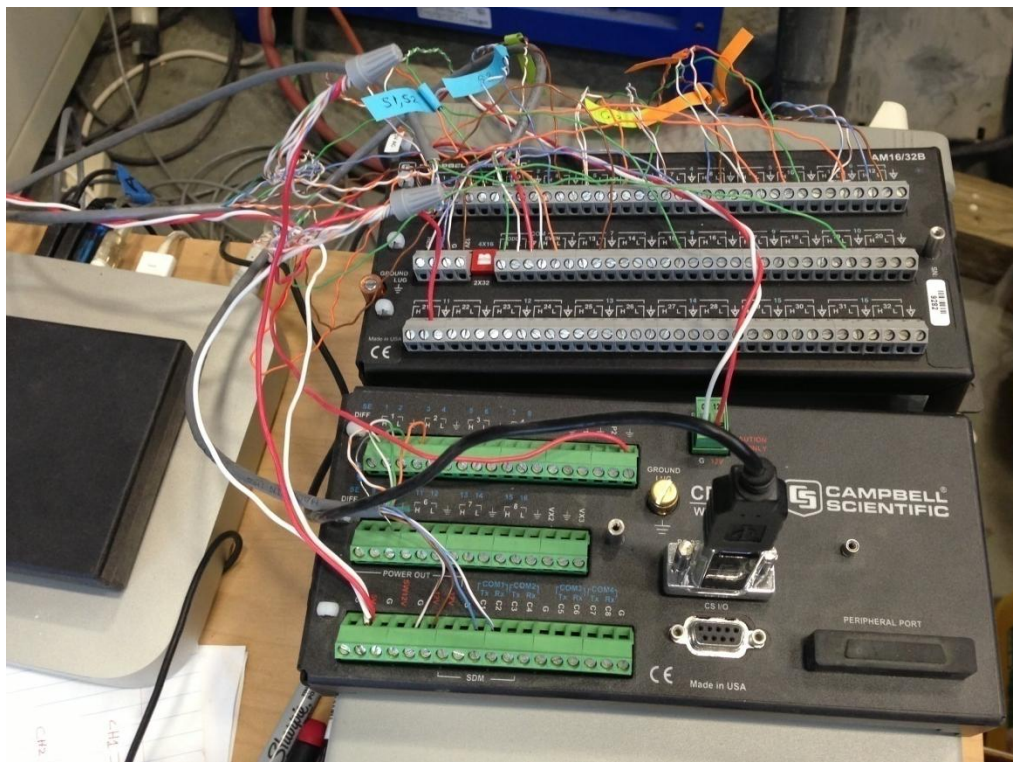
During the experiment, data acquisition was achieved by using Campbell Scientific data logger to monitor and record voltage differentials between the rebars and thermistor circuits at one minute intervals (FIGURE 5.8). In addition, current chamber temperature and humidity were recorded using the chamber's built-in sensors.

FIGURE 5.8: Data logger used to record voltage readings

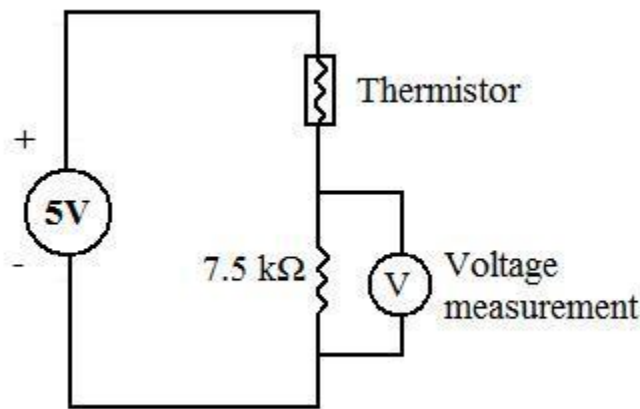
FIGURE 5.9: Schematic of thermistor circuit
