EXPERIMENTAL ASSESSMENT OF THE EFFECT OF SODIUM CHLORIDE  
DEICING AND ANTI-ICING SOLUTIONS ON EXPOSED, COATED, AND  
REINFORCING STEEL IN HIGHWAY BRIDGES

A thesis submitted to the faculty of  
The University of North Carolina at Charlotte  
in partial fulfillment of the requirements  
for the degree of Master of Science in  
Civil Engineering

2014

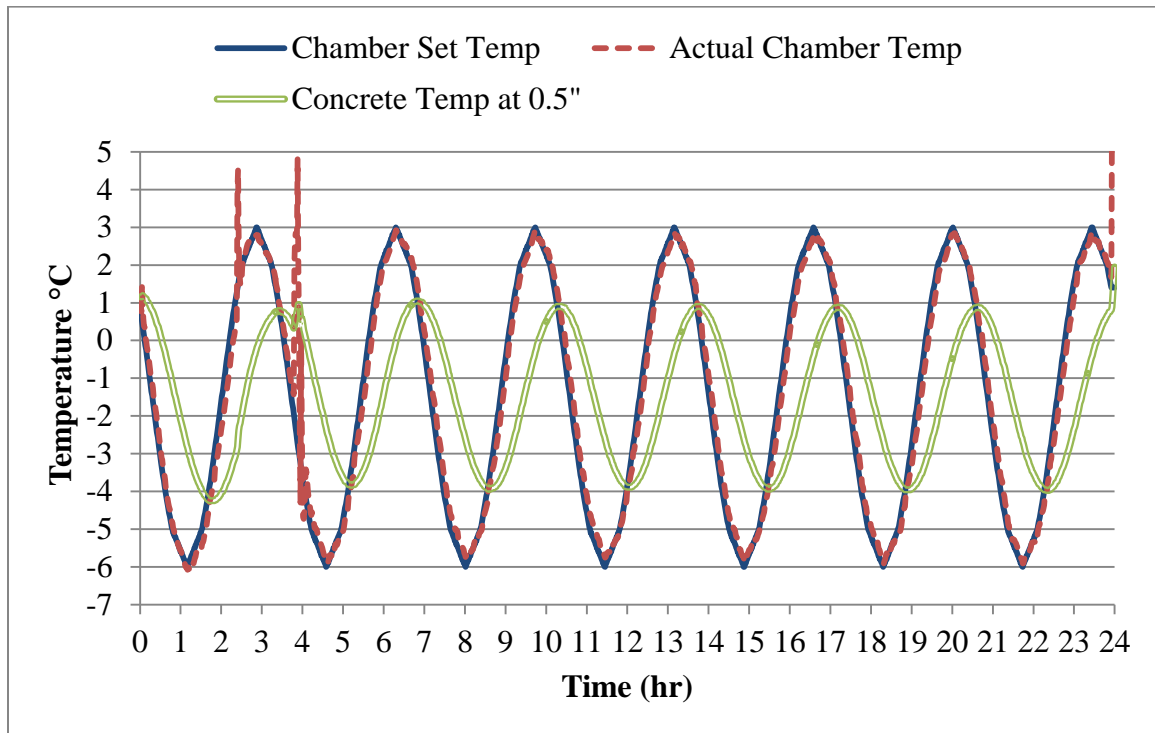
FIGURE 5.10 shows the typical recorded temperature with overlay of chamber ambient temperatures and temperatures of concrete block at 0.5" depth. FIGURE 5.11 shows a closer view of temperature readings when brine and snow with deicing treatments was applied.

FIGURE 5.10: Overview of temperature readings of one cycle

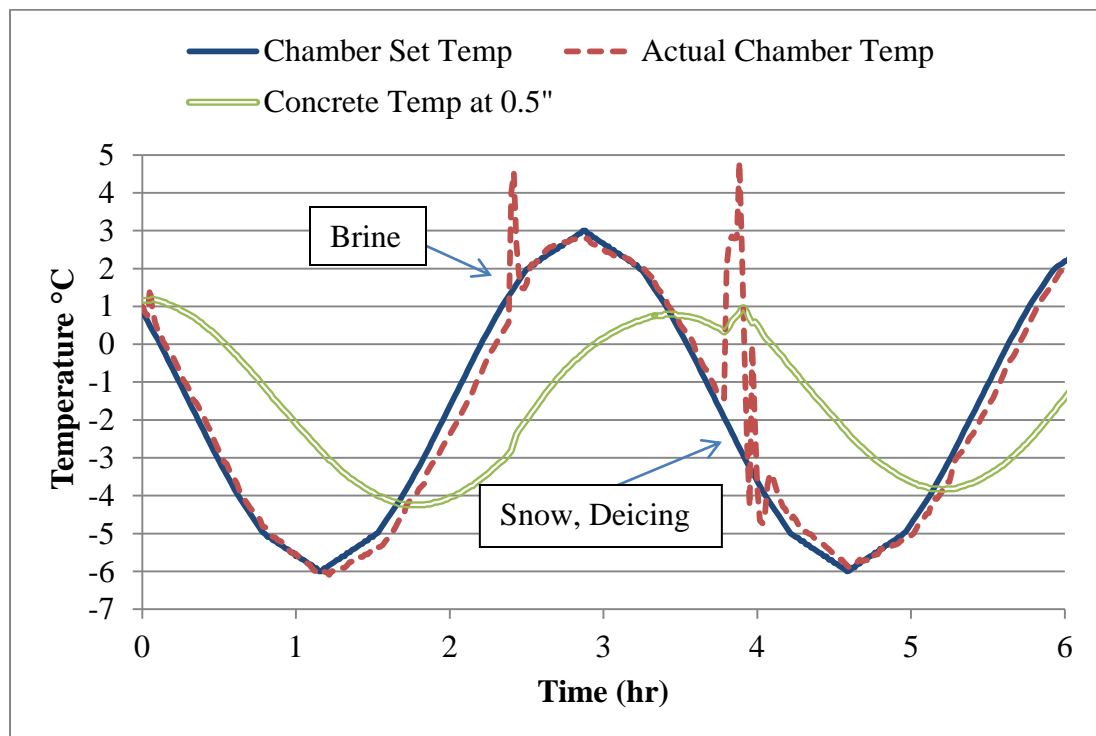
FIGURE 5.11: Temperature readings at brine, snow, and deicing application

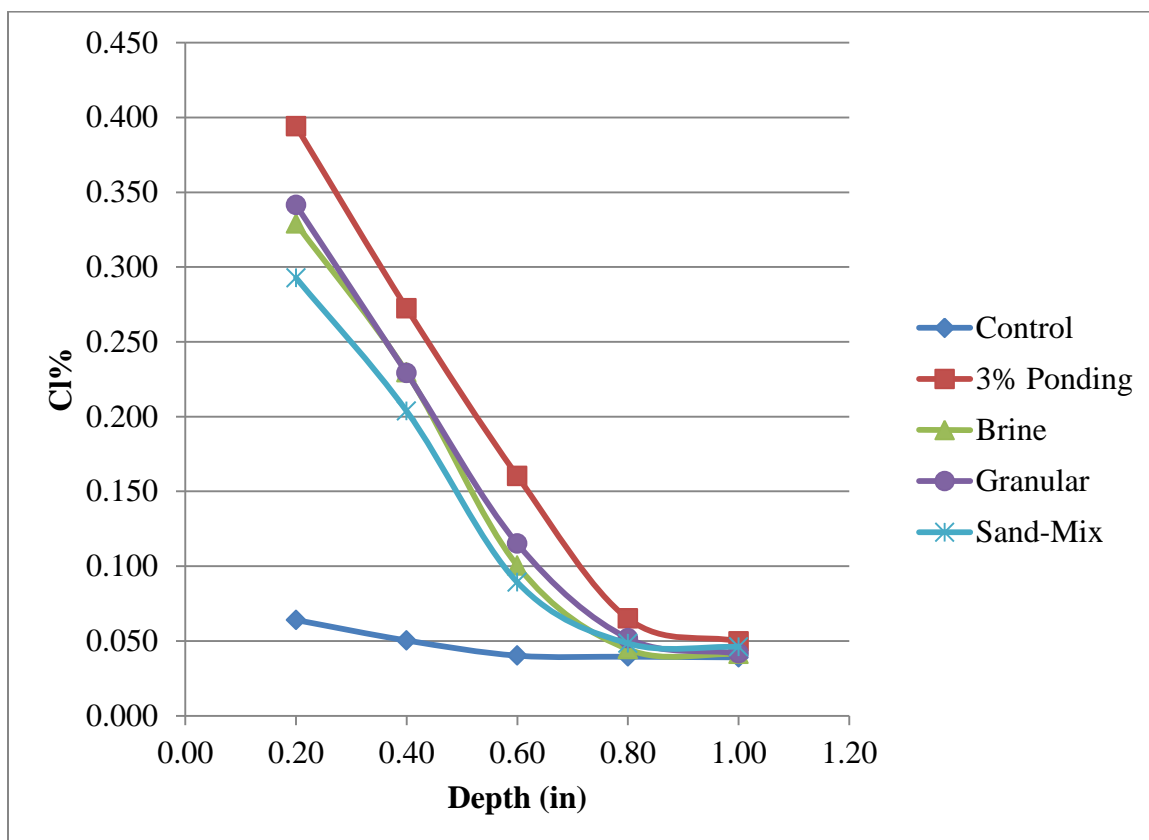
FIGURE 5.12: Chloride concentrations at drilled depth for each treatment type

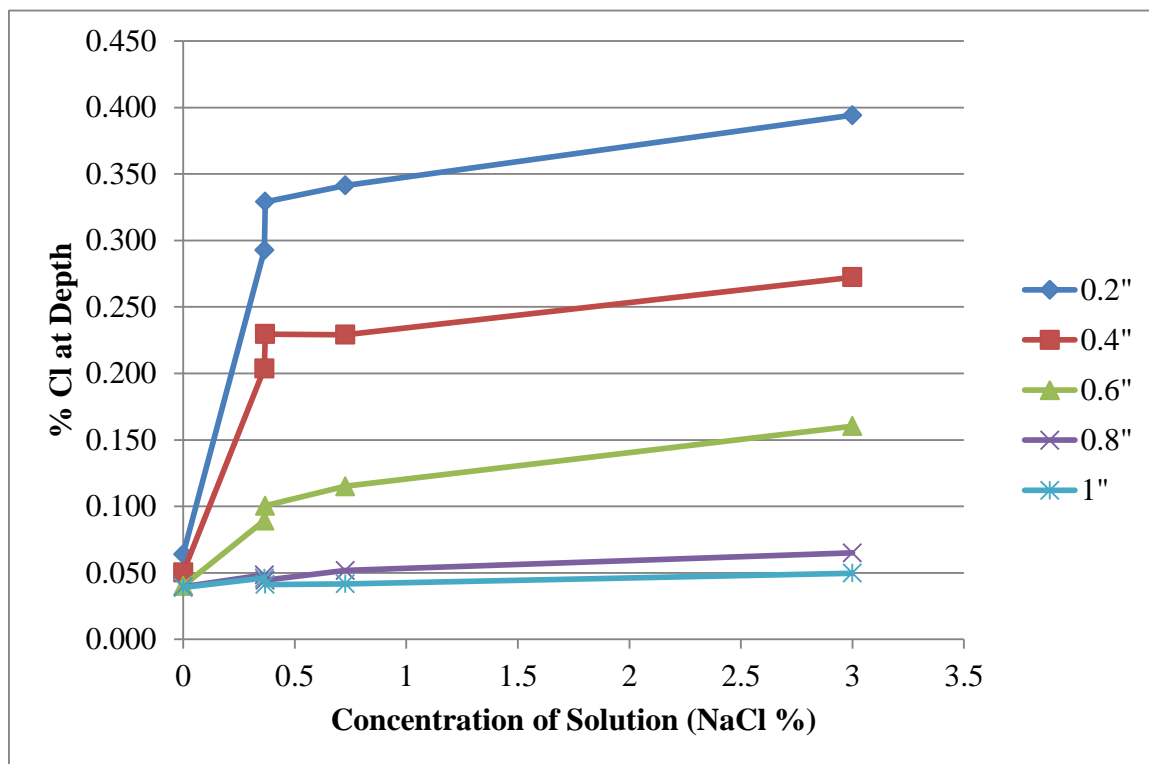
FIGURE 5.13: Plot of surface solution concentration and RCT chloride percent

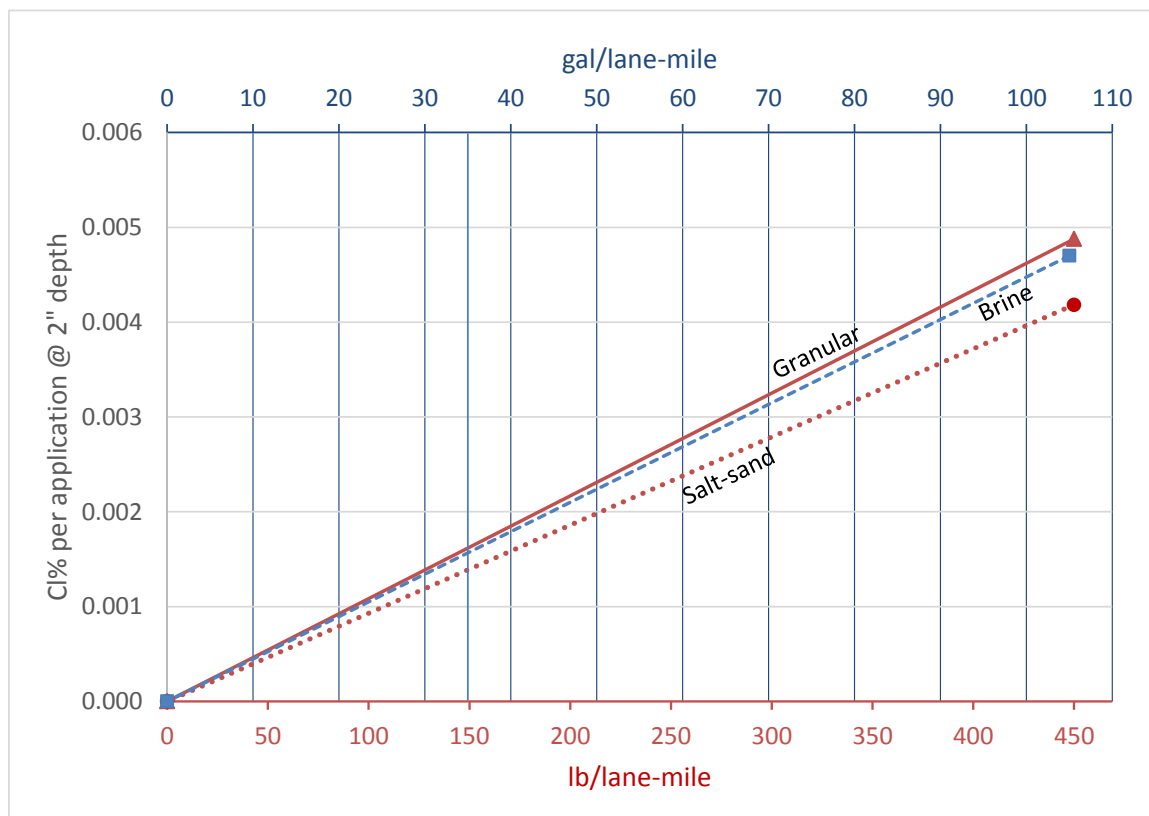
FIGURE 5.14: Plot of Cl% per application at 0.2" depth vs application rate
