THE APPLICABILITY OF FREE-FIELD ACOUSTIC SIGNATURES TO QUALITY  
INSPECTION OF ROTATING MACHINERY

A thesis submitted to the faculty of  
The University of North Carolina at Charlotte  
in partial fulfillment of the requirements  
for the degree of Master of Science in  
Applied Energy and Electromechanical Systems

2016

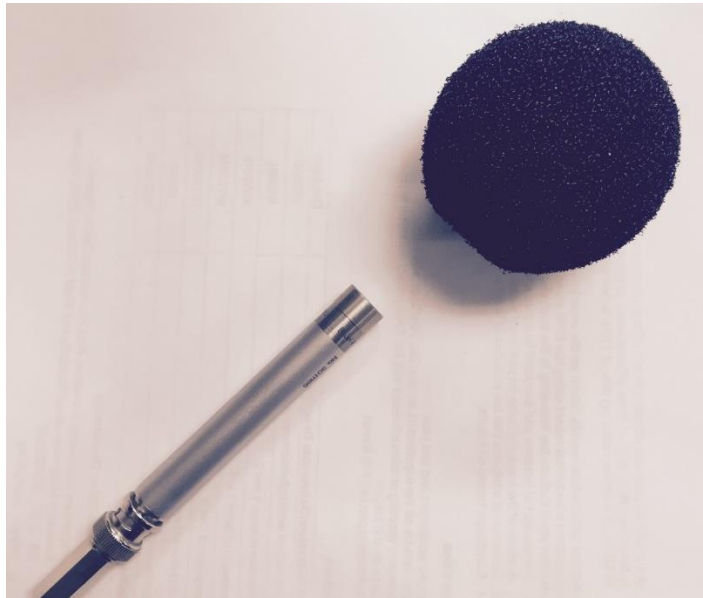
Figure 5: Preamplifier microphones assembly

The preamplifier was connected with a BNC type connector to the data logging device. The frequency response of the preamplifier was  $\pm 0.2$  dB across the band of interest. The preamplifier was supplied with 2mA excitation current. The maximum output of the preamplifier was a 7 volt peak corresponding to approximately 141 dB according to specifications. The microphone preamplifier sampling task was set up using National Instrument Measurement and Automation Explorer. The acoustic measuring system was set to measure continuously and to convert the raw pressure measurements to the commonly used decibel with 20  $\mu$ Pa used as the reference pressure. The preamplifier microphone combination can be viewed in Figure 5.

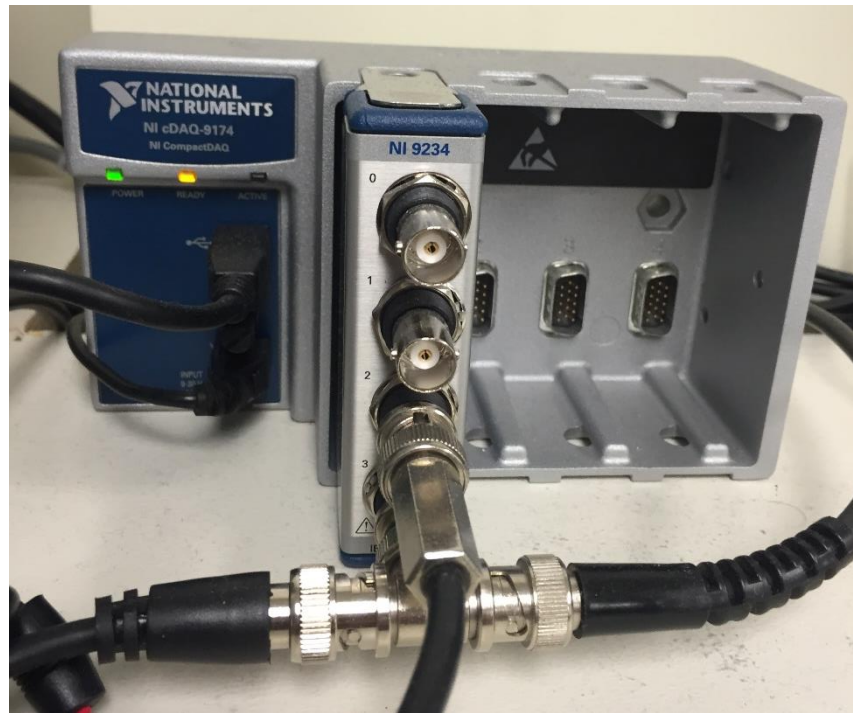
Figure 6: cDAQ and 4 channel module

The logging device that was used was National Instruments Compact Data Acquisition System (cDAQ) with four port chassis model number 9174. In the first port of the cDAQ, a NI 9234 analog input 4 channel module was installed. Figure 6 is an image of the cDAQ chassis and 4 channel module.

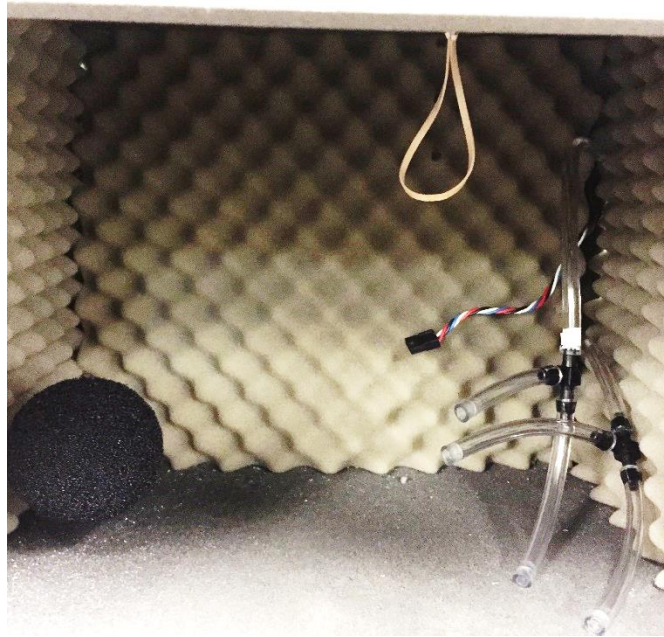
Figure 11: Foam test chamber

testing but was removable to access the pump specimen. An image of the open testing environment can be found in Figure 11.
