POST-DISASTER INVESTIGATION OF STRUCTURES IN EASTERN
INDIA AT VISAKHAPATNAM AFTER VERY SEVERE
CYCLONE HUDHUD

A thesis submitted to the faculty of
The University of North Carolina at Charlotte
in partial fulfillment of the requirements
for the degree of Master of Science in
Civil Engineering

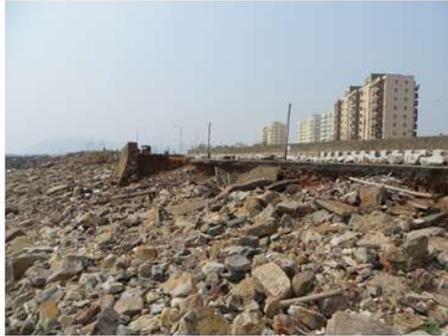
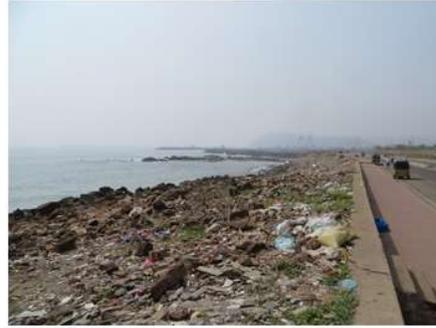
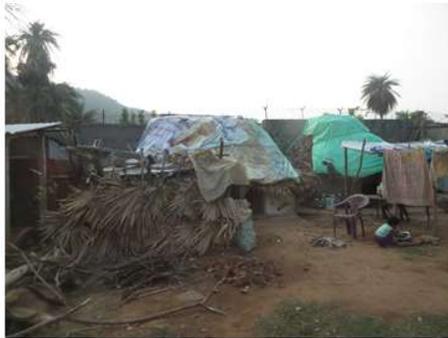
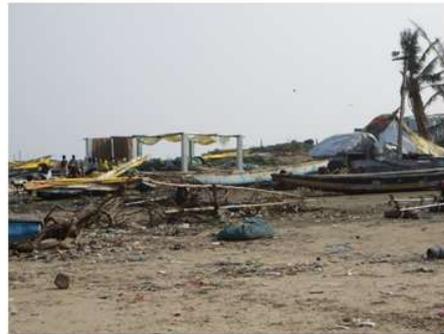
a) Damages to Vizag Coastal Area

b) Beach Road Barricaded the Waves (Distance to Nearest Structures ~40 m)

c) Damages to Fisherman's huts

d) Beach Area Erosions and Downed Masonry Buildings

Figure 2: Water Damage Scenarios in Vizag and Surrounding Areas: a) Rock Erosion and Debris Showing Strong Wave Forces; b) The Wide-Span Beach Road Protected the Structures within the City Vizag; c) Huts Damaged in Krishna Nagar; and d) Small Masonry Structures Damaged in Jelari Peta.

surface wind field and pressure field. Vizag is the largest city in the Andhra Pradesh and is situated at the west end of the Bay of Bengal. The city is naturally endowed by the beautiful coast line on the east and the surrounding of the Eastern Ghats rolling hills. Vizag has been classified as a high-risk zone for cyclonic activities (Mohapatra et al. 2012, Matta et al. 2015). Figure 2 shows the damaged coastal area in Vizag including significant rock erosions (Figure 2a). However, the city and most of its infrastructure had been protected by the steep bathymetric slopes and the wide-span, beach roadway (Beach Road in Vizag, see Figure 2b); thus, water damages in the city were not significant.

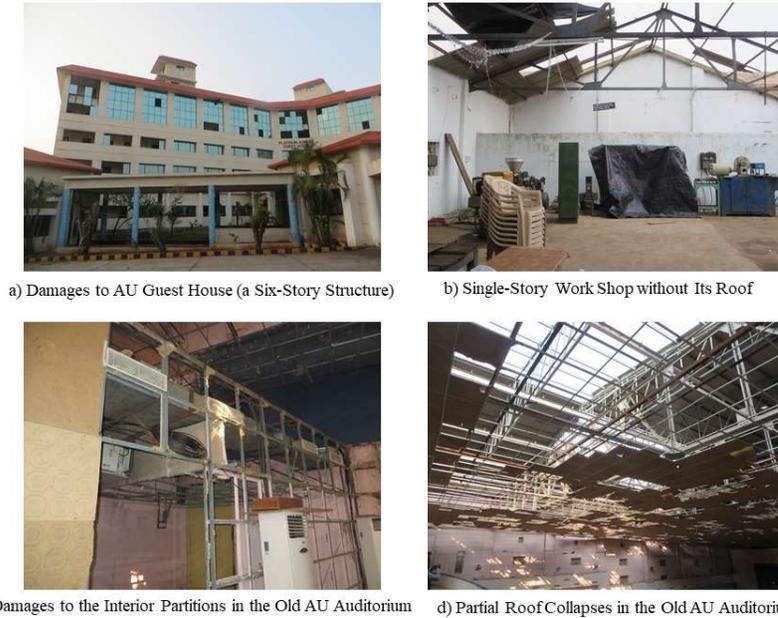
a) Damages to AU Guest House (a Six-Story Structure)

b) Single-Story Work Shop without Its Roof

c) Damages to the Interior Partitions in the Old AU Auditorium

d) Partial Roof Collapses in the Old AU Auditorium

Figure 3: Damages at the Andhra University Campus: a) Exterior Damages of AU Guest House; b) Roof Down of a Single-Story Work Shop; c) AU Old Auditorium with Interior Partition Damages; and d) Roof Damages of AU Old Auditorium.

In fact, the beach front area of Vizag is followed by a steep hill, where Andhra University (AU) campus presides. The highest point of the campus is around 70 m (229.7 ft) above sea level. The campus experienced several structural failures and trees down. The original green campus is almost exposed losing almost half its tree population. Figure 3 shows several campus structures damaged due to the storm event including multiple-story structure (Figure 3a) and single-story work shop (Figure 3b). Figure 3c and 3d shows the damages to the old auditorium that include portion of the roof damaged and damages to the interior partitions.

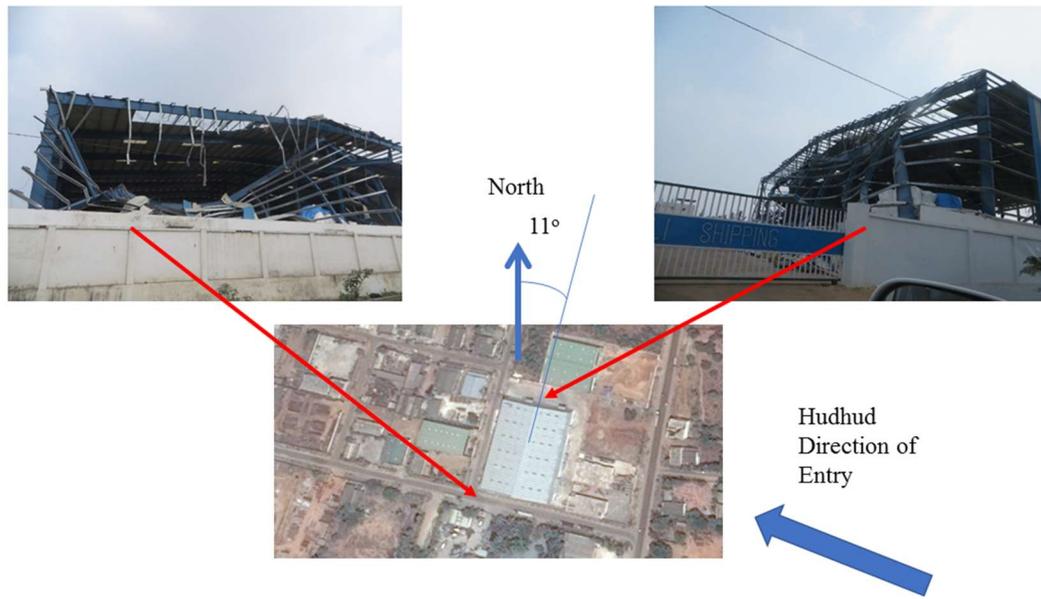
Figure 4: Wind Damaged Steel Storage Structure at 1 Km (3,280 ft) Distance Away in Autonagar, India

cyclone to travel much deeper in-land. Figure 4 shows a large steel structure (Building No. I05-001) located in Autonagar, which is located approximately 1 Km (3,280 ft) away from the coastline and experienced severe wind damages. Notably, the front and back sides of the structure experienced significant damage with almost nominal damages to the side of the building. This is consistent with the witnesses of several local personnel suggesting there were two separate wind gusts hours apart that caused the damages to the structure, first the front (a southwestern-ward gust) then the back (a northeast-ward gust). The steel structure is approximately four to five stories tall and sits in an 11-degree angle from the north direction. Also shown in Figure 4 is the general entry direction of the Hudhuad storm path.

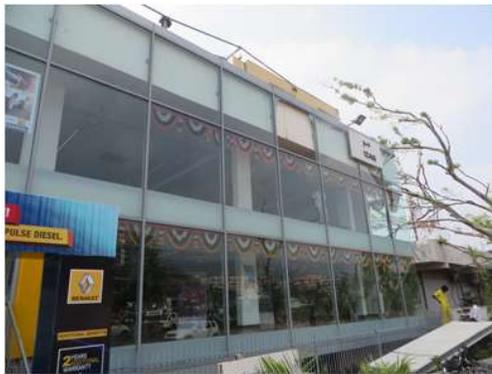
a) Main Building of a Auto Dealership

Figure 5: Wind Damaged Structure of an Automobile Dealership: a) Main Building with only façade damages; b) Roof Addition with Steel Truss; c) Support Failure of the Roof Addition with Concrete Column and Half-Filled Walls; and d) Distorted Roof Truss and Steel Frame

The most common construction methods in the eastern India are either reinforced masonry or reinforced concrete frames with concrete slab-on-grade foundations that featured metal roofing panels attached to predominantly steel roof frames. Residential structures tend to have masonry or concrete frames with metal roofing, but usually featured wood roof trusses instead of steel. Commercial structures are more typical of reinforced concrete frame with steel roof truss. Some older school structures used wood roof truss systems. Roof systems studied include both sloped and flat roofs. Most commercial structures or taller residential structures have flat roofs may have additions in the form of metal framed structures. Many of these additions are damaged during the storm and in most cases, the damages are more severe than the main building structures. As an example, Figure 5 shows a two-story automobile dealership building (Building No.

B06-001, Sai Nagar) with an elaborately constructed roof extension, which is a steel frame supporting a truss roof of its own. The main building only sustained façade damages but the additional roof structure was near completely damaged. Figure 5c shows the roof addition has a concrete footing support attached to the main building and was damaged due to collapse of the steel framing. A leaning tree may have contributed to the failing of the roof structure. Figure 6 shows other example (Building No. B02-005) where roof additions using steel tubing constructions have failed under wind loads. In this case, the building is located next to the Beach Road, Vizag.

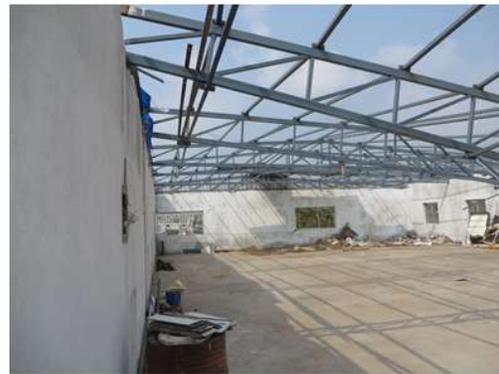
b) Roof Extension Structure

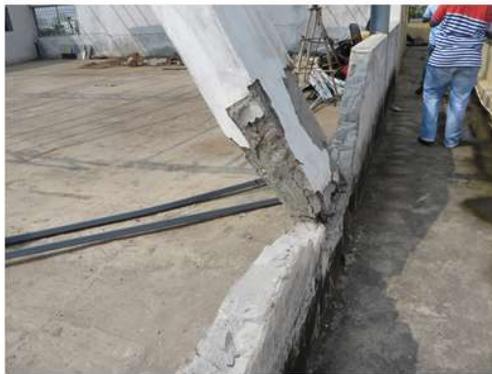
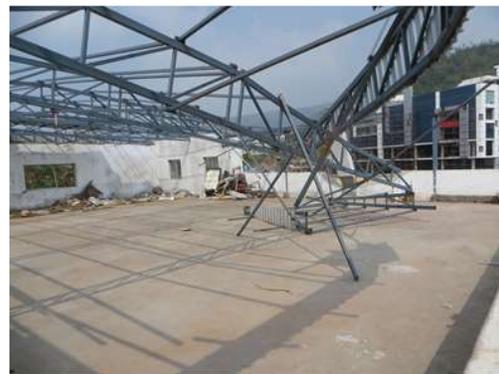
c) Damage to Extension Structure Support

d) Distorted Truss Frame

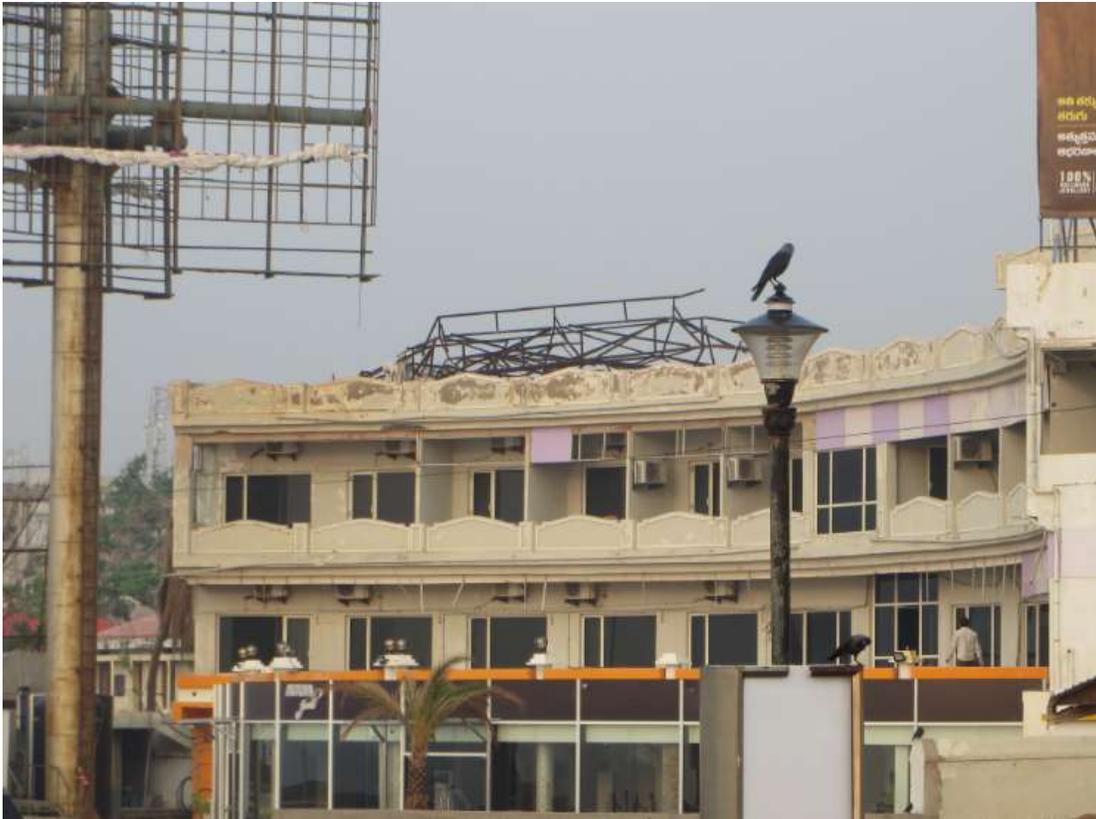
Figure 6: Roof Addition Failure on Beach Road, Vizag.

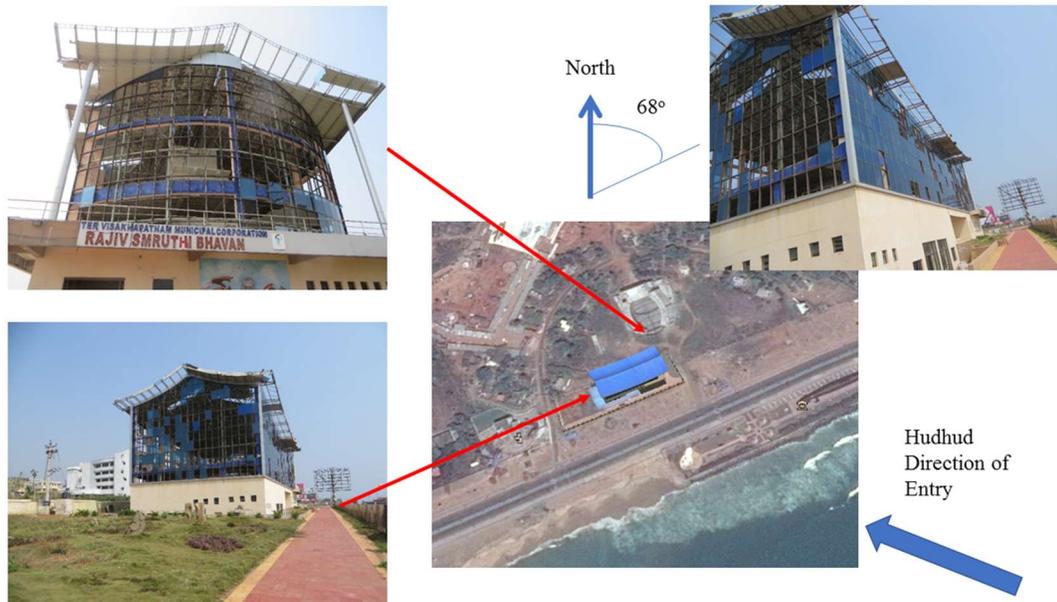
Figure 7: Damaged Gandhi Family Museum in Chinna Waltair Showing Significant Glass Damages in the front and End Sides of the Building

Another structure showed the unique, two-gust wind (southwestern-ward gust and northeast-ward gust) impacts is the Gandhi Family Museum (Building No. B02-002), which is situated on the beach front about 100 m from the coastline in Chinna Waltair and has a 68-degree tilt towards the true north. Figure 7 shows the glass covered structure has the most facade damages in the front and back of the structure and the actual sea-facing side of the building has only sustained nominal damages.

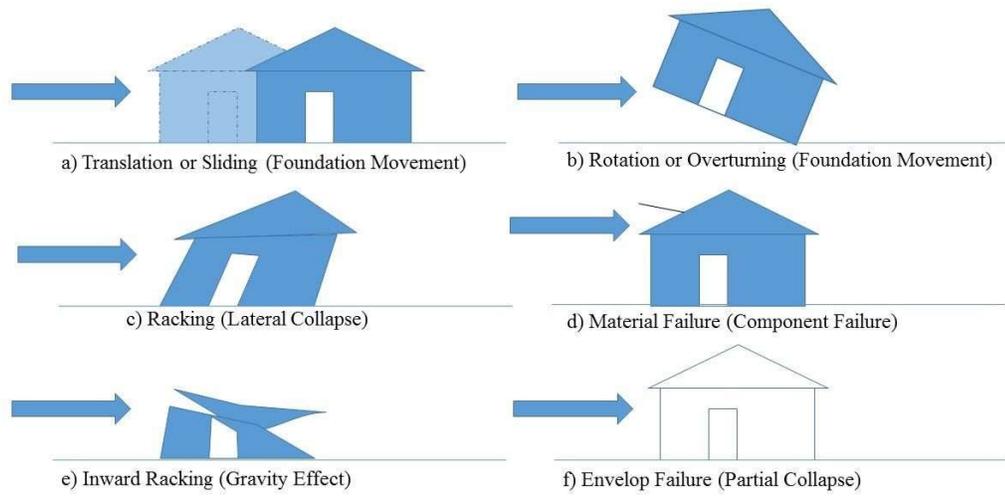
Figure 8: Global Failure Modes of Structures

Figure 8 shows six different failure modes of structures including: a) translation or sliding of structure against the foundation; b) rotation motion of structure against the foundation; c) racking or lateral collapse of the structure; d) component failures of structure such as roof damage, wall damage; e) inward racking where structure failed under gravity effect; and f) building envelop failure and only the structural components remained. The structures studied do not necessarily satisfy all the failure modes, but the failure modes are integrated into the rating scheme.

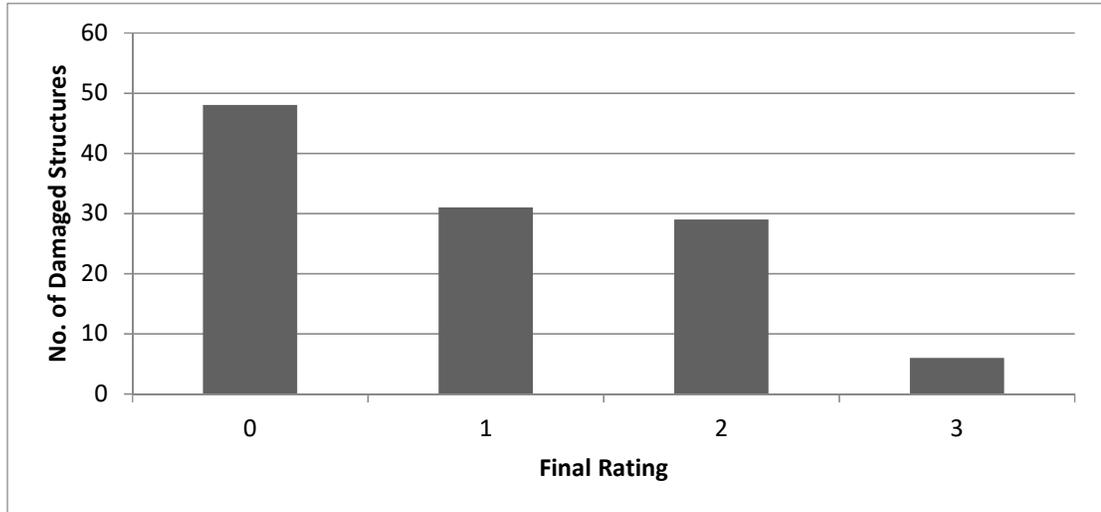
Figure 9: Overall Rating Distribution

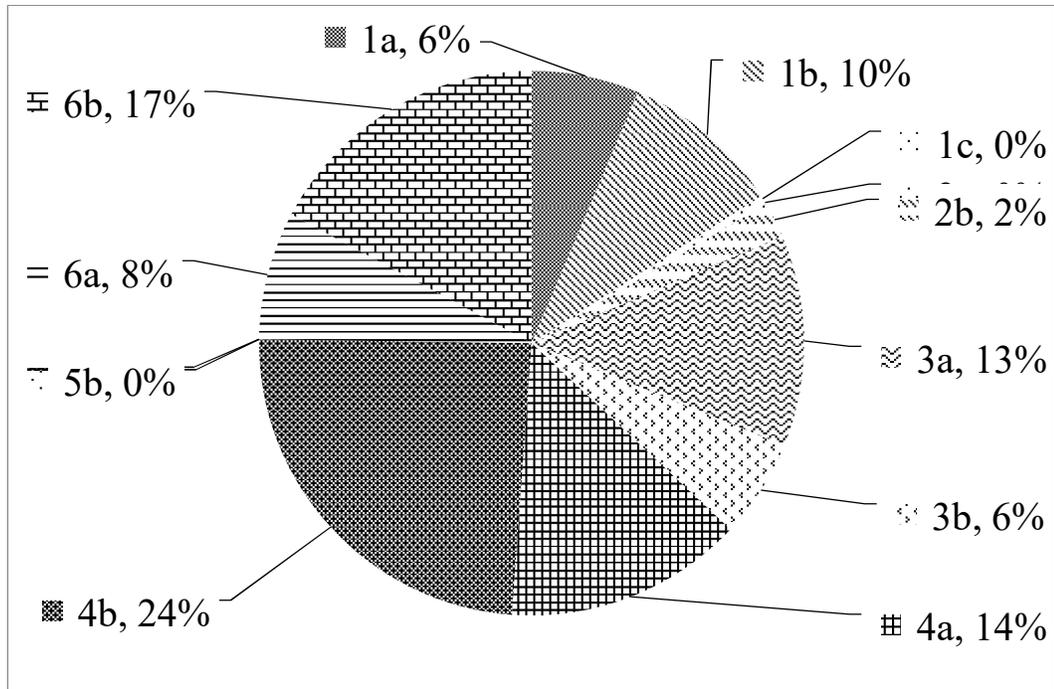
Figure 10: Statistics of Damage Condition Rankings (Key to Numbers in the Pie Chart: Condition Number, Number of Structures and the Percentage to Overall Structures)

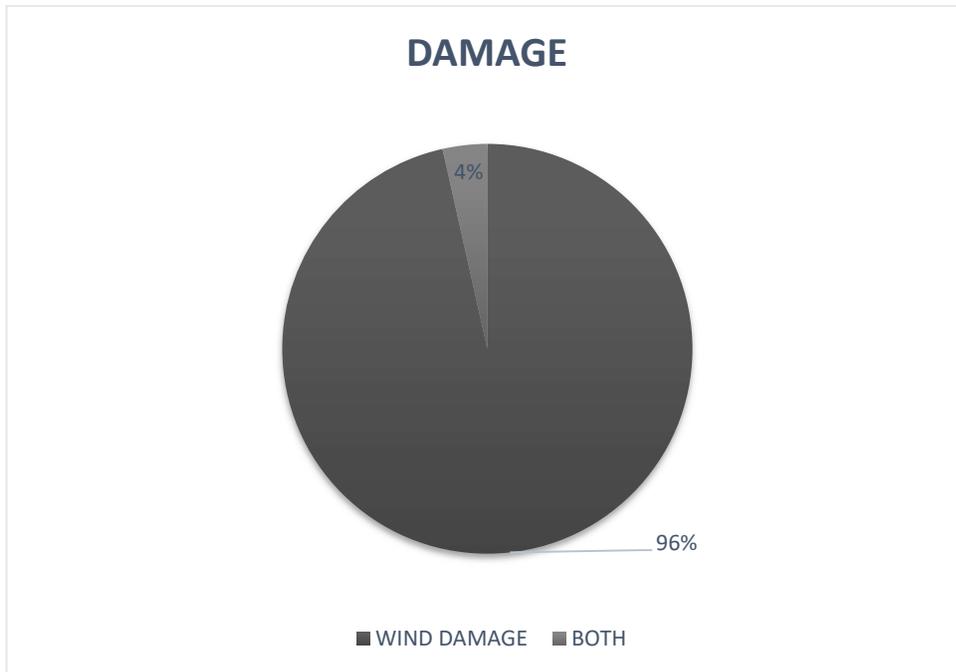
Figure 11: Damage Causes Differentiating Wind and Both Damages

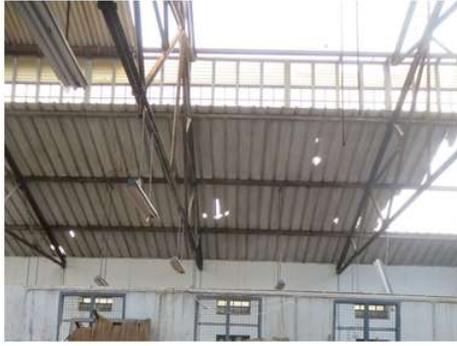
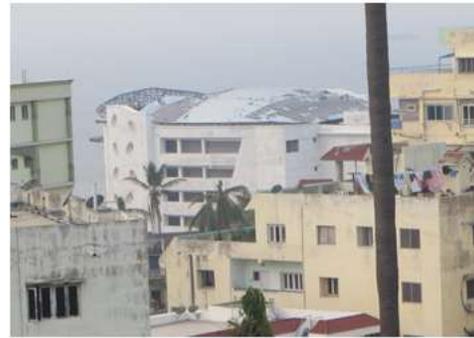
a) Tubular Truss Roofing System for Metal Sheet Roofing

c) Roofing Reconstruction

d) Distance View

Figure 13: Damaged Roof System of the AU New Auditorium – Structure Facing Directly the Ocean.

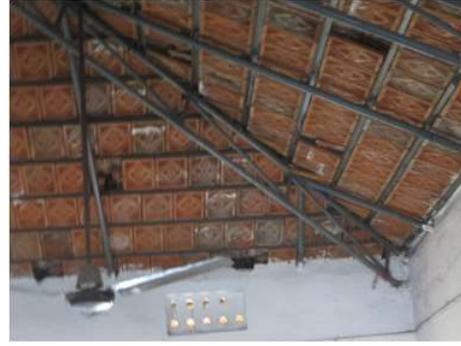
b) Truss and Frame Support for Tile and Shingle Roofing

Figure 12: Typical Roofing Designs for Single Story Structures in Vizag.

Because the investigation was conducted one month after the disaster, several sites have already been cleaned up and with ongoing repair works. This allows the exposure of actual damages to the structure due to wind loading, especially in the design of roof connections. Observations of the construction of several damaged single-story buildings indicate that the roof cover connection technique (for sheet metal roofing and shingle or tile roofing) can vary from nailing, strip connection to weld and bolt connections. If roof trusses were used, the roof truss connection to the support member can vary from bolted connection to simply bending the extended rebars around the truss connection as support. Figure 12 shows different roofing designs and connections. It is evident that most damage mechanisms from the hurricane started with the failure of roof covers in most cases; however, there are also cases where gusty winds may have brought down partially the roof trusses. Hence, there is a need for further investigation of roof cover to roof support connection designs for the wind force due to Hudhud. If the building frame remained intact, a strong roofing design may provide some safety to the occupants within the structure. Determining the wind effect becomes a very important aspect in improving design methods for roof connections against such hurricane.

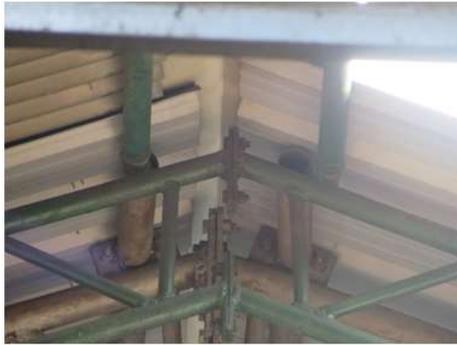
c) Bolt Connection for Roof Truss Support

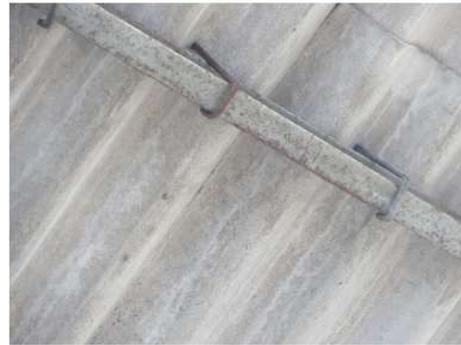
d) Hook Connection of Sheet Metal Roofing

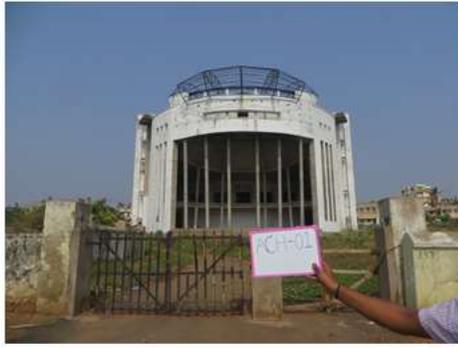
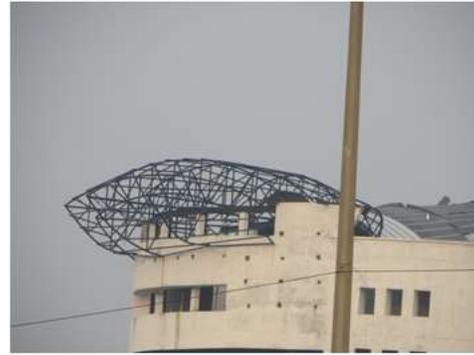
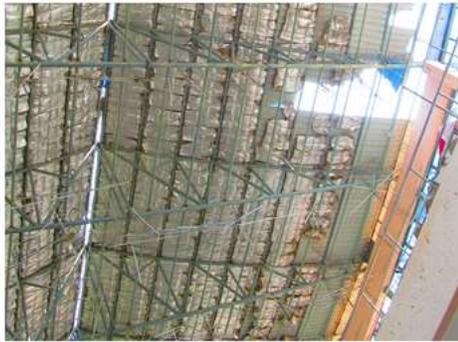
a) Front View

b) Side View

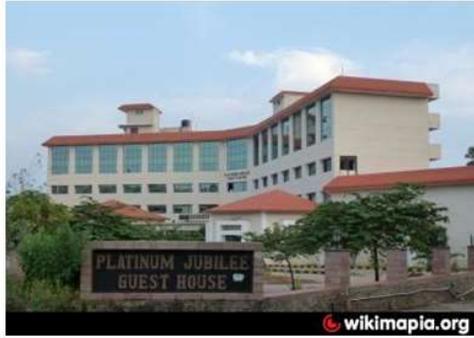
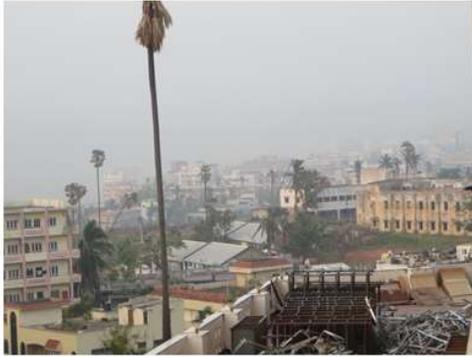
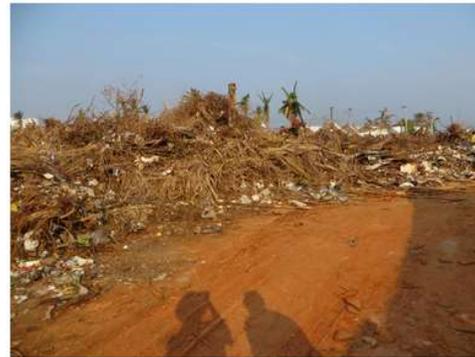
a) AU Guest House Prior to Hudhud

b) AU Guest House After Hudhud

c) Damages to Coconut Trees

d) Accumulation of Tree Debris

Figure 14: Very Severe Cyclone Hudhud Damages to Trees: a) Trees surrounding AU Guest House prior to Hudhud; b) Trees Damaged at AU Guest House after Hudhud; c) Damages to Coconut Trees in Vizag; and d) City Collection of Tree Debris.

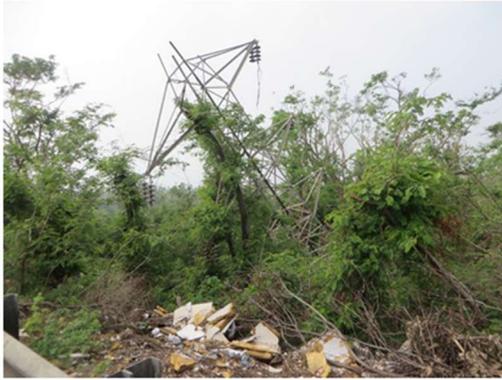
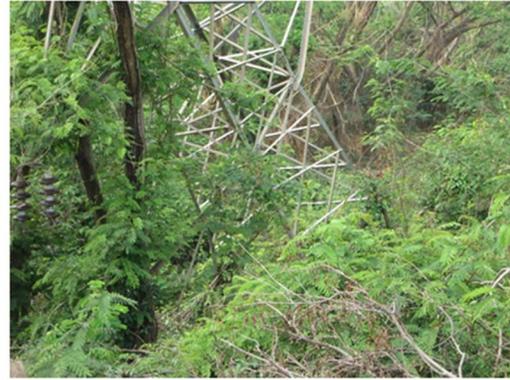
a) Downed Transmission Tower

b) Buckling of Members

Figure 15: VSC Hudhud Resulted in Massive Power Losses and Transmission Structure Failures: a) Downed Transmission Truss Tower; and b) Detail of Buckled Truss Members

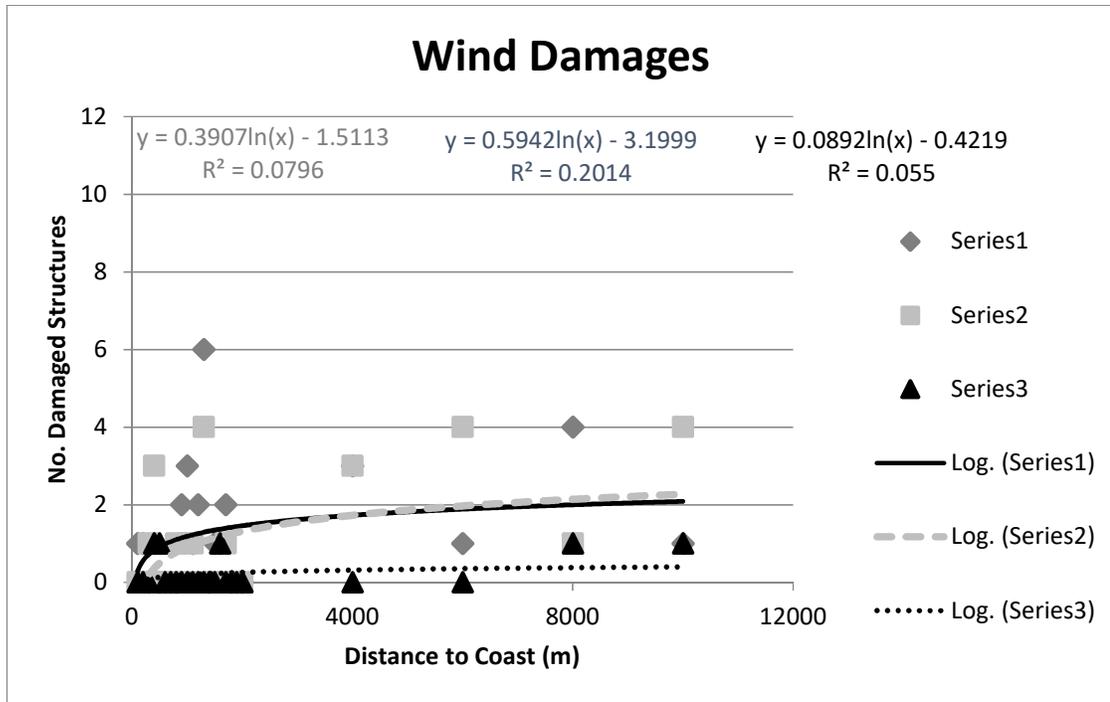
Figure 16: Damage Rating versus Distance to the Coast for Wind Damage Only with Trend Lines (Logarithmic Curves)

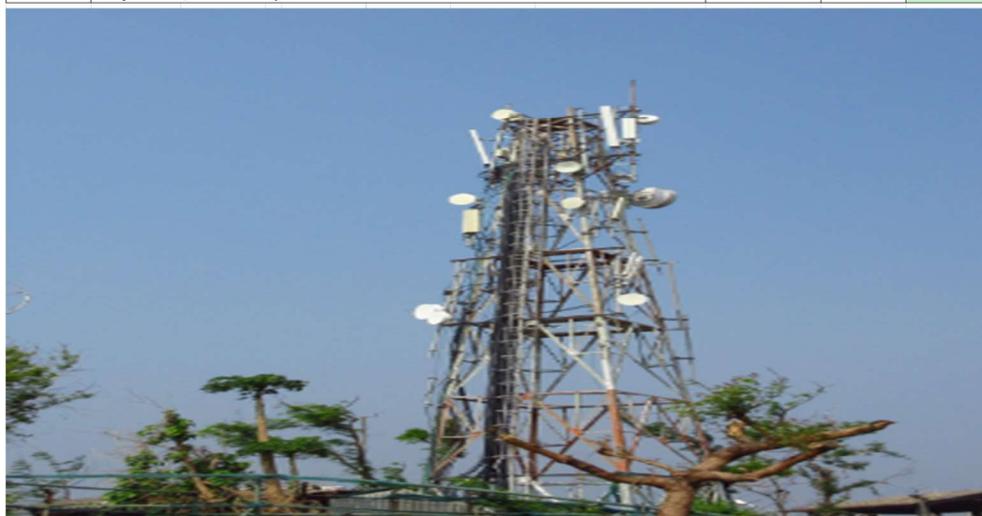
Table T4: T02-002 structural rating sheet

| 3a | Obvious Severe Damage To Primary Members | 2 | 1 | |
| 6b | Projectiles/Debris Impact On Structure | 1 | 1 | |
