EVALUATING CORROSIVE SITE PERFORMANCE AND POLICY WITH
CONCRETE ADMIXTURES

A thesis submitted to the faculty of
The University of North Carolina at Charlotte
in partial fulfillment of the requirements
for the degree of Master of Science in
Civil Engineering

2020

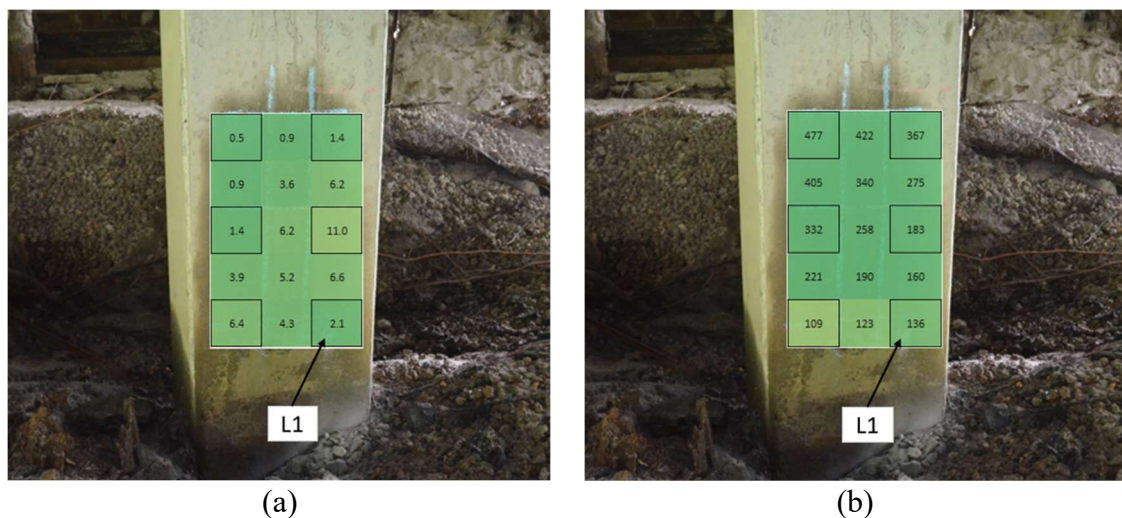
Figures 3.4 through 3.7 below show heat maps of a section of an interior bent and three separate piers at varying elevations. Figure 3.3 below shows the location of each pier shown in subsequent figures and how they are labeled. These piers appeared to only experience wetting during large storm events when the water level reaches higher elevations than typical tidal fluctuations.

(a) Pier #1: Corrosion Rate Heat Map
(b) Pier #1: Surface Resistivity Heat Map

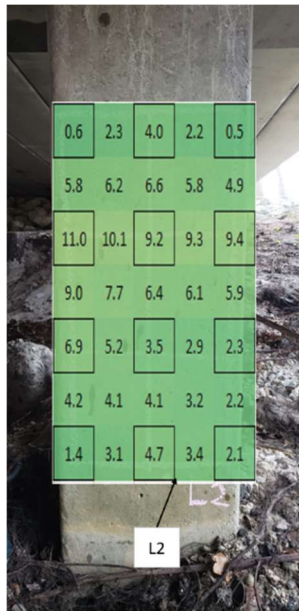
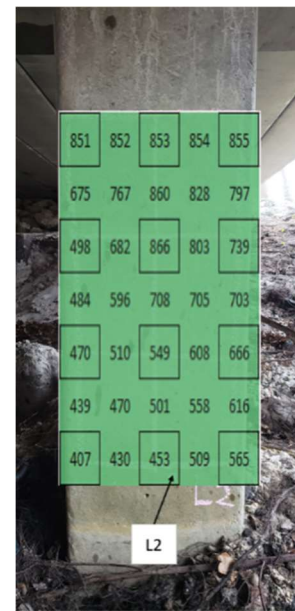
Figure 3.5. (a) Pier #2: Corrosion Rate Heat Map
(b) Pier #2: Surface Resistivity Heat Map

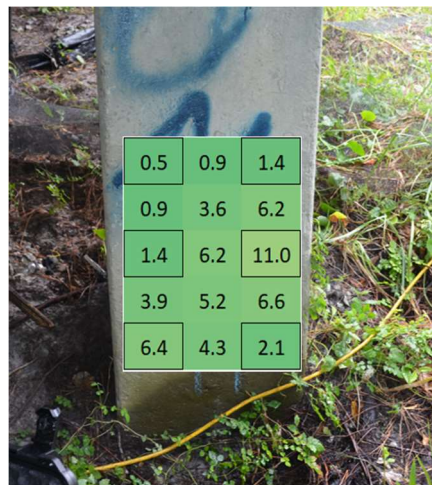
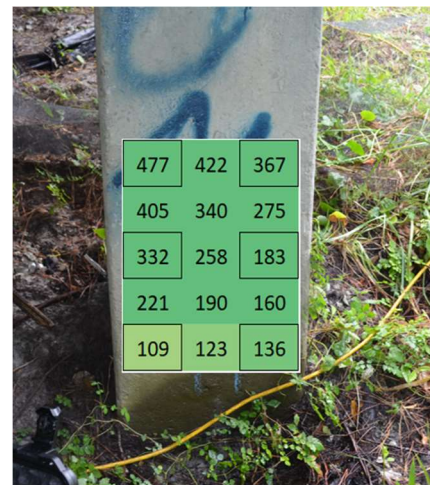
Figure 3.6. (a) Pier #3: Corrosion Rate Heat Map
(b) Pier #3: Surface Resistivity Heat Map

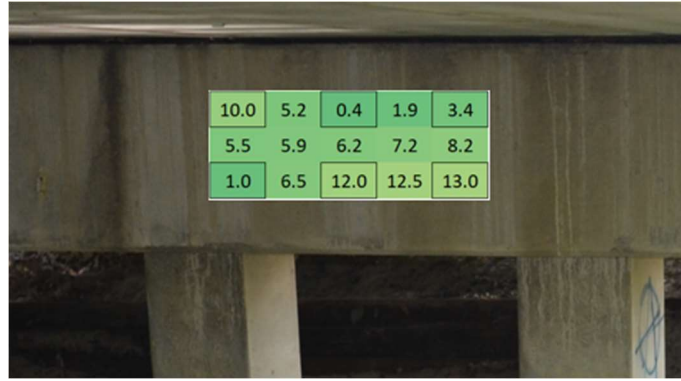
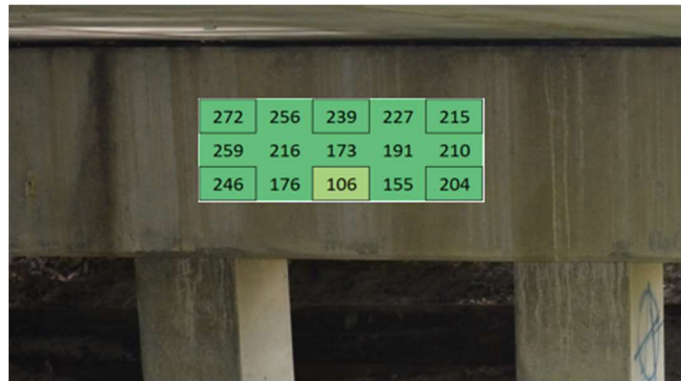
Figure 3.7. (a) Cap: Corrosion Rate Heat Map
(b) Cap: Surface Resistivity Heat Map

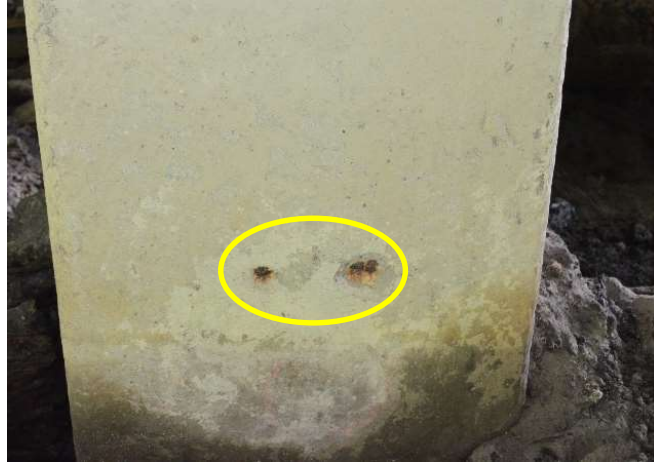
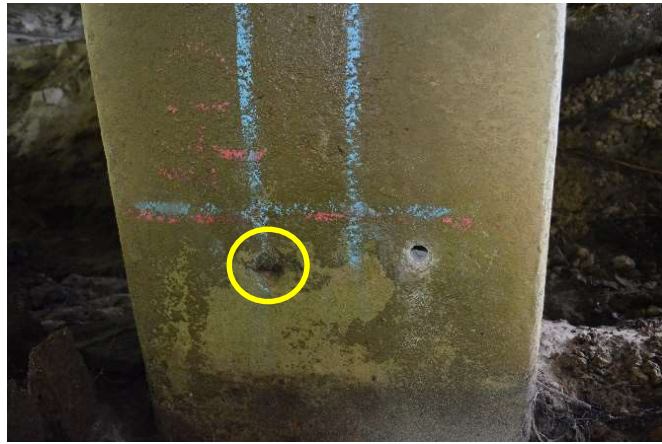
The visual inspection of structure number (SN) 150020 showed little to no sign of active corrosion. The only exception to this was on two side-by-side central piers at the same elevation that showed efflorescence. This can be seen in the following photographs (Figure 3.8 (a) and (b)). One location appeared to be a patched drill hole (Figure 3.8 (b)) where powder samples had previously been collected.

Figure 3.8. Signs of Efflorescence on Two Central Piers.

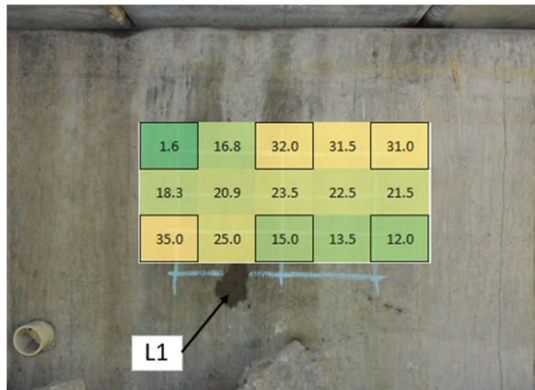
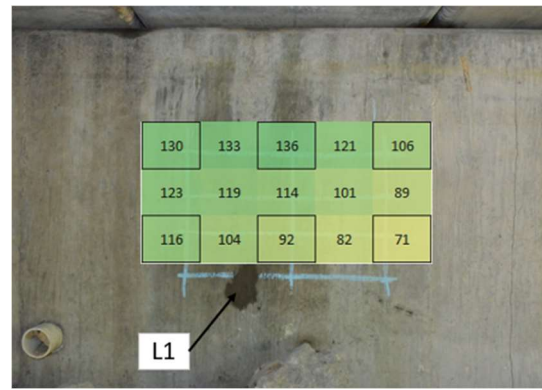
Figures 3.9 and 3.10 below show heat maps of two separate locations along an end bent well above the splash zone. There were no piers or interior bent caps analyzed on this structure due to it being a single span bridge.

Figure 3.9. (a) End Bent Location 1: Corrosion Rate Heat Map
(b) End Bent Location 2: Surface Resistivity Heat Map

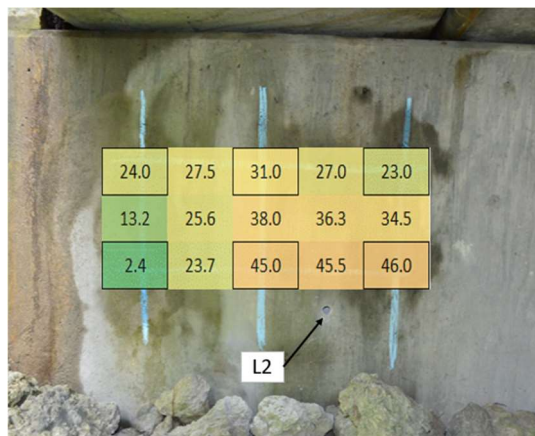
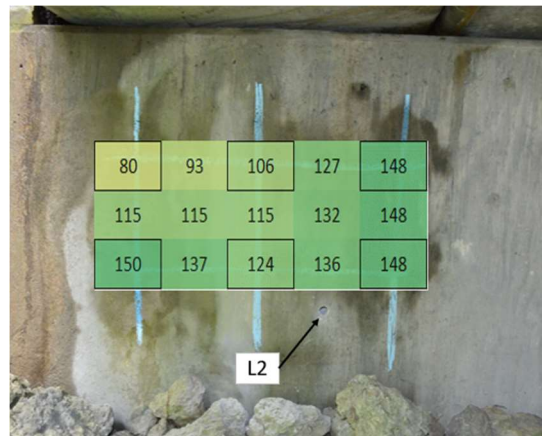
Figure 3.10. (a) End Bent Location 2: Corrosion Rate Heat Map
(b) End Bent Location 2: Surface Resistivity Heat Map

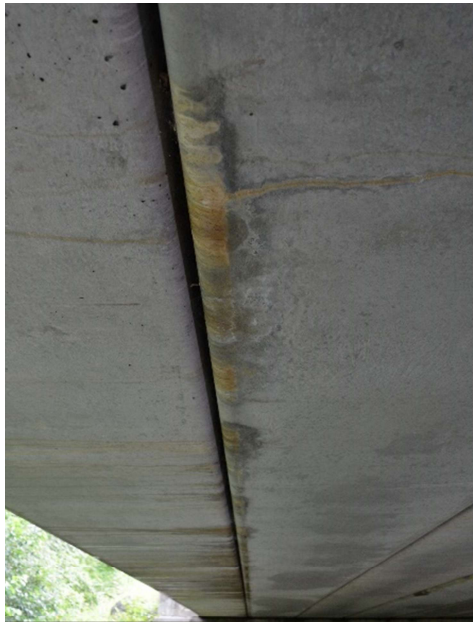
Figure 3.11. (a) Efflorescence on Side Face of Cored Slab.
(b) Efflorescence on Underside of Cored Slab.

SN 660091 had more widespread efflorescence than the other structures visited and was seen on the side and underside of the cored slabs, well above the splash zone (water level at time of inspection was approximately 10 feet below bottom of cored slabs). Based on signs of erosion on the sides of the river, the water level did not appear to ever raise high enough for the cored slabs to be within the splash zone. In addition to efflorescence, there was a large section of honeycombing on the underside of a cored slab. It was approximately 2 feet long by 2 inches wide and in the deepest section showed a prestressed strand that was corroded (see Figure 3.12 in previous section). This was the only structure visited in either corrosive zone that showed multiple visual signs of active corrosion indicating that it could be an outlier, though the number of structures visited is too small to state that definitively.

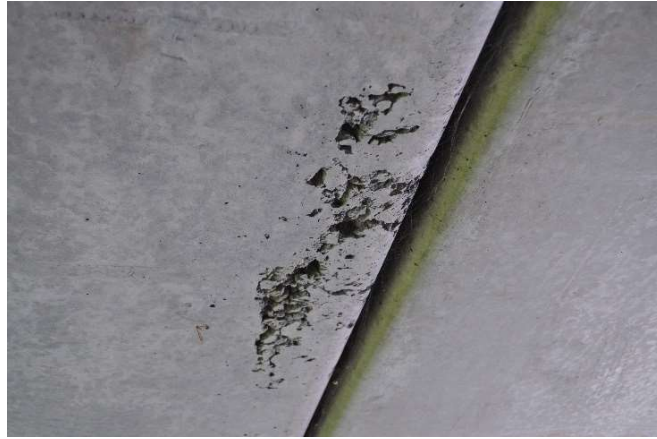
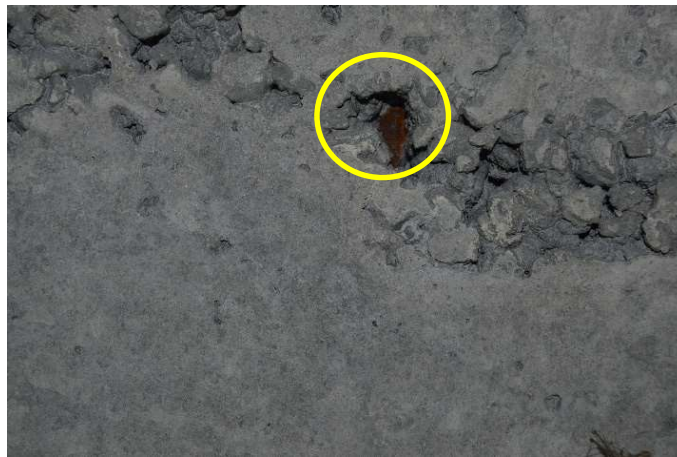
Figure 3.12. (a) Zoomed Out View of Honeycomb.
(b) Close Up Showing Exposed Prestressed Strand.

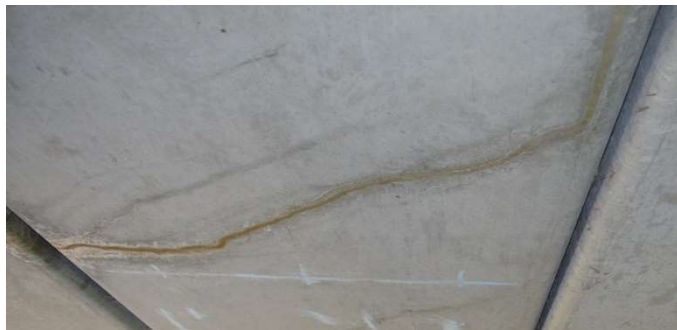
Figure 3.13. Example of Large Cracked and Repaired Section on Underside of Cored Slab.

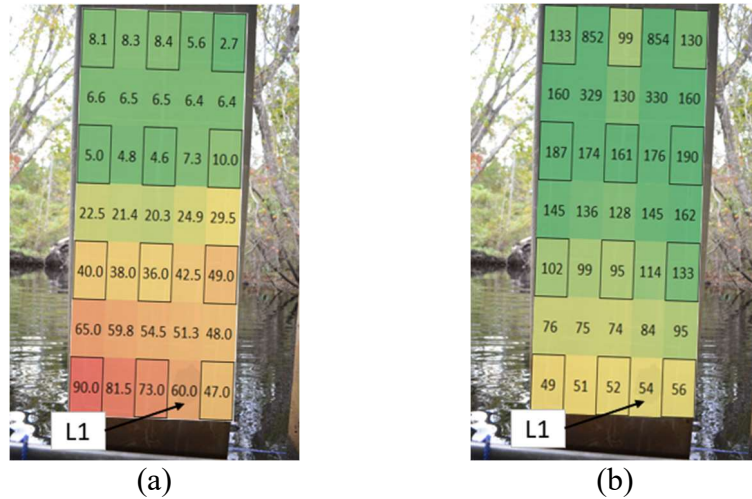
Figures 3.14 and 3.15 below show heat maps of side-by-side piers with readings at the bottom beginning in the splash zone. No readings were collected from the interior bent cap due to the lack of accessibility.

(a) (b)
Figure 3.14. (a) Pier 1: Corrosion Rate Heat Map
(b) Pier 1: Surface Resistivity Heat Map

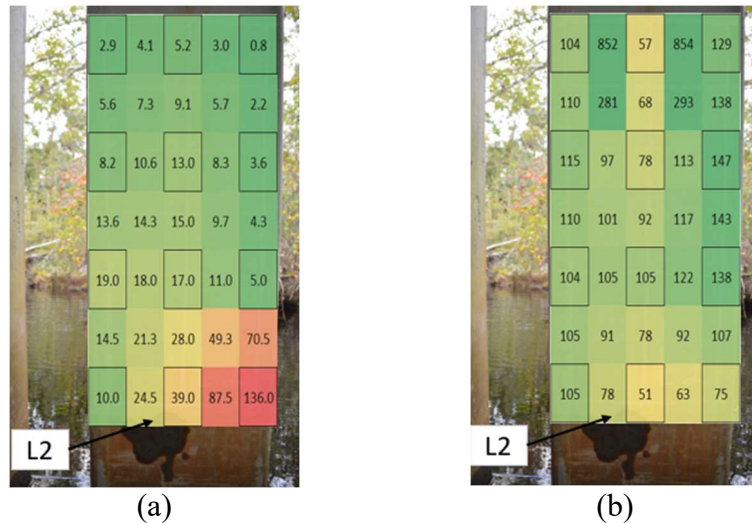
(a) (b)
Figure 3.15. (a) Pier 2: Corrosion Rate Heat Map
(b) Pier 2: Surface Resistivity Heat Map

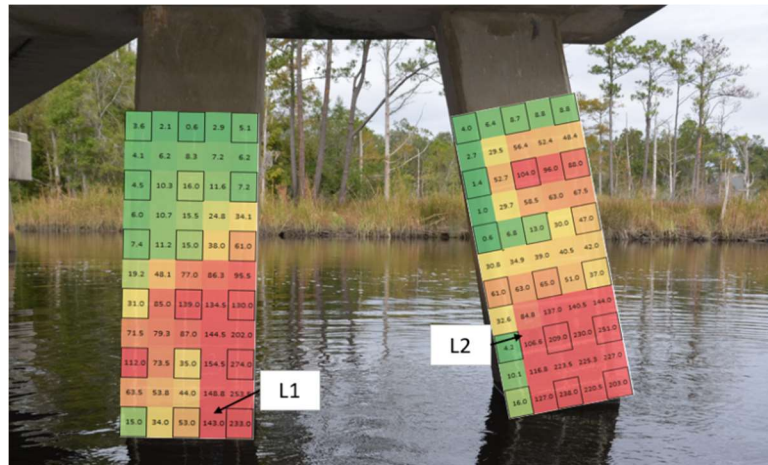
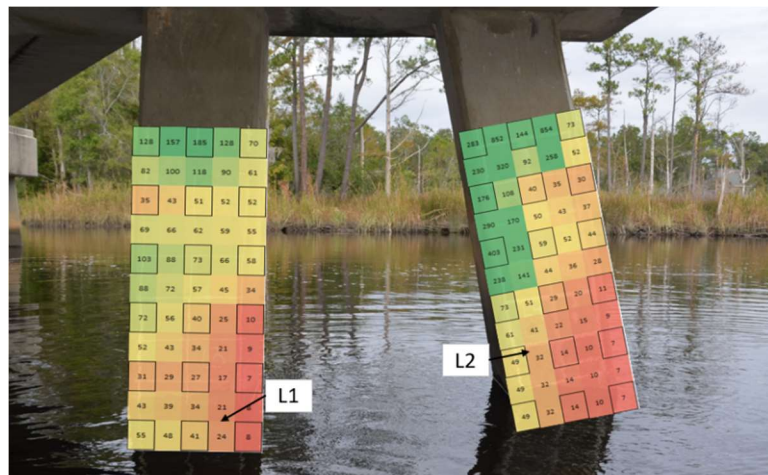
Figure 3.17 below shows heat maps on two side-by-side piers with readings at the bottom beginning in the splash zone. No readings were collected from the interior bent caps due to the lack of accessibility.

Figure 3.17. (a) Piers: Corrosion Rate Heat Map
(b) Piers: Surface Resistivity Heat Map

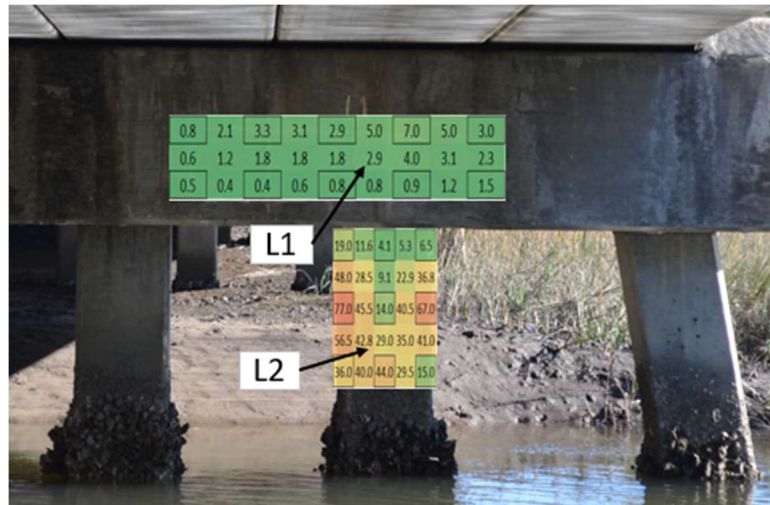
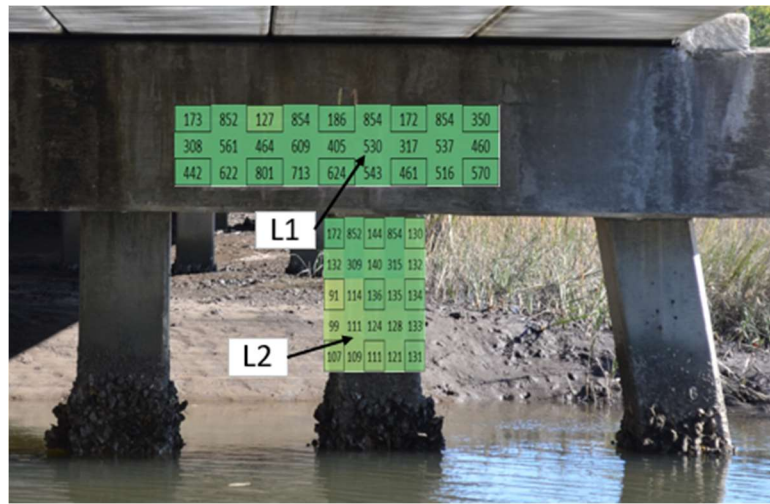
Figure 3.19. (a) Interior Bent Cap and Pier: Corrosion Rate Heat Map
(b) Interior Bent Cap and Pier: Surface Resistivity Heat Map

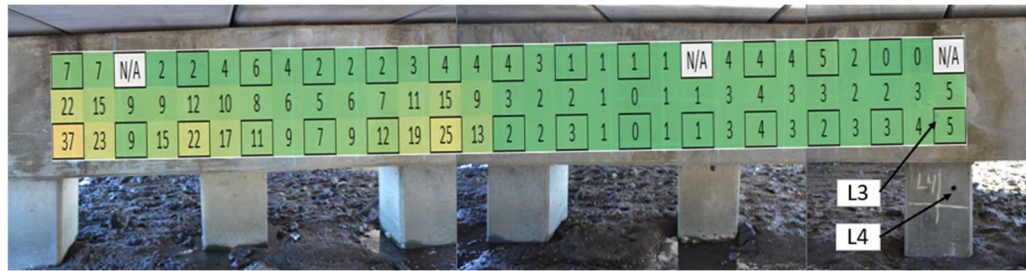
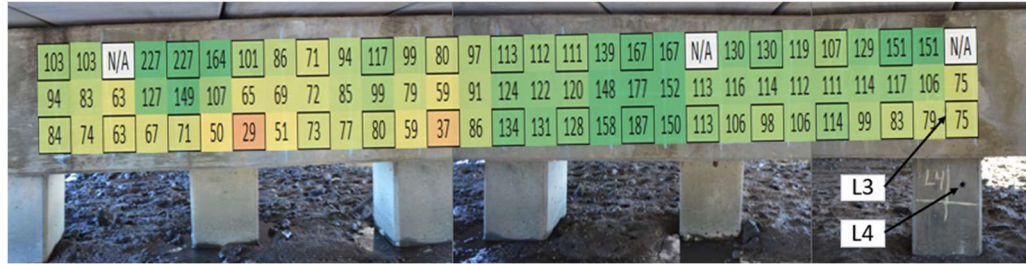
Figure 3.20. (a) Interior Bent Cap: Corrosion Rate Heat Map
(b) Interior Bent Cap: Surface Resistivity Heat Map

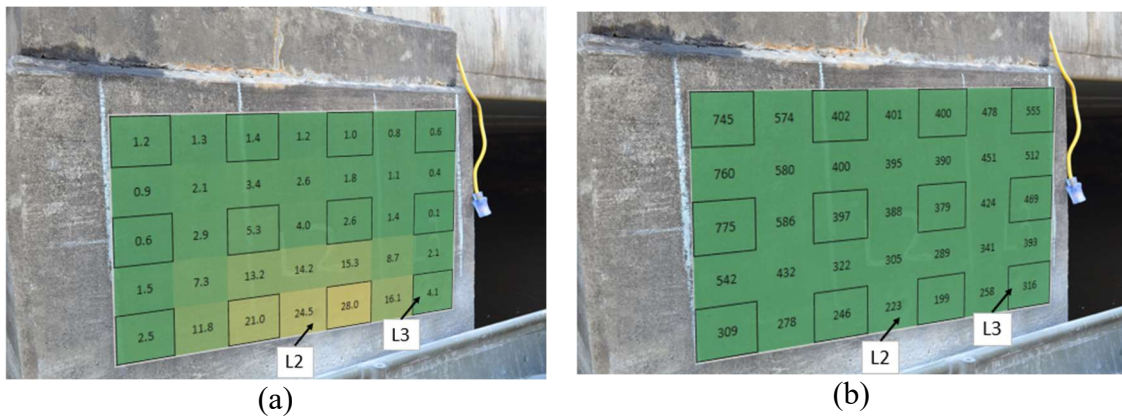
Figures 3.22 and 3.23 below show heat maps of the face of an interior bent cap and the face of a wing wall. The interior piers were not tested because the water level was even with the bottom of the interior bent cap.

Figure 3.22. (a) Cap Face: Corrosion Rate Heat Map
(b) Cap Face: Surface Resistivity Heat Map

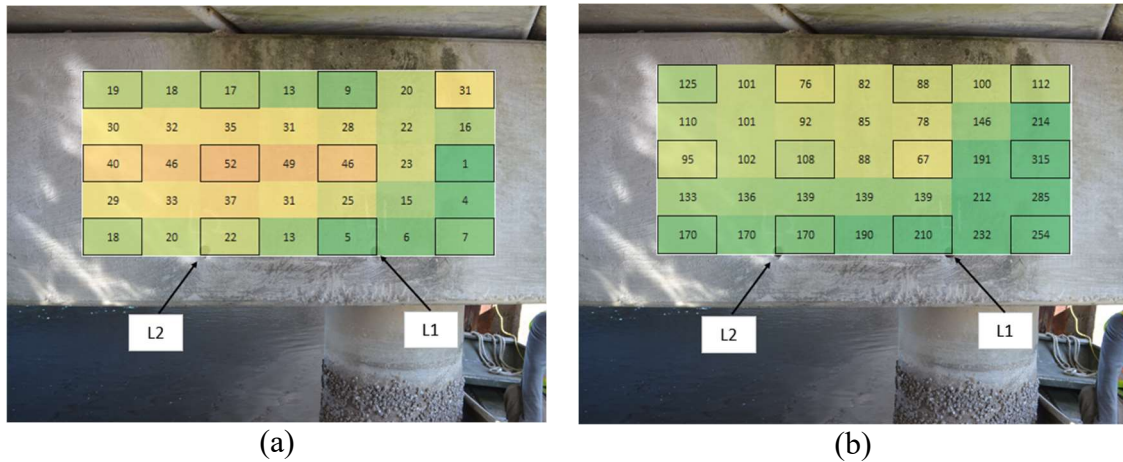
Figures 3.25 and 3.26 below show heat maps of a section on both an interior face and an end face of an interior bent cap. No piers were tested on this structure due to them all being either steel piles or steel encased concrete.

Figure 3.25. (a) Face of Interior Bent Cap: Corrosion Rate Heat Map
(b) Face of Interior Bent Cap: Surface Resistivity Heat Map

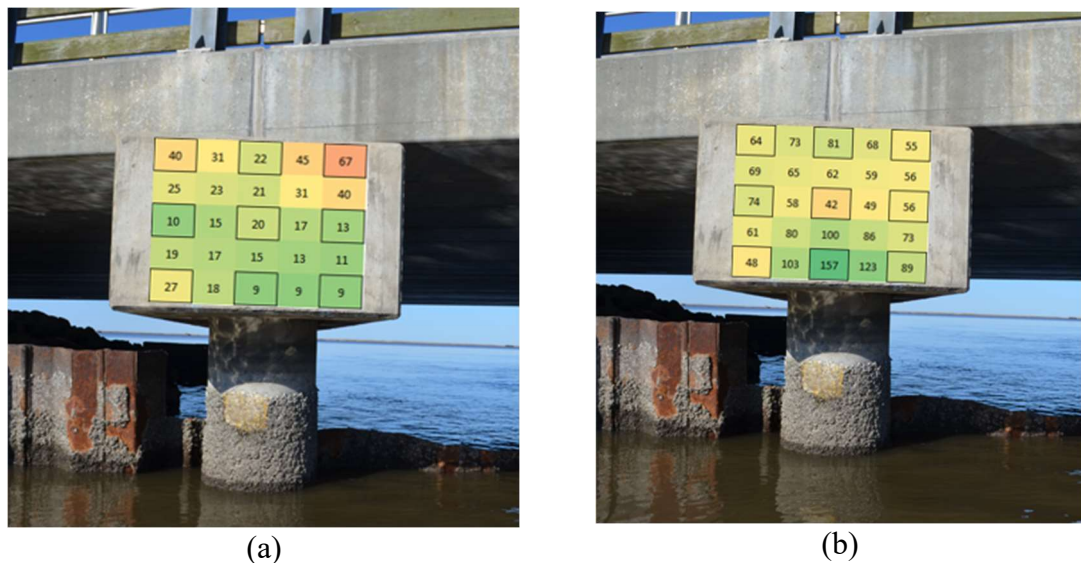
Figure 3.26. (a) End Face of Interior Bent Cap: Corrosion Rate Heat Map
(b) End Face of Interior Bent Cap: Surface Resistivity Heat Map

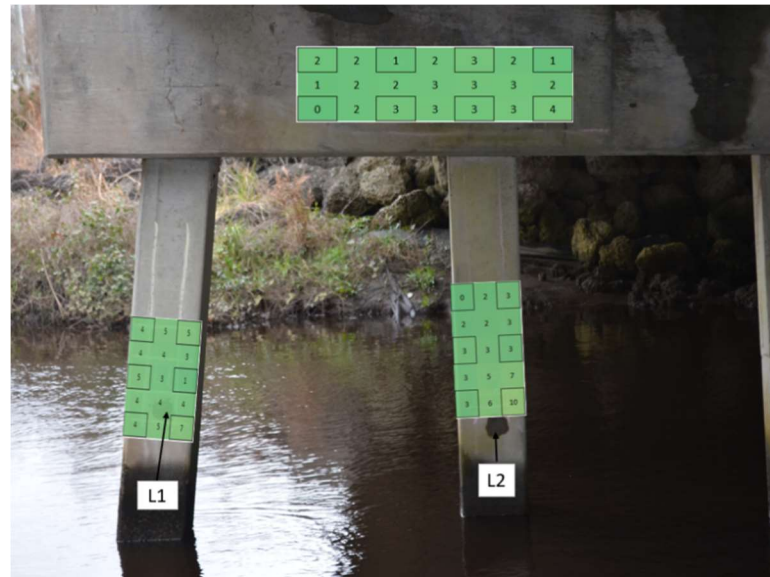
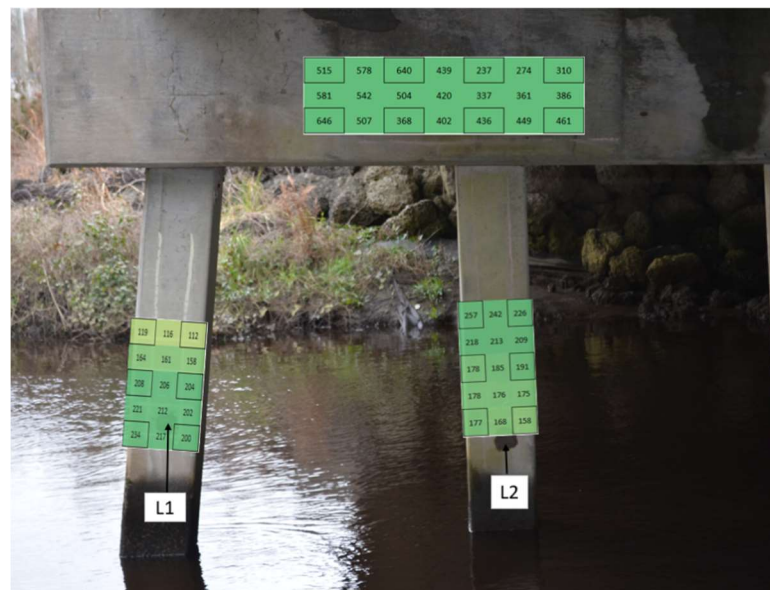
Figure 3.29 below shows heat maps of two interior bent piles near the splash zone and on the face of the interior bent cap.

Figure 3.29. (a) Interior Bent Cap and Piles: Corrosion Rate Heat Map
(b) Interior Bent Cap and Piles: Surface Resistivity Heat Map

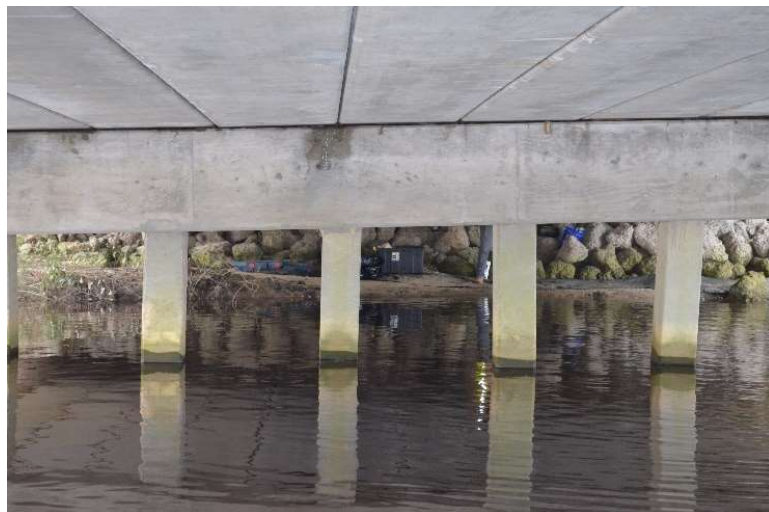
The visual investigation of SN 660021 revealed little to no sign of active corrosion. The only signs were efflorescence on the underside of the cored slabs and within the splash zone on the interior bent piles. Photographs of these potential signs of corrosion can be seen below.

Figure 3.31. Efflorescence within splash zone on interior bent piles.

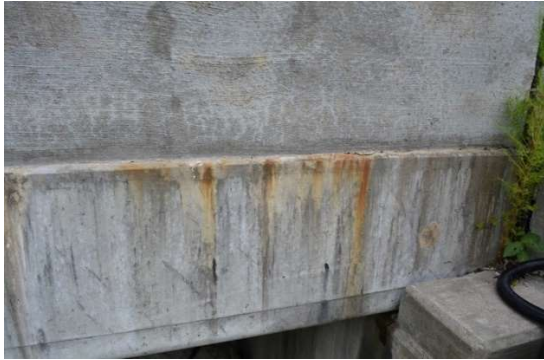
Figure A1.8. Efflorescence on Side Face of Cored Slab at Southwestern Side of End Bent 1.

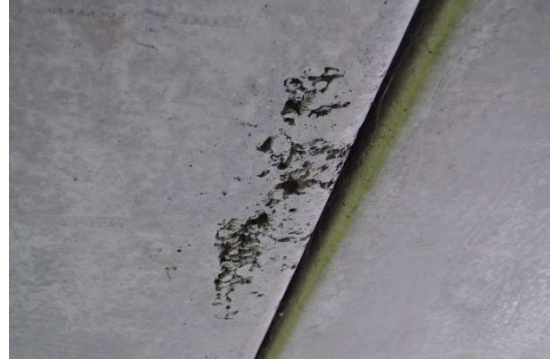
Figure A1.9. Deep Section of Honeycombing on Underside of Cored Slab.

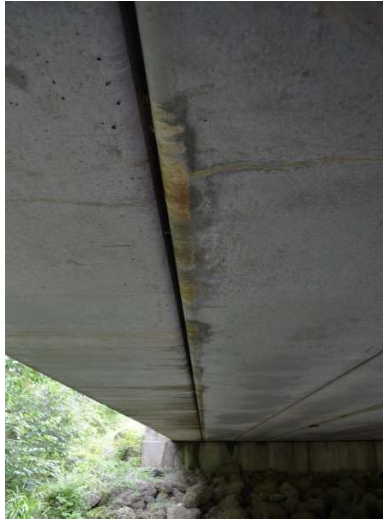
Figure A1.10. Efflorescence on Underside of Cored Slab.

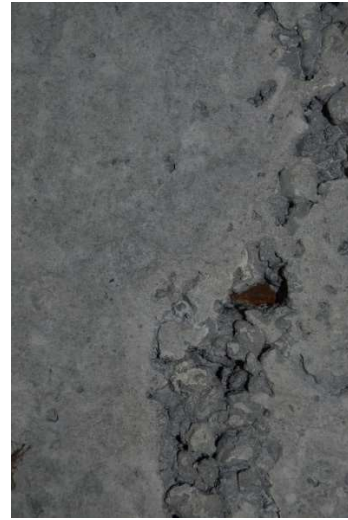
Figure A1.11. Close-Up of Honeycombing (Shown in Figure A1.9); Note Exposed Rebar.

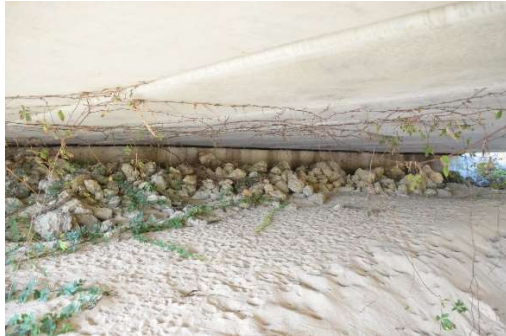
Figure A1.21. Growth Along Underside of Cored Slabs.

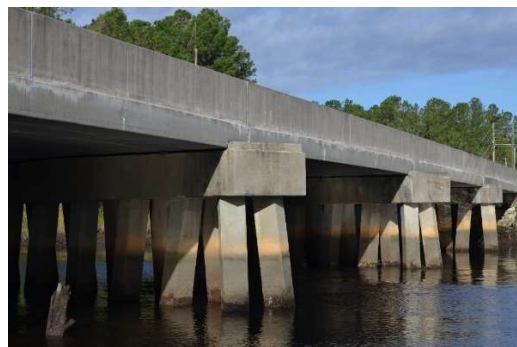
Figure A1.25. Interior Bent Caps and Piers; Notice The Identical Staining on All Piers Showing High Tide Location.

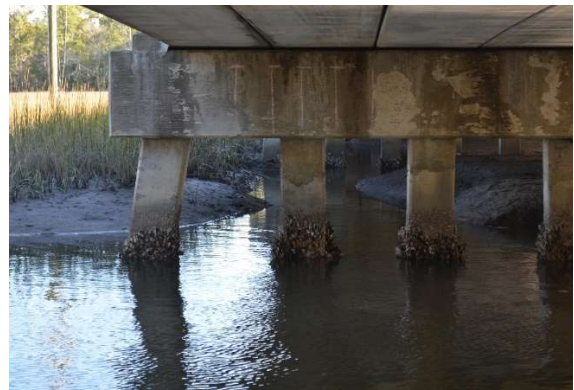
Figure A1.29. Testing Grid For iCOR; Notice the Significant Shell Buildup on The Piers.

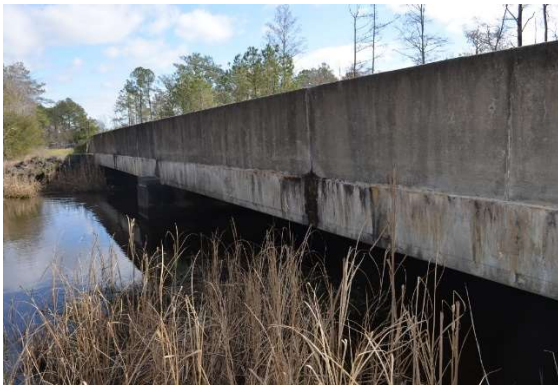
Figure A1.33. Side Face of Cored Slabs. Note the Staining on Right Side of Image.

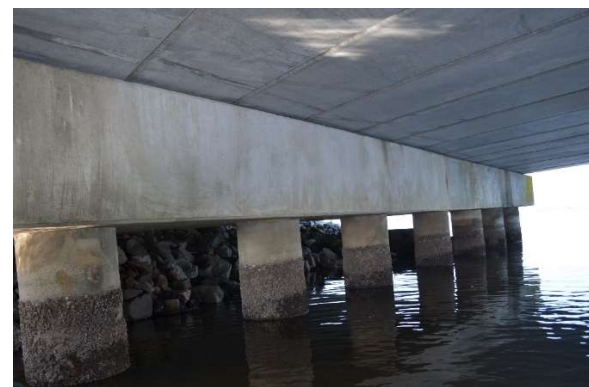
Figure A1.38. Interior Cap with Piers. Note the Significant Barnacle Buildup at The High Tide Line.

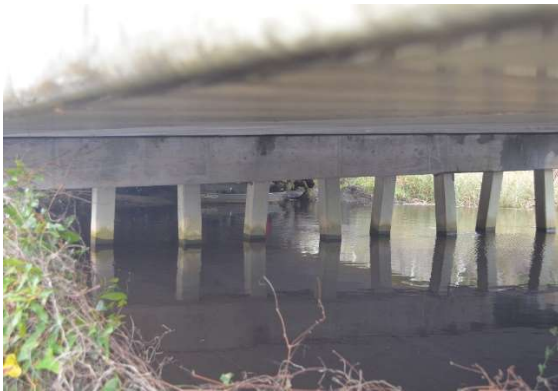
Figure A1.39. Interior Cap with Piers;
Note the Drainage Patterns on Right Side
of Cap.

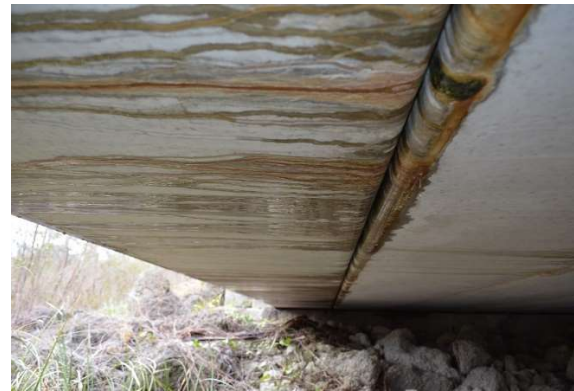
Figure A1.40. Underside of Exterior
Cored Slab; Note the Significant
Efflorescence.

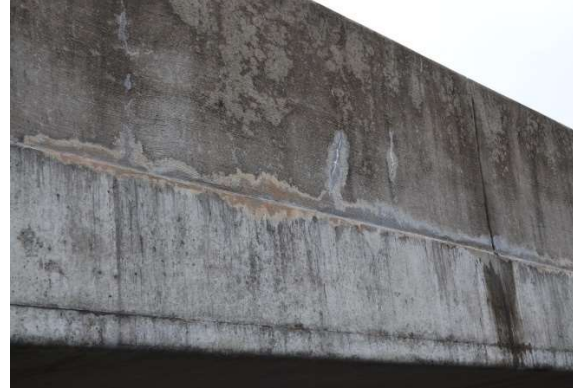
Figure A1.42. Exterior Face of Concrete Barrier Wall; Note the Cracking and Staining.

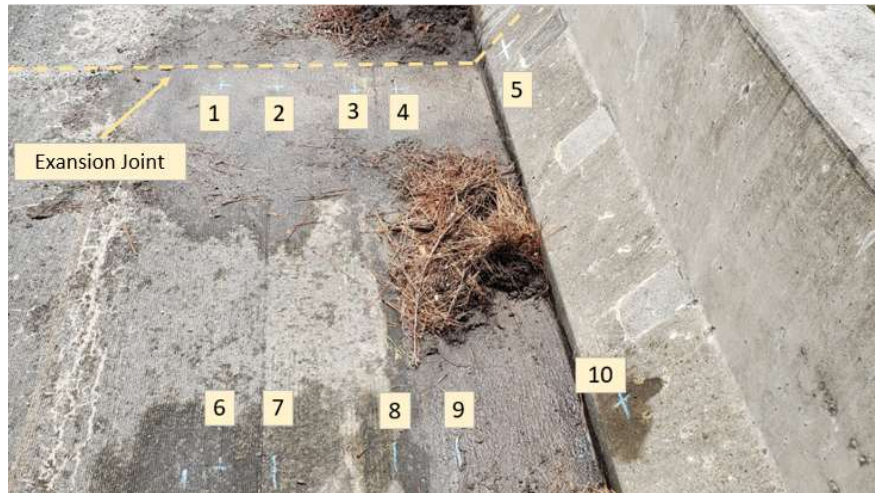
Figure B1.5. Reference locations for Table B1.5.

Table B1.5. Readings from top shoulder of deck near expansion joint
(see Figure B1.5).

Reference Location	Corrosion Rate (µm/year)	Concrete Resistivity (kohm.cm)	Temperature (°F)	Humidity	R ²
1	36	49	31	56%	0.84
2	51	25.1	31	63%	0.98
3	153	23.9	31	59%	0.88
4	110	10.5	31	60%	0.96
5	1.7	292.4	31	61%	0.99
6	109	37.8	31	62%	0.33
7	33	25.3	31	59%	0.99
8	1	284	31	63%	0.99
9	28	34.3	31	64%	0.99
10	6.7	193.6	31	60%	0.92

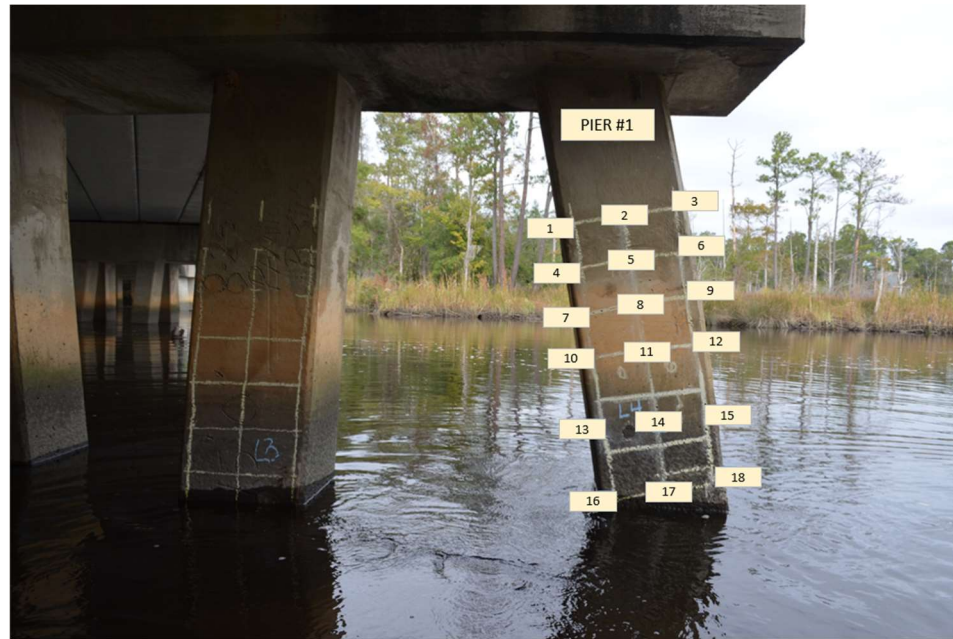
Figure B1.12. Reference locations for Table B1.12.

Table B1.12. Results from face of pier #1 (see Figure B1.12).

Reference Location	Corrosion Rate ($\mu\text{m}/\text{year}$)	Concrete Resistivity (kohm.cm)	Temperature ($^{\circ}\text{F}$)	Humidity	R ²
1	8.8	73	59	69%	0.93
2	8.7	144	59	66%	0.98
3	4	283	57	68%	1
4	88	30	59	68%	0.97
5	104	40	59	69%	0.96
6	1.4	176	59	69%	1
7	47	44	59	68%	0.99
8	13	59	59	67%	0.99
9	0.59	403	59	69%	0.98
10	37	11	57	71%	0.99
11	65	29	57	70%	0.99
12	61	73	57	70%	0.99
13	251	6.7	57	73%	0.98
14	209	14	57	72%	0.98
15	4.2	49	57	72%	0.99
16	203	6.8	57	73%	0.99
17	238	14	57	70%	0.99
18	16	49	57	70%	1

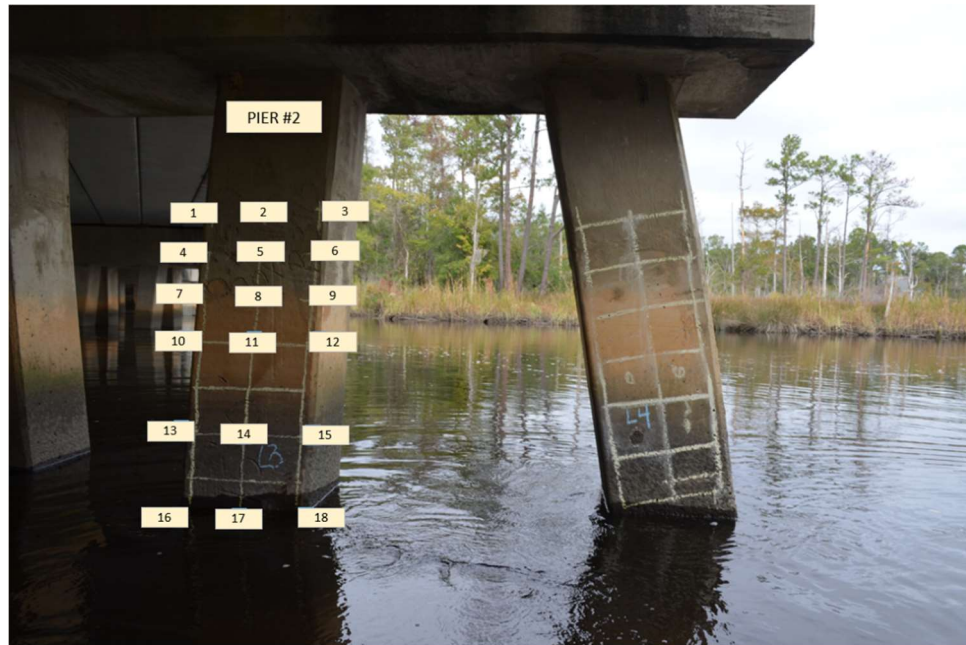
Figure B1.13. Reference locations for Table B1.13.

Table B1.13. Results from face of pier #2 (see Figure B1.13).

Reference Location	Corrosion Rate ($\mu\text{m}/\text{year}$)	Concrete Resistivity (kohm.cm)	Temperature ($^{\circ}\text{F}$)	Humidity	R ²
1	5.1	70	59	69%	0.96
2	0.6	185	59	69%	0.92
3	3.6	128	59	68%	1
4	7.2	52	59	68%	0.98
5	16	51	59	69%	1
6	4.5	35	59	67%	1
7	61	58	59	68%	0.93
8	15	73	59	67%	0.99
9	7.4	103	59	71%	1
10	130	9.9	57	70%	1
11	139	40	57	69%	1
12	31	72	57	70%	0.99
13	274	7.2	57	71%	0.99
14	35	27	57	71%	1
15	112	31	57	72%	1
16	233	7.8	57	72%	1
17	53	41	57	69%	0.99
18	15	55	57	70%	0.99

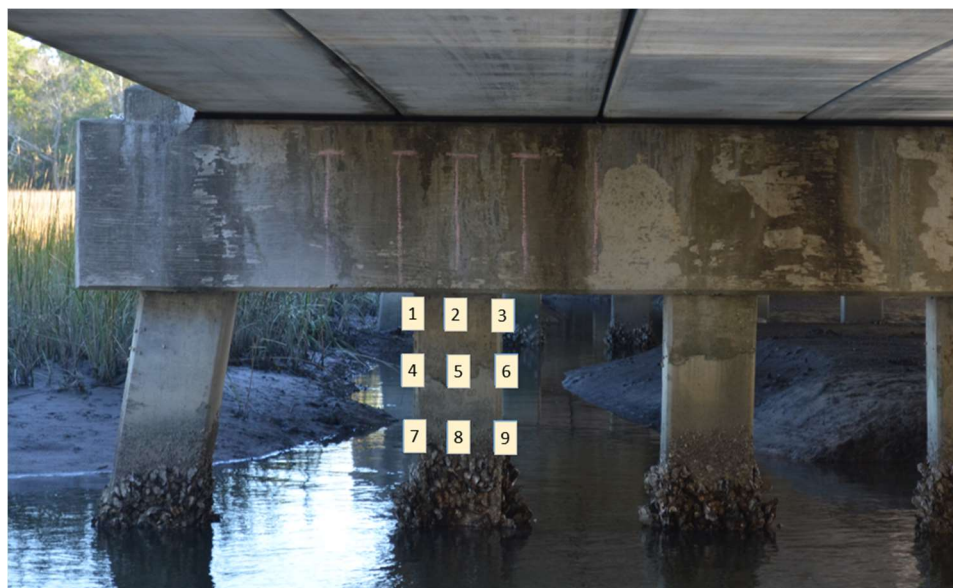
Figure B1.15. Reference locations for Table B1.15.

Table B1.15. Results from face of pier on interior bent (see Figure B1.15).

Reference Location	Corrosion Rate ($\mu\text{m}/\text{year}$)	Concrete Resistivity (kohm.cm)	Temperature ($^{\circ}\text{F}$)	Humidity	R^2
1	8.7	72	57	48%	1
2	6	65	57	51%	1
3	4.3	13	57	53%	1
4	9.2	189	55	49%	1
5	7	50	55	47%	1
6	5.4	57	55	51%	1
7	1.7	160	55	49%	0.99
8	17	88	55	50%	1
9	7.6	124	55	49%	1

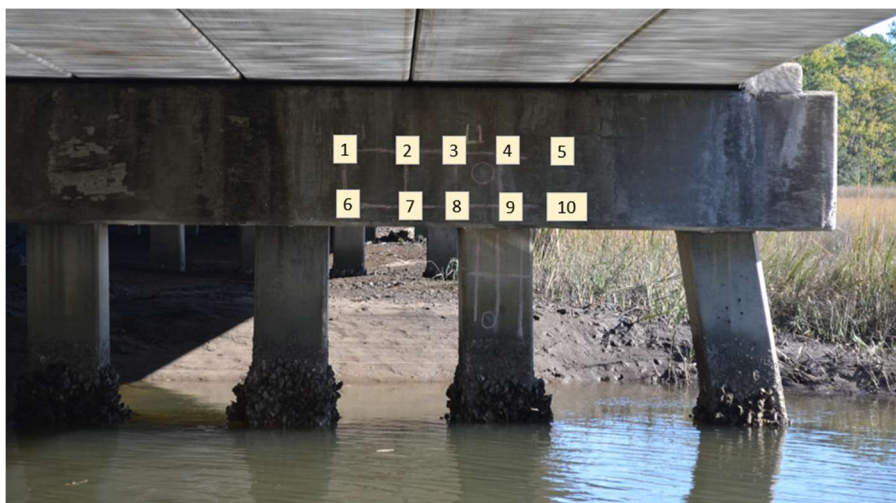
Figure B1.16. Reference locations for Table B1.16.

Table B1.16. Results from face of interior bent (see Figure B1.16).

Reference Location	Corrosion Rate ($\mu\text{m}/\text{year}$)	Concrete Resistivity (kohm.cm)	Temperature ($^{\circ}\text{F}$)	Humidity	R ²
1	0.83	173	57	53%	1
2	3.3	127	57	50%	1
3	2.9	186	57	50%	1
4	7	172	55	50%	1
5	3	350	55	56%	0.99
6	0.46	442	55	52%	1
7	0.37	801	55	53%	1
8	0.76	624	55	54%	1
9	0.92	461	55	54%	1
10	1.5	570	55	55%	0.99

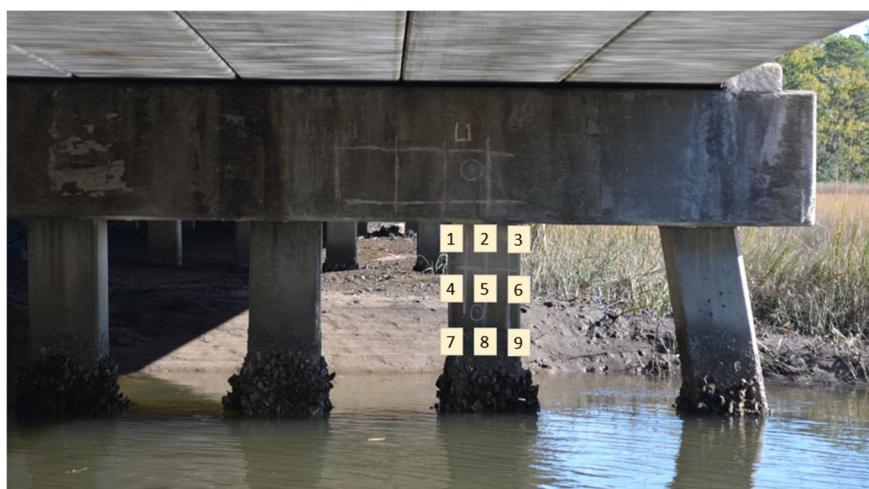
Figure B1.17. Reference locations for Table B1.17.

Table B1.17. Results from face of pier on interior bent (see Figure B1.17).

Reference Location	Corrosion Rate ($\mu\text{m}/\text{year}$)	Concrete Resistivity (kohm.cm)	Temperature ($^{\circ}\text{F}$)	Humidity	R ²
1	19	172	55	52%	1
2	4.1	144	59	49%	0.98
3	6.5	130	55	53%	1
4	77	91	59	50%	0.97
5	14	136	55	55%	1
6	67	134	57	50%	0.96
7	36	107	55	54%	0.99
8	44	111	55	57%	0.96
9	15	131	55	53%	0.97

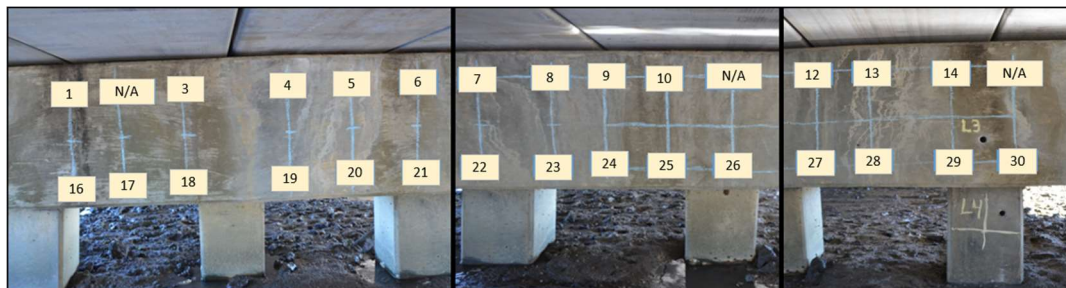
Figure B1.18. Reference locations for Table B1.18.

Table B1.18. Results from face of interior bent (see Figure B1.18).

Reference Location	Corrosion Rate ($\mu\text{m}/\text{year}$)	Concrete Resistivity (kohm.cm)	Temperature ($^{\circ}\text{F}$)	Humidity	R ²
1	7.4	103	73	39%	0.99
3	1.7	227	66	42%	0.99
4	5.5	101	72	38%	0.99
5	2.3	71	68	41%	0.88
6	2.3	117	70	41%	0.99
7	4.3	80	70	38%	1
8	4.4	113	68	46%	0.96
9	0.91	111	70	39%	1
10	0.82	167	68	42%	1
12	3.5	130	66	41%	1
13	4.5	107	66	43%	1
14	0.03	151	68	43%	0.99
16	37	84	68	45%	0.99
17	8.7	63	66	40%	1
18	22	71	66	45%	1
19	11	29	66	41%	0.99
20	6.7	73	68	43%	1
21	12	80	66	44%	1
22	25	37	68	42%	1
23	1.8	134	66	41%	0.99
24	2.8	128	68	39%	0.99
25	0.11	187	66	43%	1
26	1.4	113	68	42%	0.99
27	3.8	98	66	43%	1
28	2.1	114	68	41%	0.97
29	3.2	83	66	42%	1
30	5.3	75	68	42%	1

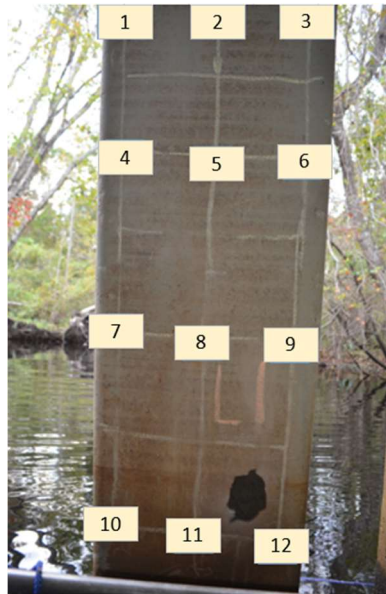
Figure B1.19. Reference locations for Table B1.19.

Table B1.19. Results from face of pier #1 (see Figure B1.19).

Reference Location	Corrosion Rate ($\mu\text{m}/\text{year}$)	Concrete Resistivity (kohm.cm)	Temperature ($^{\circ}\text{F}$)	Humidity	R ²
1	8.1	133	66	63%	1
2	8.4	99	66	63%	1
3	2.7	130	66	62%	1
4	5	187	66	63%	1
5	4.6	161	66	63%	1
6	10	190	66	63%	0.95
7	40	102	66	65%	0.99
8	36	95	66	64%	0.99
9	49	133	66	63%	0.98
10	90	49	66	65%	0.99
11	73	52	66	63%	0.94
12	47	56	66	61%	0.99

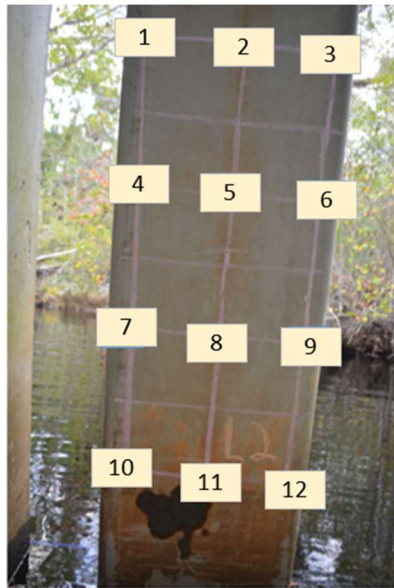
Figure B1.20. Reference locations for Table B1.20.

Table B1.20. Results from face of pier #2 (see Figure B1.20).

Reference Location	Corrosion Rate ($\mu\text{m}/\text{year}$)	Concrete Resistivity (kohm.cm)	Temperature ($^{\circ}\text{F}$)	Humidity	R ²
1	2.9	104	66	62%	1
2	5.2	57	66	60%	1
3	0.82	129	66	64%	1
4	8.2	115	68	59%	1
5	13	78	68	60%	0.99
6	3.6	147	68	60%	1
7	19	104	68	60%	1
8	17	105	68	60%	0.99
9	5	138	68	61%	1
10	10	105	68	62%	1
11	39	51	68	62%	1
12	136	75	66	64%	0.95

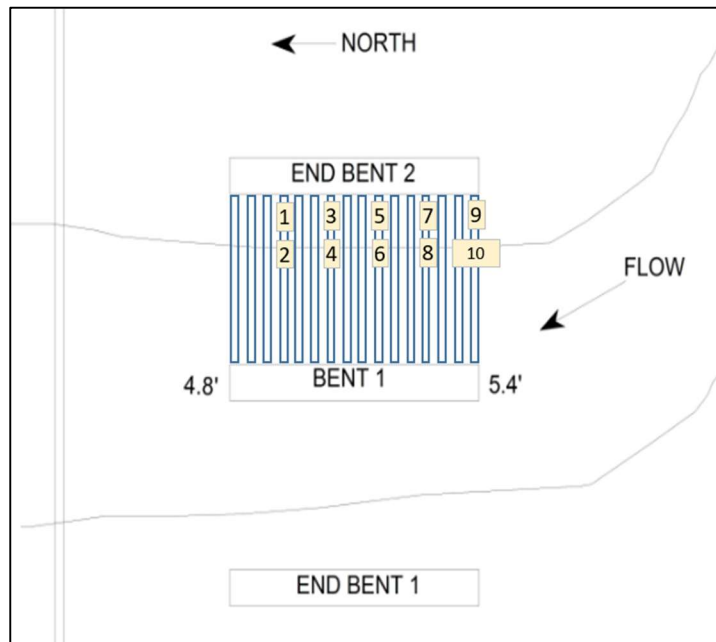
Figure B1.21. Reference locations for Table B1.21 (sketch from 2018 NCDOT inspection report of SN 660019 (NCDOT 2018)).

Table B1.21. Results from underside of cored slabs (see Figure B1.21).

Reference Location	Corrosion Rate ($\mu\text{m}/\text{year}$)	Concrete Resistivity (kohm.cm)	Temperature ($^{\circ}\text{F}$)	Humidity	R ²
1	15	42	66	61%	1
	11	32	66	60%	1
2	21	51	66	61%	1
	11	52	66	61%	1
3	6.3	37	66	62%	1
	4	46	66	62%	1
4	6.6	27	66	61%	1
	10	38	66	61%	1
5	6.6	32	66	63%	1
	7.2	37	66	63%	1
6	6.6	42	66	63%	1
	8	38	66	63%	0.99
7	5.9	31	66	66%	1
	5.8	41	66	63%	1
8	7.5	46	64	63%	1
	12	43	64	63%	0.99
9	11	38	64	62%	0.99
	9.6	29	64	62%	1
10	14	31	64	62%	1
	15	26	64	63%	1

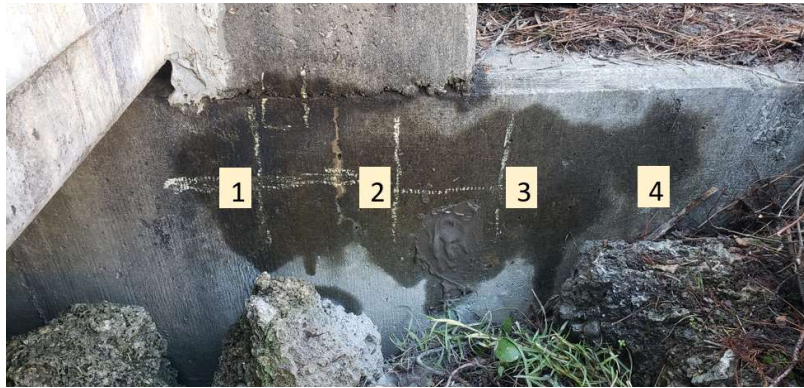
Figure B1.22. Reference locations for Table B1.22.

Table B1.22. Readings from face of wing wall (see Figure B1.22).

Reference Location	Corrosion Rate ($\mu\text{m}/\text{year}$)	Concrete Resistivity (kohm.cm)	Temperature ($^{\circ}\text{F}$)	Humidity	R ²
1	52	134	39	71%	0.93
2	5.9	148	39	78%	0.92
3	3.8	328	39	77%	0.99
4	1.2	404	39	74%	1

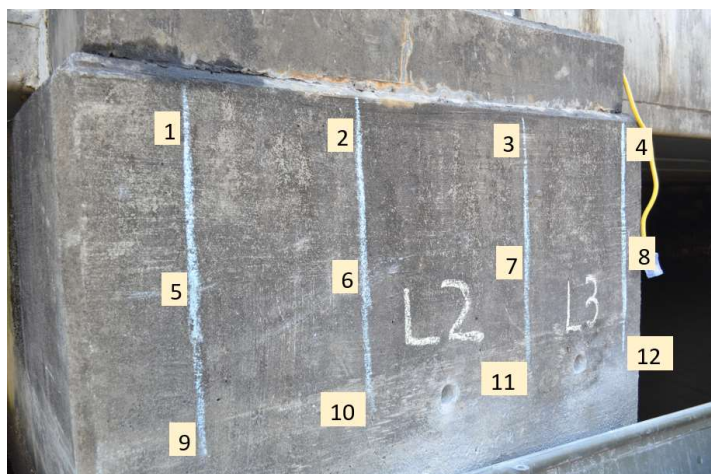
Figure B1.23. Reference locations for Table B1.23.

Table B1.23. Readings from face of interior cap (see Figure B1.23).

Reference Location	Corrosion Rate ($\mu\text{m}/\text{year}$)	Concrete Resistivity (kohm.cm)	Temperature ($^{\circ}\text{F}$)	Humidity	R ²
1	1.2	745	39	73%	0.99
2	1.4	402	39	73%	0.99
3	0.98	400	39	71%	0.99
4	0.57	555	39	70%	0.99
5	0.59	775	39	85%	1
6	5.3	397	39	83%	0.99
7	2.6	379	39	82%	0.99
8	0.13	469	39	79%	1
9	2.5	309	39	73%	1
10	21	246	39	68%	0.96
11	28	199	39	69%	0.94
12	4.1	316	39	72%	0.96

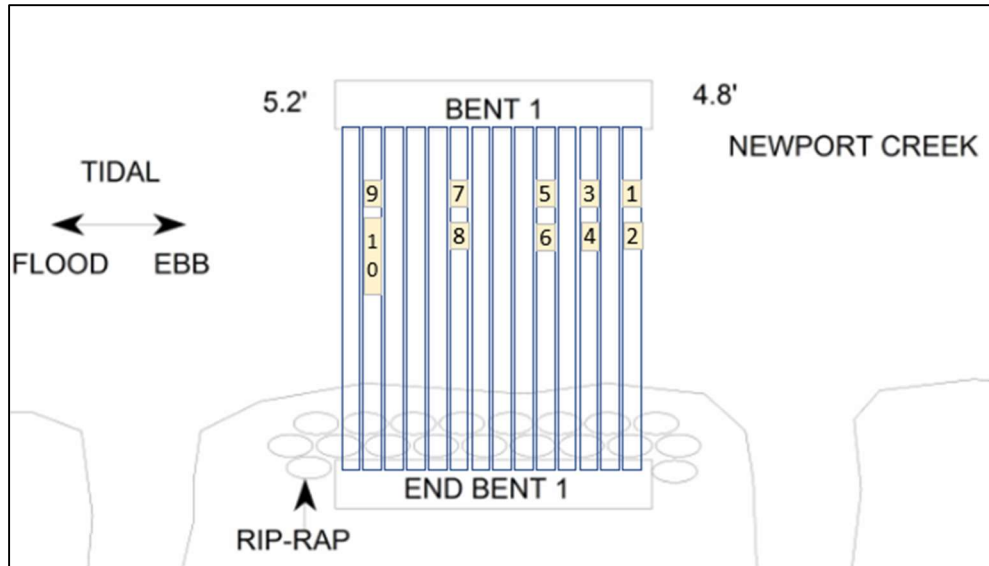
Figure B1.24. Reference locations for Table B1.24 (sketch from 2017 NCDOT inspection report of SN 150026 (NCDOT 2017)).

Table B1.24. Readings from underside of cored slabs (see Figure B1.24).

Reference Location	Corrosion Rate ($\mu\text{m}/\text{year}$)	Concrete Resistivity (kohm.cm)	Temperature ($^{\circ}\text{F}$)	Humidity	R ²
1	4.4	293	39	65%	1
	6.7	133	39	68%	1
2	6.8	206	39	69%	1
	12	123	39	68%	0.97
3	6.8	188	39	68%	1
	4.7	246	39	68%	0.97
4	2.2	304	39	69%	1
	3	277	39	69%	0.99
5	4.8	234	39	69%	1
	3	221	39	69%	1
6	3.8	272	39	64%	1
	4.6	239	39	67%	0.99
7	2.9	245	39	70%	0.99
	6.3	239	39	71%	0.99
8	1.9	312	39	71%	0.97
	3.3	233	39	71%	0.98
9	1.4	196	39	70%	0.91
	6.8	143	39	71%	0.99
10	4	216	39	71%	0.97
	13	150	39	70%	0.95

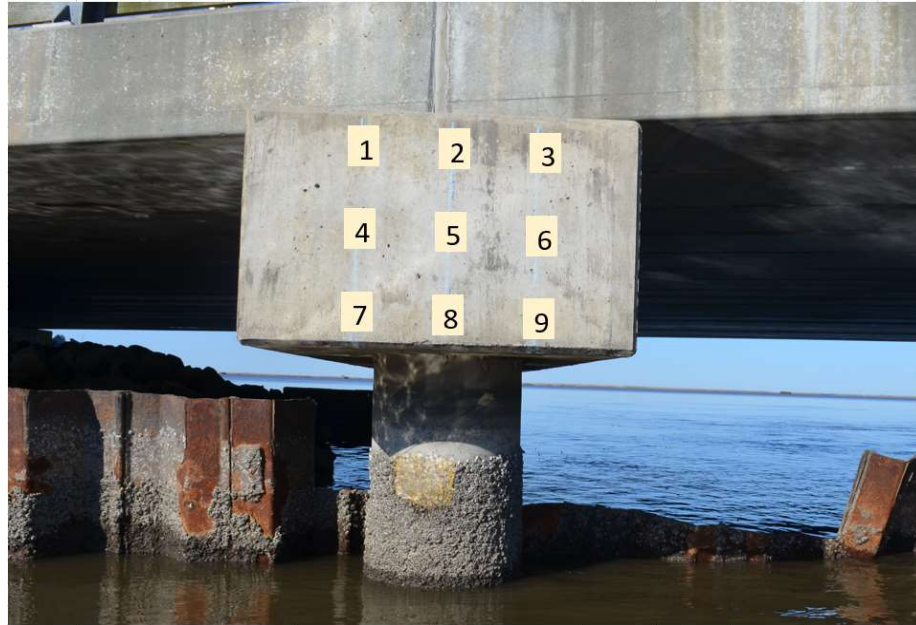
Figure B1.25. Reference locations for Table B1.25.

Table B1.25. Readings from side face of cap (see Figure B1.25).

Reference Location	Corrosion Rate (µm/year)	Concrete Resistivity (kohm.cm)	Temperature (°F)	Humidity	R ²
1	40	64	59	48%	0.96
2	22	81	46	80%	0.93
3	67	55	46	80%	0.96
4	10	74	55	38%	0.88
5	20	42	55	42%	0.99
6	13	56	57	55%	0.97
7	27	48	55	38%	0.99
8	9.1	157	57	40%	0.99
9	9.2	89	57	44%	0.99
