EVALUATING CORROSIVE SITE PERFORMANCE AND POLICY WITH
CONCRETE ADMIXTURES

A thesis submitted to the faculty of
The University of North Carolina at Charlotte
in partial fulfillment of the requirements
for the degree of Master of Science in
Civil Engineering

2020

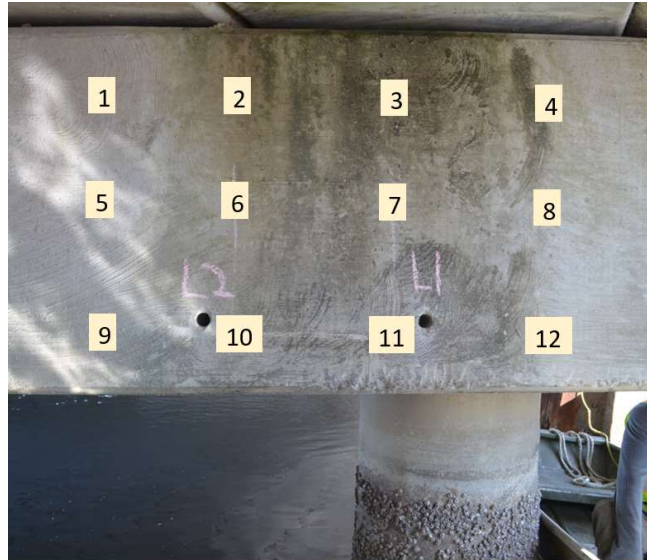
Figure B1.26. Reference locations for Table B1.26.

Table B1.26. Readings from interior face of cap (see Figure B1.26).

Reference Location	Corrosion Rate ($\mu\text{m}/\text{year}$)	Concrete Resistivity (kohm.cm)	Temperature ($^{\circ}\text{F}$)	Humidity	R ²
1	19	125	54	34%	0.99
2	17	76	55	37%	0.99
3	9.2	88	57	32%	1
4	31	112	54	37%	0.99
5	40	95	55	37%	0.98
6	52	108	54	34%	0.99
7	46	67	52	37%	0.99
8	0.72	315	52	37%	0.97
9	18	170	52	36%	0.95
10	22	170	52	43%	0.97
11	4.6	210	50	40%	0.98
12	7	254	50	40%	1

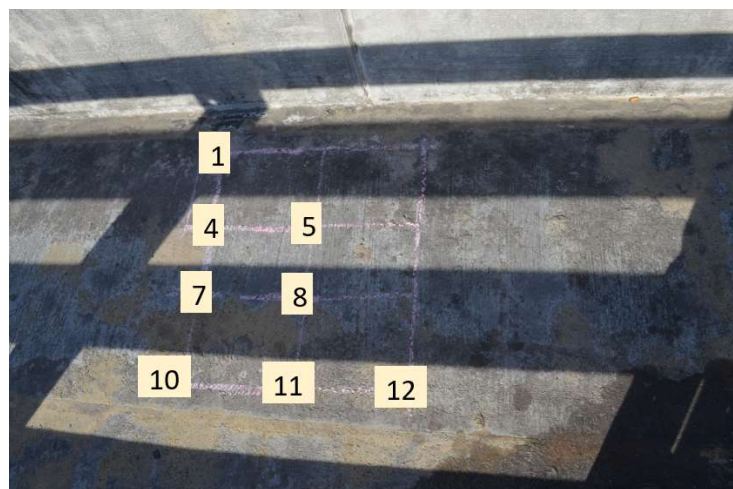
Figure B1.27. Reference locations for Table B1.27.

Table B1.27. Readings from top of sidewalk (see Figure B1.27).

Reference Location	Corrosion Rate ($\mu\text{m}/\text{year}$)	Concrete Resistivity (kohm.cm)	Temperature ($^{\circ}\text{F}$)	Humidity	R^2
1	3.1	874	55	37%	0.98
4	0.27	899	54	41%	1
5	6.9	452	57	43%	0.97
7	0.63	734	54	45%	1
8	1.1	180	57	40%	1
10	2.2	189	55	38%	1
11	3.7	355	55	39%	0.98
12	2.5	638	57	39%	1

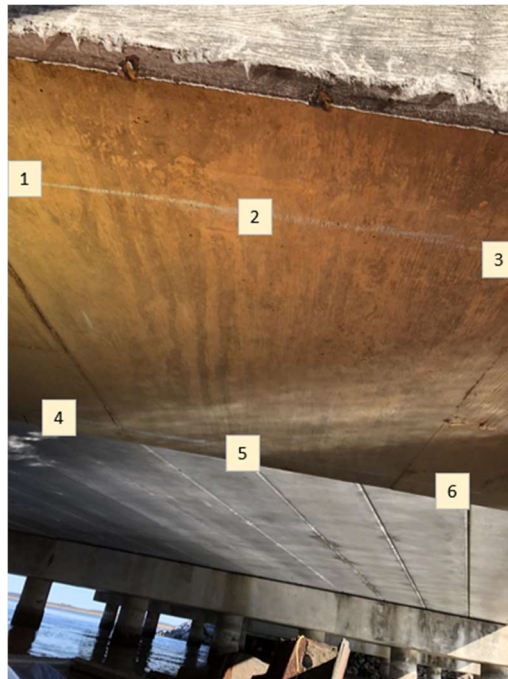
Figure B1.28. Reference locations for Table B1.28.

Table B1.28. Readings from underside of cap (see Figure B1.28).

Reference Location	Corrosion Rate ($\mu\text{m}/\text{year}$)	Concrete Resistivity (kohm.cm)	Temperature ($^{\circ}\text{F}$)	Humidity	R ²
1	25	120	54	36%	0.99
2	11	194	55	33%	0.99
3	1.5	180	55	35%	0.98
4	30	161	59	30%	0.99
5	8.7	245	55	35%	0.98
6	3.8	158	61	30%	1

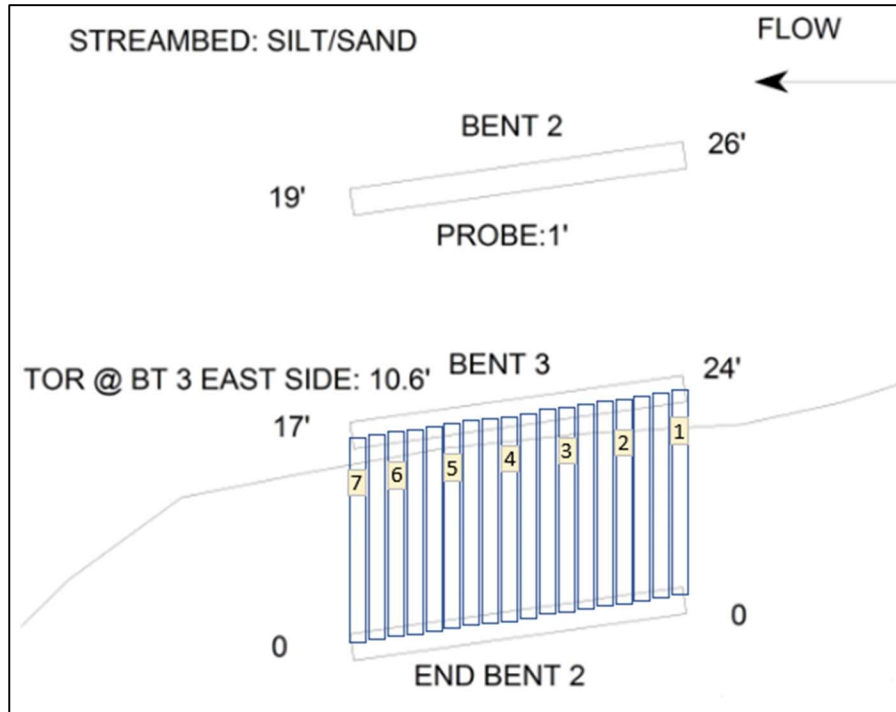
Figure B1.29. Reference locations for Table B1.29 (sketch from 2018 NCDOT inspection report of SN 260007 (NCDOT 2018)).

Table B1.29. Readings from underside of cored slabs (see Figure B1.29).

Reference Location	Corrosion Rate ($\mu\text{m}/\text{year}$)	Concrete Resistivity (kohm.cm)	Temperature ($^{\circ}\text{F}$)	Humidity	R ²
1	6.6	147	54	38%	1
2	7.9	137	55	38%	0.90
3	3.3	180	55	35%	0.99
4	0.34	155	57	33%	0.99
5	9.1	170	59	34%	0.99
6	11	137	59	36%	0.98
7	6.2	159	61	41%	0.95

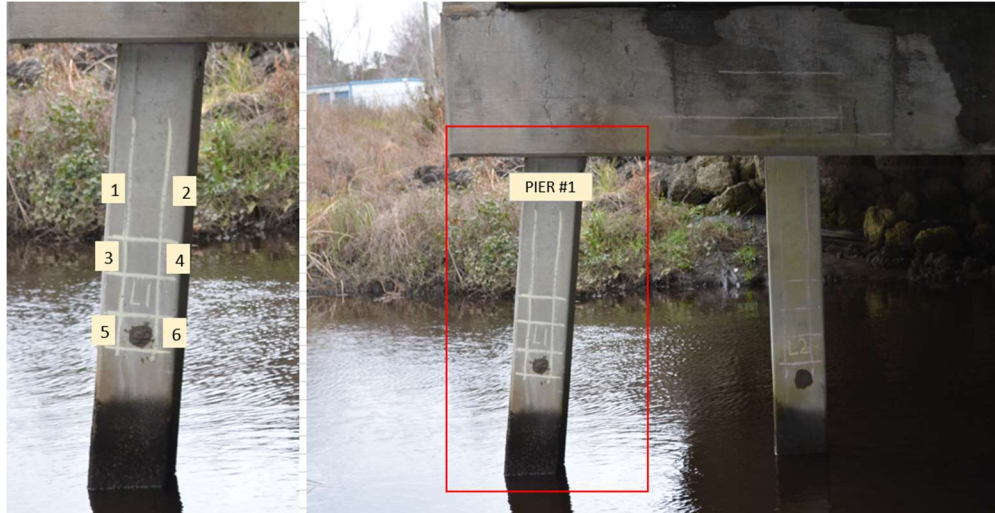
Figure B1.30. Reference locations for Table B1.30.

Table B1.30. Readings from face of pier #1 (see Figure B1.30).

Reference Location	Corrosion Rate ($\mu\text{m}/\text{year}$)	Concrete Resistivity (kohm.cm)	Temperature ($^{\circ}\text{F}$)	Humidity	R ²
1	4.2	119	34	77%	1
2	5.4	112	34	77%	0.97
3	4.6	208	34	77%	0.99
4	1.1	204	34	76%	0.99
5	4.1	234	34	77%	0.96
6	6.5	200	34	78%	0.89

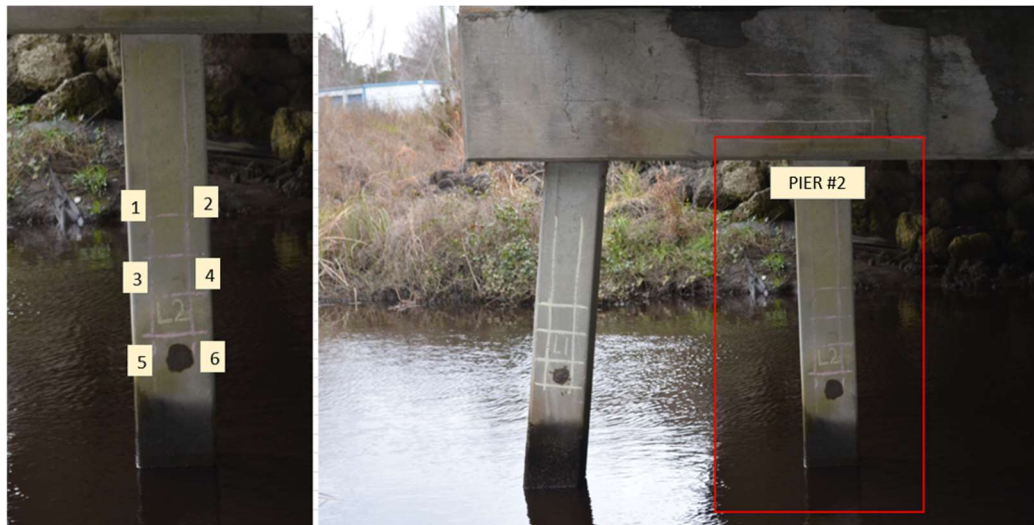
Figure B1.31. Reference locations for Table B1.31.

Table B1.31. Readings from face of pier #2 (see Figure B1.31).

Reference Location	Corrosion Rate ($\mu\text{m}/\text{year}$)	Concrete Resistivity (kohm.cm)	Temperature ($^{\circ}\text{F}$)	Humidity	R ²
1	0.23	257	34	76%	0.97
2	2.9	226	34	76%	0.97
3	3.2	178	34	76%	1
4	3	191	34	76%	0.98
5	2.6	177	34	77%	0.99
6	10	158	34	77%	0.98

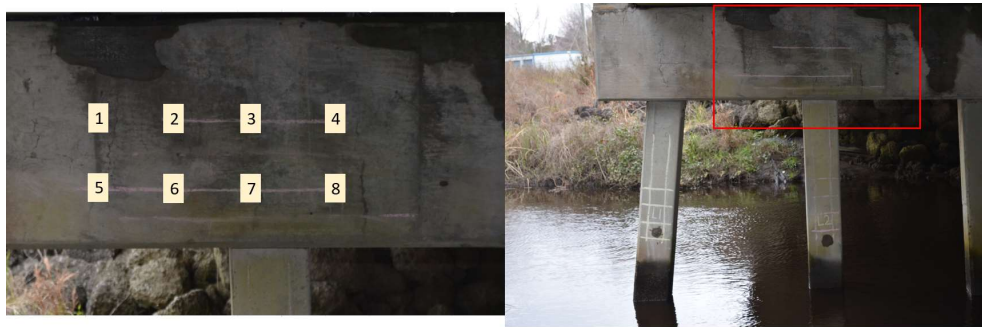
Figure B1.32. Reference locations for Table B1.32.

Table B1.32. Readings from face of cap (see Figure B1.32).

Reference Location	Corrosion Rate ($\mu\text{m}/\text{year}$)	Concrete Resistivity (kohm.cm)	Temperature ($^{\circ}\text{F}$)	Humidity	R ²
1	2.3	515	34	77%	0.97
2	1.4	640	34	78%	0.97
3	3.3	237	34	78%	0.98
4	0.69	310	34	78%	1
5	0.47	646	34	75%	0.94
6	3.1	368	34	77%	1
7	2.8	436	34	76%	0.99
8	4.1	461	34	77%	0.98

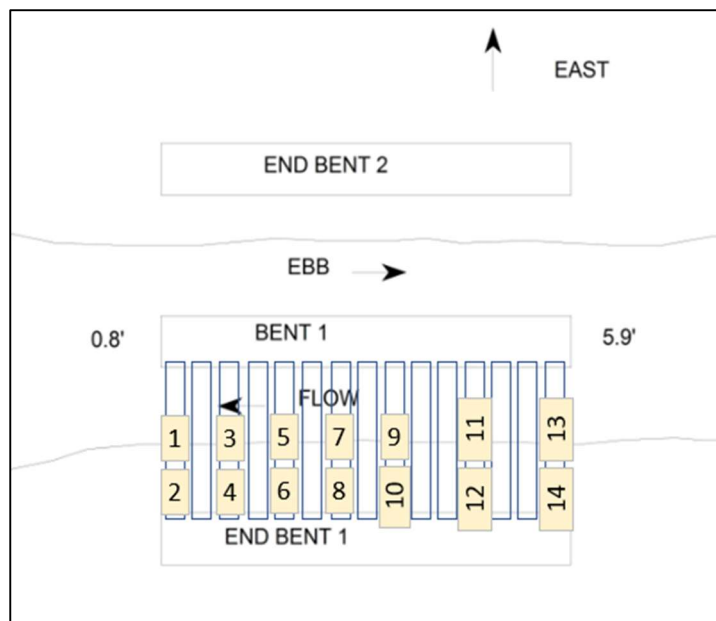
Figure B1.33. Reference locations for Table B1.33 (sketch from 2018 NCDOT inspection report of SN 660021 (NCDOT 2018)).

Table B1.33. Readings from underside of cored slabs (see Figure B1.33).

Reference Location	Corrosion Rate (µm/year)	Concrete Resistivity (kohm.cm)	Temperature (°F)	Humidity	R ²
1	2.4	45	34	74%	1
	3.7	56	34	74%	1
2	2.5	54	34	73%	1
	4.7	69	34	73%	1
3	3.3	100	34	73%	0.99
	5.7	83	34	73%	1
4	9.7	115	34	73%	0.98
	1.4	153	34	73%	1
5	1.9	101	34	74%	0.99
	2.7	96	34	73%	1
6	2.7	122	34	74%	0.99
	3.1	143	34	73%	1
7	1.8	121	34	75%	1
	-0.21	145	34	75%	1
8	1.7	50	36	74%	1
	1.3	56	36	74%	0.98
9	2.9	47	34	73%	1
	2.2	50	34	73%	1
10	1.9	96	34	72%	0.99
	3	127	34	72%	1
11	0.69	221	34	73%	0.93
	6.3	108	34	72%	0.97
12	4.1	105	34	74%	1
	0.38	80	34	74%	1
13	2.3	104	34	73%	1
	1.9	107	34	73%	1
14	0.74	130	34	75%	0.99
	0.38	411	34	76%	1
