POST-DISASTER INVESTIGATION OF STRUCTURES IN THE PHILIPPINES
(LEYTE AND EAST SAMAR) AFTER SUPER TYPHOON HAIYAN

A thesis submitted to the faculty of
The University of North Carolina at Charlotte
in partial fulfillment of the requirements
for the degree of Master of Science in
Engineering

2016

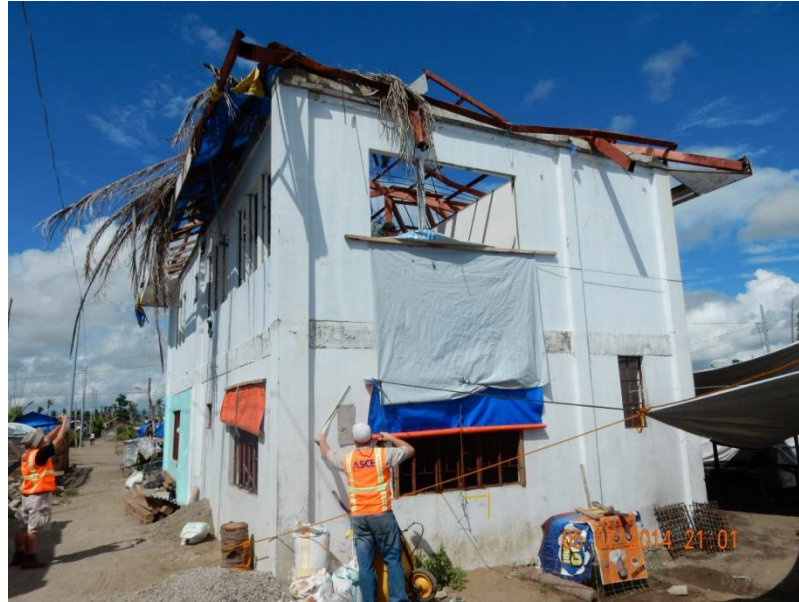
Figure 13: Structural Investigation Using GPS-Camera in Tanauan, Leyte

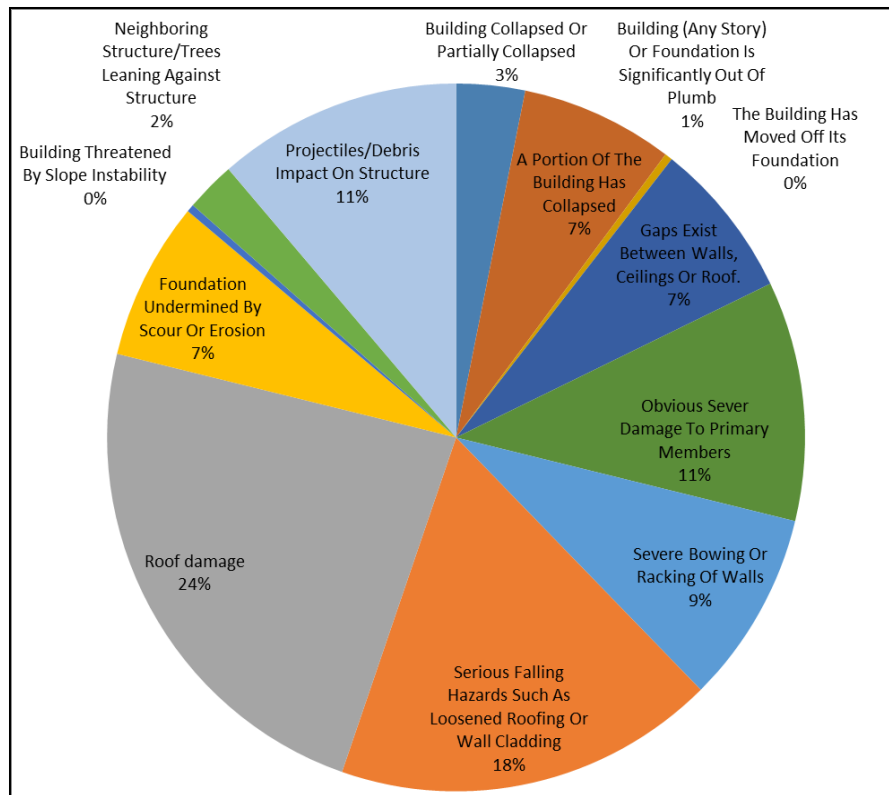
The individual condition ranking is shown in Figure 31. The most common condition is roof failures (21%) indicating wind effects. There are a few cases of storm surge force damaging the roof system (wave impact) as shown in Figure 32. Because of roof damages, there are also several cases of falling object hazards (17%). Finally, because of connection design, roof damage also resulted in damages in primary members such as wall beams and columns. The resulting damages to primary members is about 11%.

Figure 31: Statistics of Damage Condition Rankings

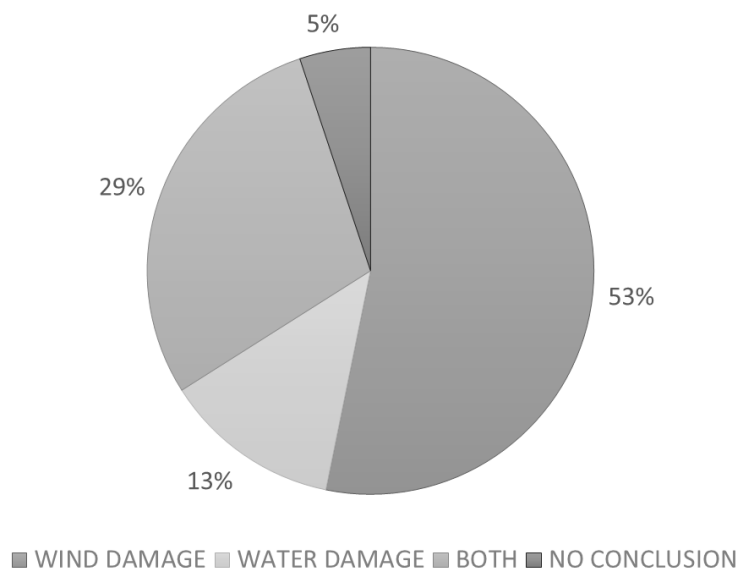
The basic rating technique helps in identifying failure modes of the damaged structures. Figure 33 summarizes the different failure modes at Leyte and East Samar Islands into wind, water (storm surge) failures and possible combined effects. The results indicate that wind is the predominant induced damage for about 53% of all studied structures, although that may be a low estimate as there are several combined effect damage (29%). Water damage accounts for 13% of the damaged structures. To clearly distinguish between wind and water damage would require a more detailed analysis of the damaged structures.

Figure 33: Damage Causes Differentiating Wind and Water (Storm Surge) Damage

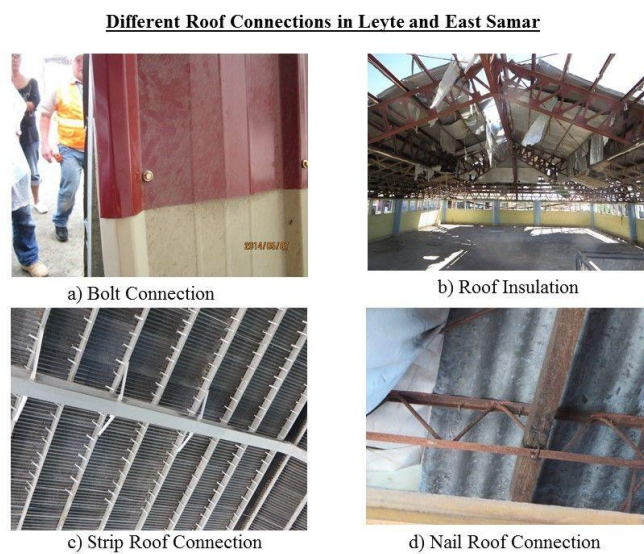
the construction – we have to rely on more detailed data to establish the effect of construction quality. Observations of the construction of the buildings made in the field indicate that the roof cover connection technique can vary from nailing to strip connections. The roof truss connection to the support member can also vary from bolted connection to simply bending the extended rebars around the truss connection as support. Figure 34 shows different roof sheet connections and Figure 35 shows the different roof support systems in Leyte and East Samar Islands.

Figure 34: Different Roof Cover Connections in Leyte and East Samar Islands

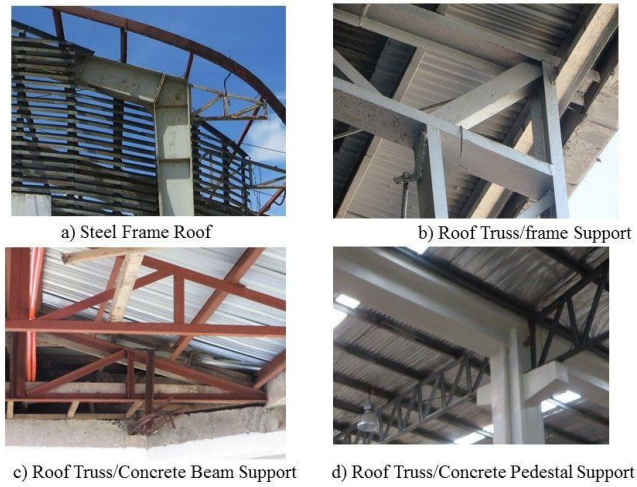
It is evident that most failure mechanisms from the hurricane started with the failure of roof covers; however, there are also cases where gusty wind may have brought down the entire roof truss. It is of concern that some of some roof structures are not adequately designed for load reversals and may have brought down the entire building (Failure mode for gravity effect, Figure 35e). This may be the case for the Palo008-D2 structure (Figure 36). If the building frame remained intact it may provide some minimal safety to the occupants within the structure. Hence, it is important to enhance future structural design to include higher lateral loading capacity for wide-spanned structures.

Figure 35: Different Roof Support Systems in Leyte and East Samar Islands

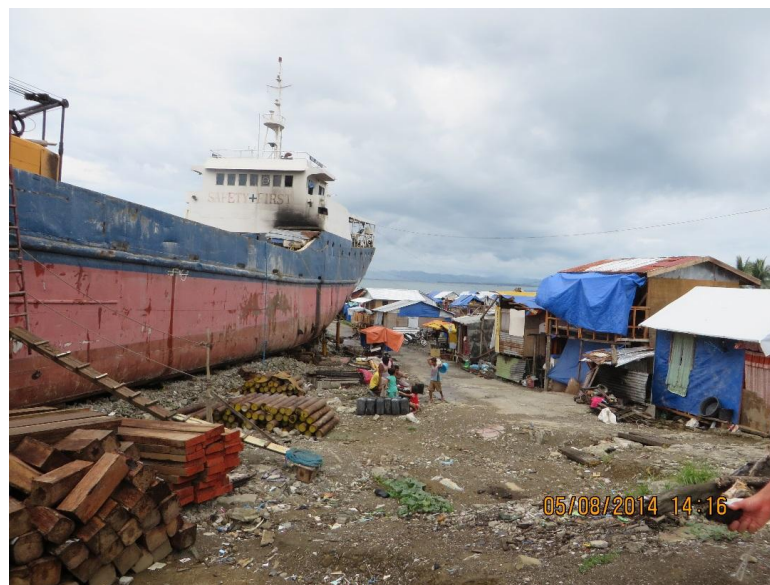
The ASCE team visited the Leyte Park Resort at the Panirugan Point, which suffered significant wind and storm surge damages to multiple structures. Based on interview of local witnesses, there were two large waves that impacted Tacloban City. A theory is suggested that the initial wave is probably the long distance wave traveling along the path of the typhoon and the second wave is probably reflected waves from the Samar Island side. Figure 43 shows the two-wave hypothesis where the long traveling waves from the Pacific entered into the San Pedro Bay caused significant amount of water trapped within the bay. The waves reflected from the coasts of Samar Island would force more water into the Port of Tacloban. This combined water may be the force behind pushing several cargo ships that eventually docked on land at Balangay 70 near Anibong. Figure 44 shows the one of ships that were docked at Anibong.

More detailed studies and modeling are required to fully understand the forces that have been applied to the ships to move them on land.

Figure 44: One of the Cargo Ships Docked in Land due to Wave Motion. Ship was originally docked at Anibong

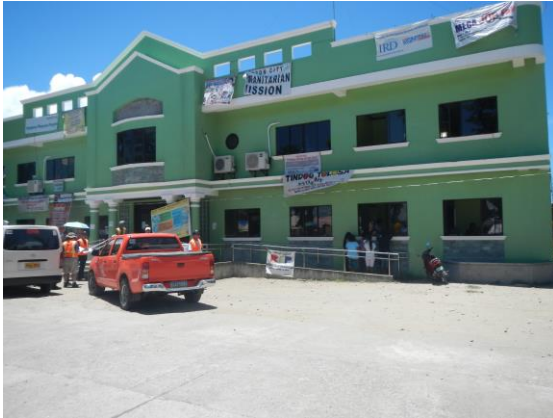
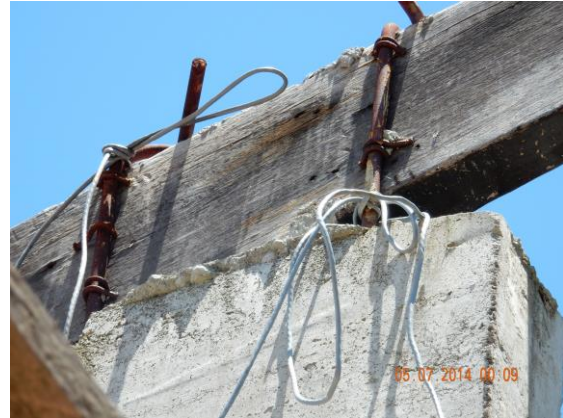
Figure A151: Tanauan, Building 4, View 1 (left), View 2 (right)

1.Wind damage is severe on the second story of the building.				
2.Obvious wall damage/separation of walls is existing.				
3.Water markings are observed in ground story

4.Interior and Exterior walls are completely damaged.

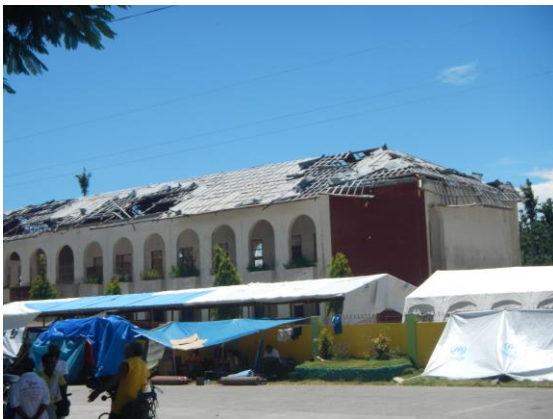
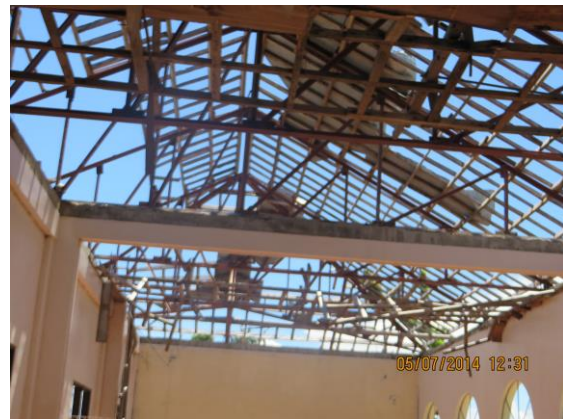
Figure A153: Tolosa, Building 2, View 1 (left), View 2 (right)

STRUCTURE IDENTITY	: TOLOSA-002		
TYPE OF STRUCTURE	: COMMERCIAL, DZRMES ELEMENTRY SCHOOL, TWO STORY		
LOCATION	: 125.0374396,11.06392088		
DISTANCE FROM THE OCEAN	: 249 METERS	ELEVATION:	26 feet
DATE OF DAMAGE	: Nov-13-2013		
DATE OF PICTURES COLLECTED	: May-07-2014

- 1.The roof of the building is completely gone.
- 2.Water damage is observed up to first story of the building
- 3.Primary members are severely damaged.
- 4.The Eaves of the truss are damaged.
- 5.Exterior wall of the building is completely collapsed.
- 6.Connection failures are observed in truss members.

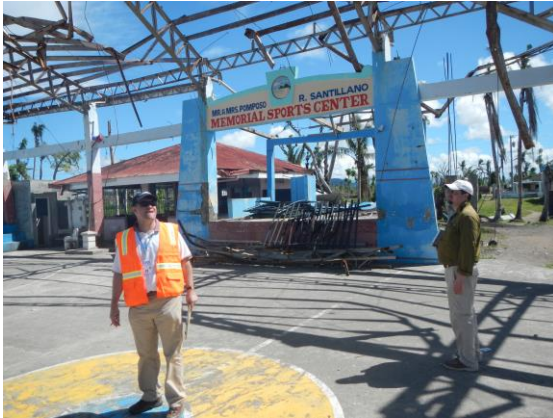
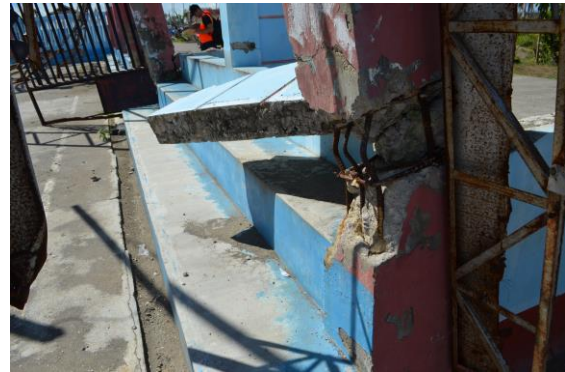
Figure A154: Tolosa, Building 3, View 1 (left), View 2 (right)

STRUCTURE IDENTITY	: TOLOSA-003-B3		
TYPE OF STRUCTURE	: COMMERCIAL, MEMORIAL SPORTS CENTER, SINGLE STORY		
LOCATION	: 125.0319592,11.07626064		
DISTANCE FROM THE OCEAN	: 197 METERS	ELEVATION:	33 feet
DATE OF DAMAGE	: Nov-13-2013		
DATE OF PICTURES COLLECTED	: May-07-2014

- 1.Primary members are severely Damaged.
- 2.Leaning of columns are observed.
- 3.Bond failures are observed in columns.
- 4.Plastic hinges are formed at end portion of the beams.
- 5.Minor Scouring action is observed.
- 6.Roof trusses are completely Damaged.
- 7.connection problems are observed in truss.
- 8.columns are separated from the walls.

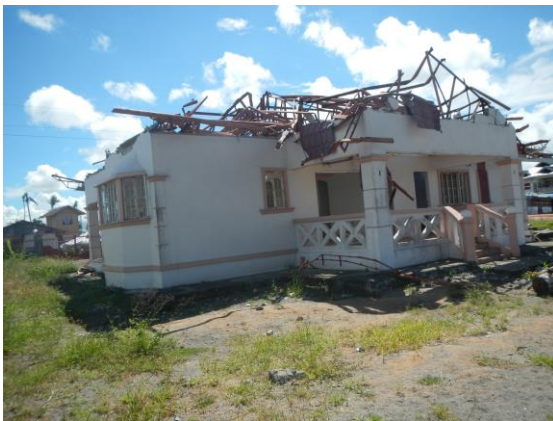
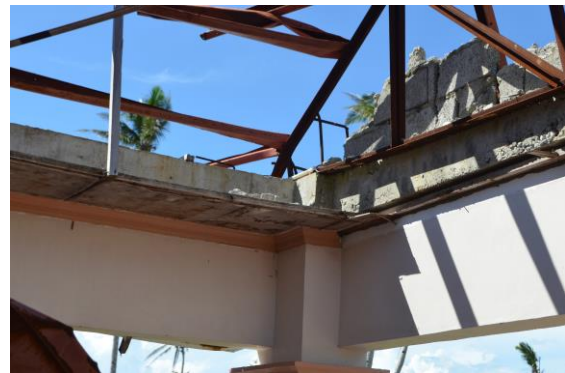
Figure A155: Tolosa, Building 4, View 1 (left), View 2 (right)

STRUCTURE IDENTITY	: TOLOSA-004-B4		
TYPE OF STRUCTURE	: RESIDENTIAL, SINGLE STORY		
LOCATION	: 125.032127,11.07681491		
DISTANCE FROM THE OCEAN	: 140 METERS	ELEVATION:	34 feet
DATE OF DAMAGE	: Nov-13-2013		
DATE OF PICTURES COLLECTED	: May-07-2014

CONDITION		Significance Factor	Rating	Overall Rating
1a	Building Collapsed Or Partially Collapsed	3	0	2
1b	A Portion Of The Building Has Collapsed	2	0	
1c	The Building Has Moved Off Its Foundation	2	0	
2a	Building (Any Story) Or Foundation Is Significantly Out Of Plumb	3	0	
2b	Gaps Exist Between Walls, Ceilings Or Roof.	2	0	
3a	Obvious Severe Damage To Primary Members	2	1	
3b	Severe Bowing Or Racking Of Walls	2	0	
4a	Serious Falling Hazards Such As Loosened Roofing Or Wall	2	3	
4b	Roof damage	2	3	
5a	Foundation Undermined By Scour Or Erosion	3	0	
5b	Building Threatened By Slope Instability	3	0	
6a	Neighboring Structure/Trees Leaning Against Structure	1	0	
6b	Projectiles/Debris Impact On Structure	1	1	
Observations:				
1.Roof of the building is completely gone.				
2.Water damages are observed in the building.
