THERMO-MECHANICAL PERFORMANCE OF DOWELED CONNECTIONS IN
TALL TIMBER BUILDINGS

A dissertation submitted to the faculty of
The University of North Carolina at Charlotte
in partial fulfillment of the requirements
for the degree of Doctor of Philosophy in
Civil Engineering

MILAD SHABANIAN. Thermo-mechanical performance of doweled connections in tall timber buildings. (Under the direction of Dr. Nicole L. Braxtan)

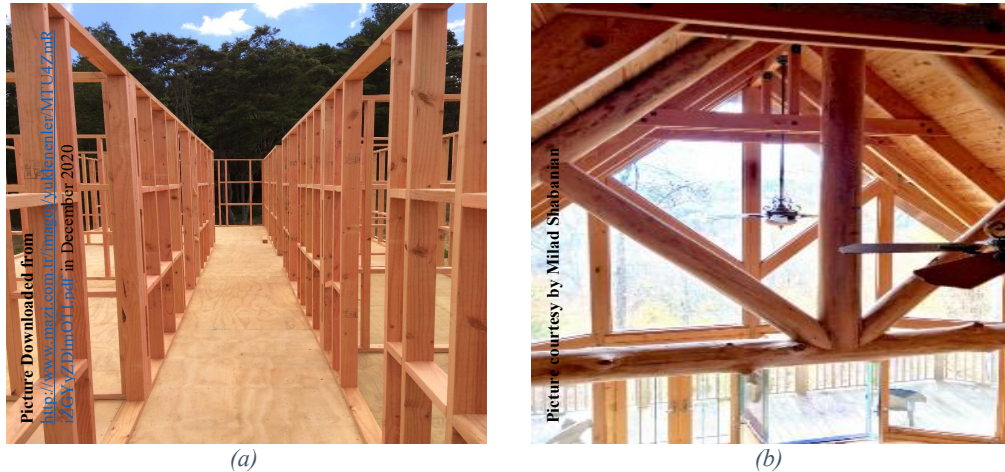
Figure 2.1. Different types of timber structures: (a) LT framing vs. (b) HT framing.

There are two major types of timber structures: light-timber (LT) and heavy-timber (HT). Figure 2.1 compares light timber construction versus heavy timber construction. Light timber construction typically consists of 2 in by 4 in studs and 2 in by 6 in, 8 in, or 10 in joists in residential buildings up to 6 story (65 ft). The structural elements are typically protected against fire through encapsulation with gypsum board protection [2]. On the other hand, heavy timber construction includes wood columns, walls, posts, and beams with nominal section size usually greater than 6 in by 6 in. Heavy timber members inherently exhibit better fire-performance and structural strength due to their large size. Thus, heavy timber construction may be applicable for use also in high-rise buildings.

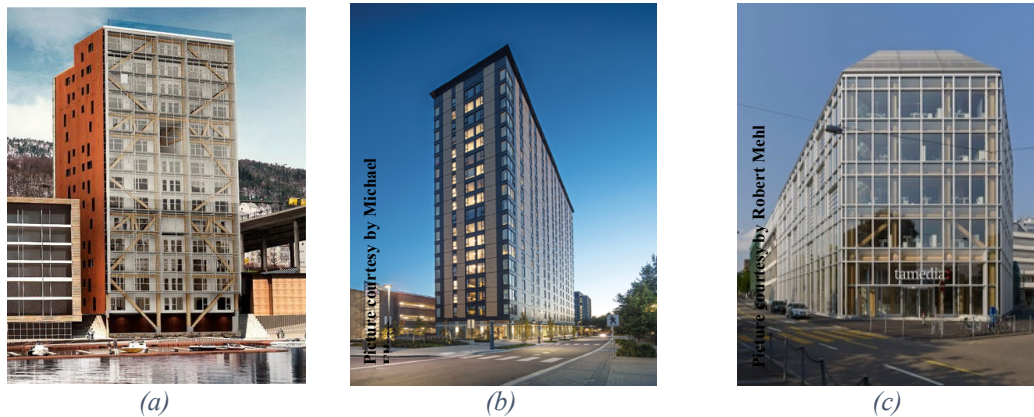
Figure 2.4. Modern heavy timber constructions: (a) Treat, Norway [16], (b) Brock Commons, Canada, (c) Medienhaus Tamedia, Switzerland.

The invention and development of engineered wood products during the last century, has led to increased feasibility of construction of tall timber structures. Engineered wood products such as glued-laminated timber (glulam or GL), laminated veneer lumber (LVL), cross-laminated timber (CLT) and nailed-laminated timber (NLT) presented with higher strength and quickly increased in popularity. Figure 2.4 shows examples of contemporary heavy timber construction using engineered wood products as the main structural elements.

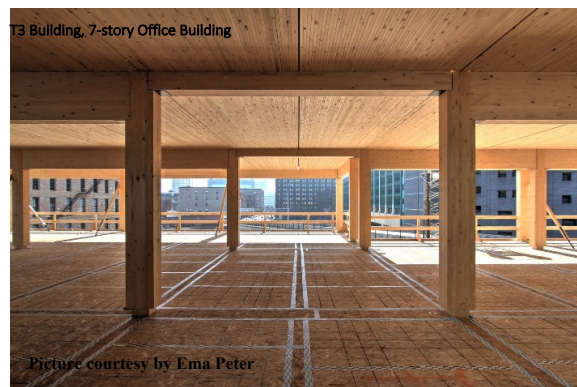
Figure 2.5. (a) Glulam beam and (b) its application as beams and columns in HT construction.

Glue laminated timber (glulam or GL) is an innovative engineered wood product that was first used in 1893 to construct an auditorium in Switzerland [12]. Glulam is made up of individual layers of dimensional lumber. These layers are end jointed together in order to have longer lengths and glued together with adhesives to provide larger cross sections. Because of their configuration, large glulam elements can be produced from small trees. Glulam has higher strength compared to solid sawn lumber and due to this high strength glulam can span longer distances. It is very common to use glulam elements as posts and beams in structures. Figure 2.5 shows glulam elements and their application as structural elements.

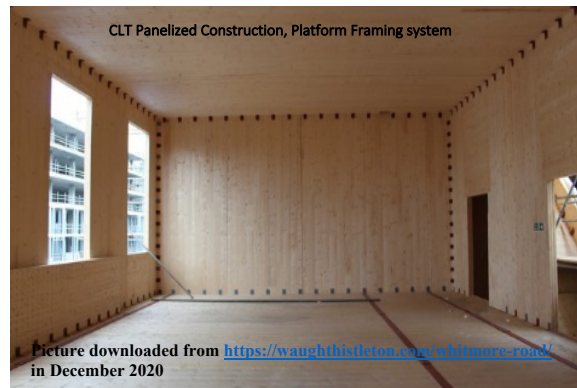
Figure 2.7. (a) Cross Laminated Timber (CLT) and (b) its application in panelized construction.

Around 1990s, Cross laminated timber, or CLT developed in Switzerland, Germany and Austria [13]. CLT is a wood based composite panel product, comprised of multiple layers of lumbers stacked together with the grains in alternating, perpendicularly orientations in order to achieve higher strength in different directions where the exterior layers are laid out in a direction parallel to the direction of the applied load. CLT can be used as wall, floor, beam, and column elements – however, using CLT as beam and column elements is still uncommon. CLT panels are most applicable for panelized construction. One of the advantages of CLT is that prefabrication is completed off-site, reducing the construction time and cost in addition to increasing the construction accuracy. Figure 2.7 indicates a CLT panel and its application in panelized construction.

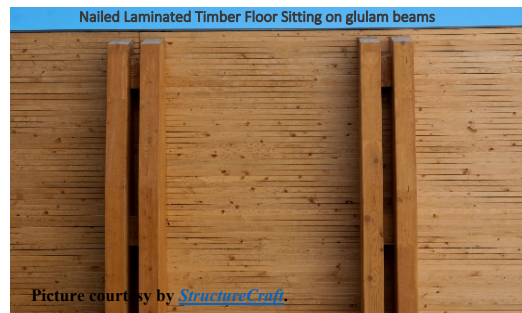
Figure 2.8. (a) NLT Panel and (b) its application as floor panel.

Nailed laminated timber (NLT) is an engineered wood product consisting of sawn lumbers aligned next to each other side by side and nailed together. NLT panels are applicable for floors and decking systems. Doweled laminated timber, or DLT, is another engineered wood product very similar to NLT, but has timber dowels instead of nails. Figure 2.8 shows the NLT panel and its application as a floor panel.

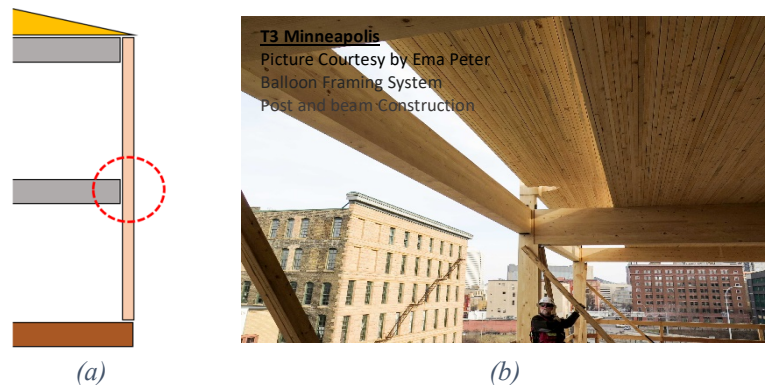
Figure 2.10. (a) Connection configuration in balloon framing system and (b) an example of balloon framing system.

framing system as the floor acts as a firestop. Conversely, the chimney effect occurring in the balloon framing system during fire can lead to vertical fire spread within a structure. Therefore, in balloon framing system, it is essential to cover and fill the gaps between the elements by proper fire sealants. Figure 2.10 illustrates the balloon framing system and connection details in this system.

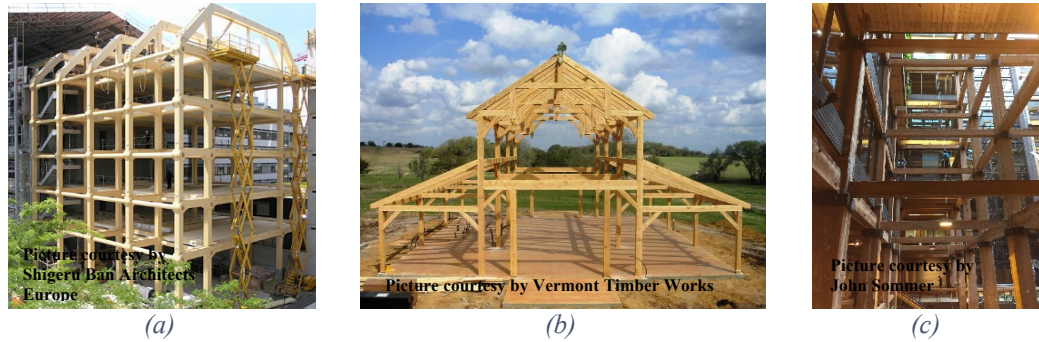
Figure 2.11. Post and beam constructions. (a) Medienhaus Tamedia, Switzerland, (b) Traditional post and beam construction, (c) Butler Square, USA.

for constructions following the balloon framing system. Figure 2.11 shows examples of heavy timber post and beam construction.

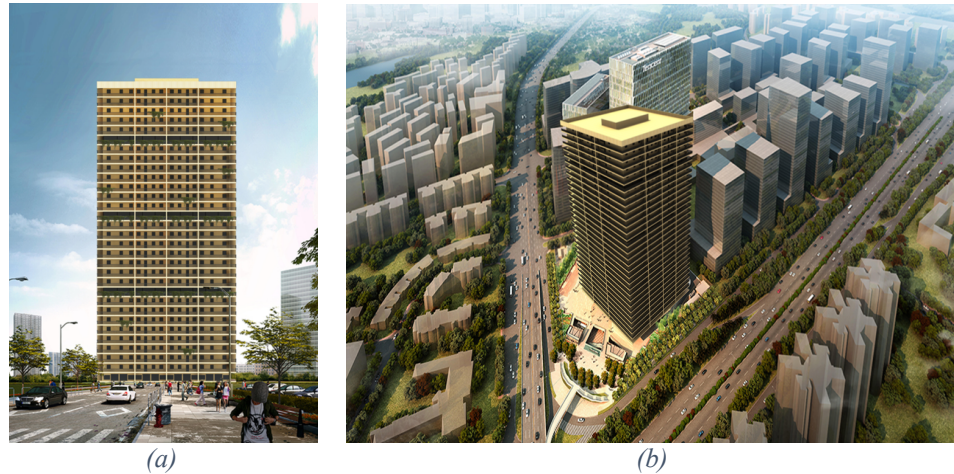
Figure 2.16. Designed 30-story CLT building for the 12th SFPE International Conference (a) front view, (b) 3D Model [1].

drawings. Figure 2.16 shows the front elevation view and 3D model of the 30-story structure proposed in the case study.

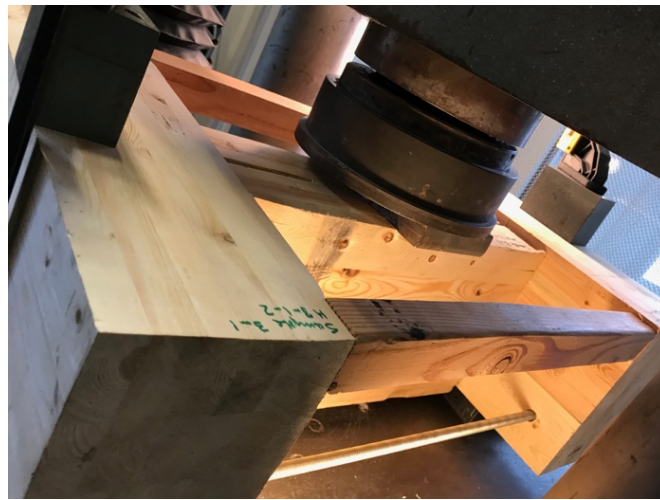
temperature was maintained at approximately 70 °F. Experimental set-up was developed based on the standard specification for testing and establishing allowable loads of joist hangers [42] which includes blocking for stabilization as shown in Figure 3.4. Each sample was fixed to the Universal Testing Machine (UTM) platform and then a vertical load was imposed at the mid-span of the Glulam-beam at a uniform crosshead rate of 0.05 in. per minute until failure.

Figure 3.4. Modified Glulam beam-to-girder assembly and ambient temperature test set-up.

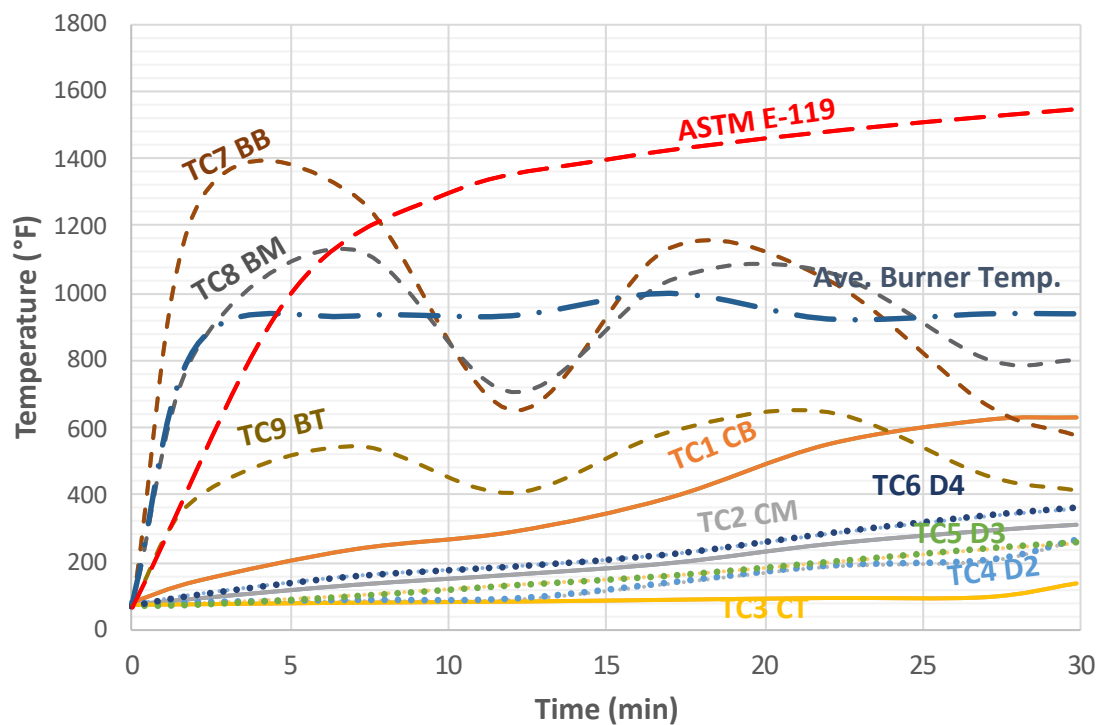
The PFP tests results include the temperature distribution recorded along the exposed area during fire and the residual load-displacement behavior of the assembly during mechanical loading post-fire. Figure 3.11 and Figure 3.13 display the test results related to the assembly exposed to the non-standard fire for 30 minutes (PFP30) and 60 minutes (PFP60), respectively. After the initial heating phase, the average burner temperature was approximately 920 °F in the PFP30 tests, and 1100 °F in the PFP60 tests. Figure 3.11 and 3.13 also show the ASTM E119 standard fire curve which, in comparison, reaches 1550°F at 30 minutes and 1700°F at 60 minutes. As expected with fire applied to the bottom of the assembly, in both fire experiments, TC1 recorded the highest temperature

within the steel connection (at the bottom of the connection) and TC7 recorded the highest temperature over the height of the beam (at the beam bottom). Also, the lowest dowel experienced the highest temperature during the PFP30 test. Unfortunately, the TC 3 and TC6 were disconnected during the PFP60 test, but it is assumed that this dowel also had the highest temperature of the dowels. At the completion of the test, there is a temperature range of nearly 400 °F over the height of the connection.

Figure 3.11. PFP30 heat distribution of Glulam beam-to-girder.

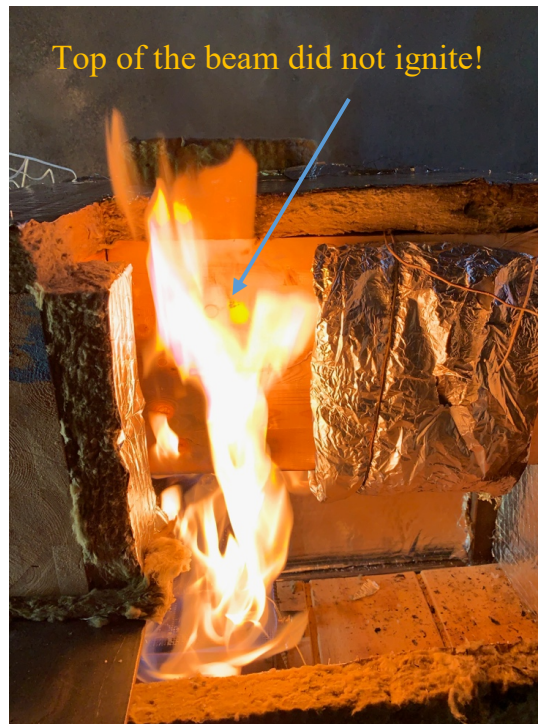
During the fire tests, the Glulam beams ignited when their temperature reached the wood ignition temperature of 570 °F. This occurred at approximately 2-3 minutes into the PFP30 test when TC7 and TC8 at the bottom and middle of the beam began to exceed the burner temperature. This is visually confirmed in the captured picture at two minutes shown below (Figure 3.12).

Figure 3.12.PFP30 beam ignition captured from side view of the Glulam beam-to-girder assembly.

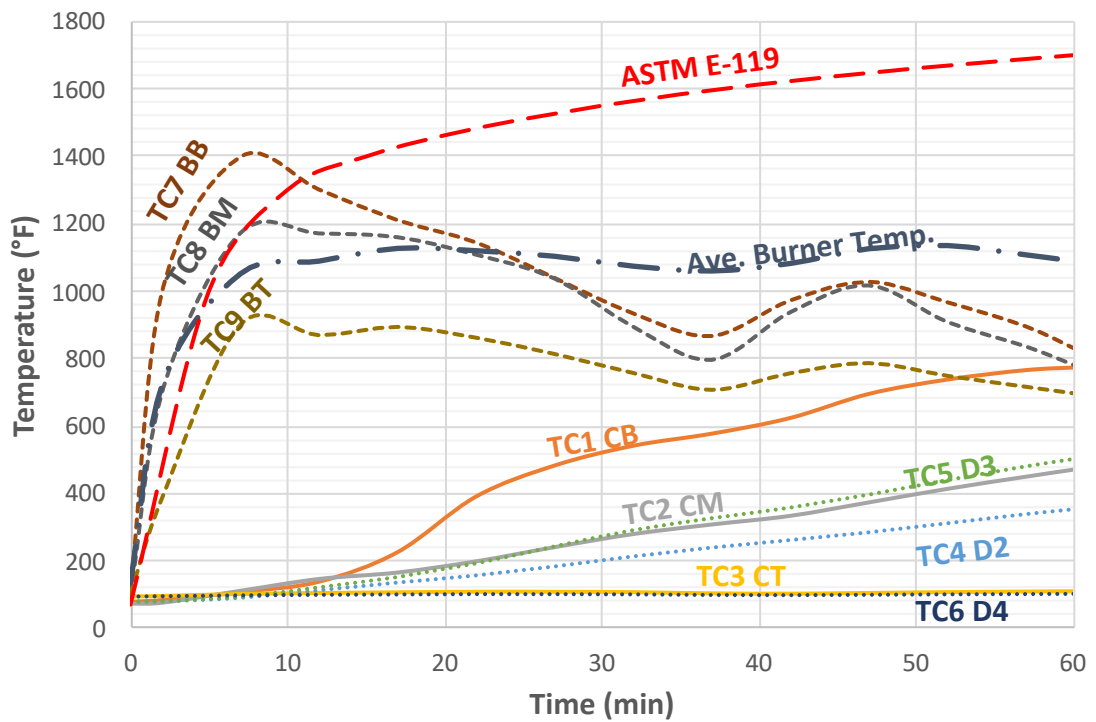
Figure 3.13. PFP60 heat distribution of Glulam beam-to-girder.

The PFP60 test results for the beam temperatures showed similar patterns, with ignition occurring in the beam bottom and middle at approximately 2-3 minutes into the fire test. The temperatures at the beam top were slightly higher in the PFP60 tests than the PFP 30 tests, as expected since the burner temperature in PFP60 was slightly higher than during the PFP30 test. At the completion of the tests, the temperature range over the height of the beam was less than the range in the PFP30 tests, this is a consequence of ignitions over a greater portion of the beam causing more uniform temperatures.

When comparing the connection temperatures between the PFP30 test and the PFP60 tests, the effect of the fire sealant is clear. The maximum temperature in the PFP30 connection was 647 °F at 30 minutes into the test with a burner temperature of 900 °F. At 30 minutes into the PFP60 test, the connection temperature was 525 °F while the burner

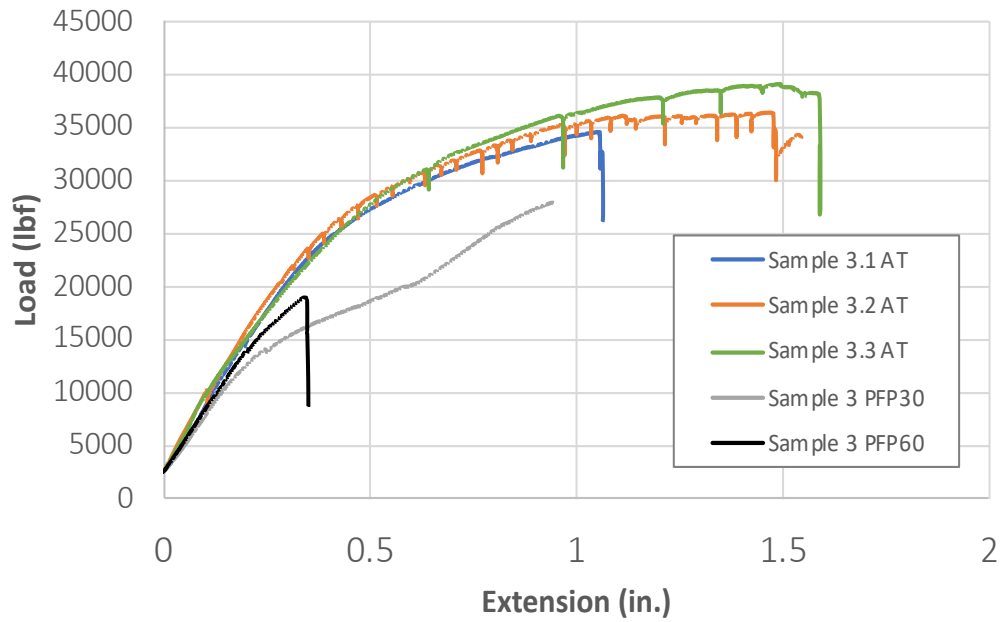
Figure 3.14 compares the load-displacement behavior of post-fire performance tests and the ambient temperature tests. Recall the average ambient temperature capacity was 36.7 kips. Residual capacity of the PFP30 test was reduced to 28.0 kips (76.3% of ambient) and the residual capacity of the PFP60 test was reduced to 19.2 kips (52.3% of ambient). Since the steel connection is assumed to maintain the ambient temperature strength after both PFP exposures, the reduction in load-carrying capacity is attributed to the loss in gross cross-section and strength of the wooden elements. Timber losses strength significantly between 212 °F and 572 °F [2] in the thermal penetration zone, which extends behind the char layer.

Figure 3.14. Residual strength of assembly after 30 minutes (R30) and 60 minutes non-standard fire exposure.

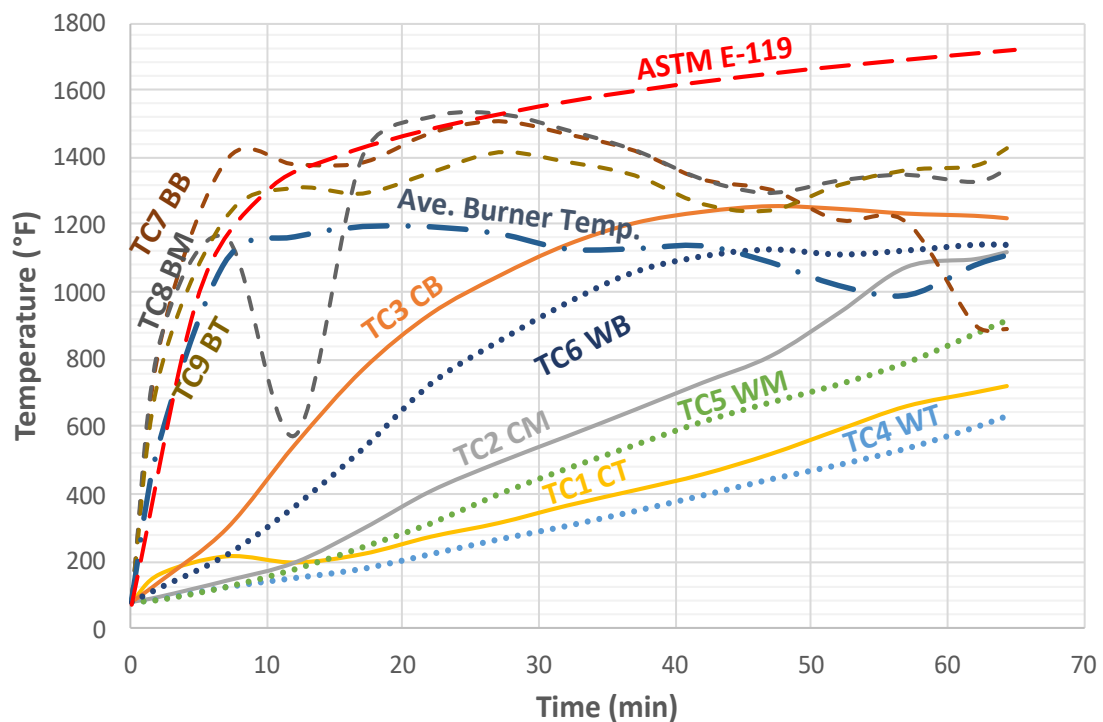
Figure 3.17 displays the temperature distribution along the exposed area of the assembly along with the fire temperature prescribed by the burner – approximately 1100 °F steady state after approximately 8 minutes of initial transient heating.

Figure 3.17. Temperature distribution along the exposed area of the assembly during FP test.

Figure 3.17 also shows the maximum recorded temperature in the steel connection (located in the bottom edge) at 30 minutes was 1110 °F, which is nearly the same as the burner temperature of approximately 1130 °F. While 30 minutes into the PFP30 tests, the maximum connection temperature was 647 °F – approximately 72% of the burner temperature of 900 °F. Neither the PFP30 nor the FP tests had fire sealant, yet the FP tests experienced a greater connection temperature in comparison to the applied thermal load of the burner. The increase in temperatures in the connection may be attributed to the initially deformed condition of the assembly due to the applied mechanical load. The PFP tests considered uncoupled fire and mechanical load; the FP test considered these simultaneously wherein the heat flow may have been impacted by potential opening of the

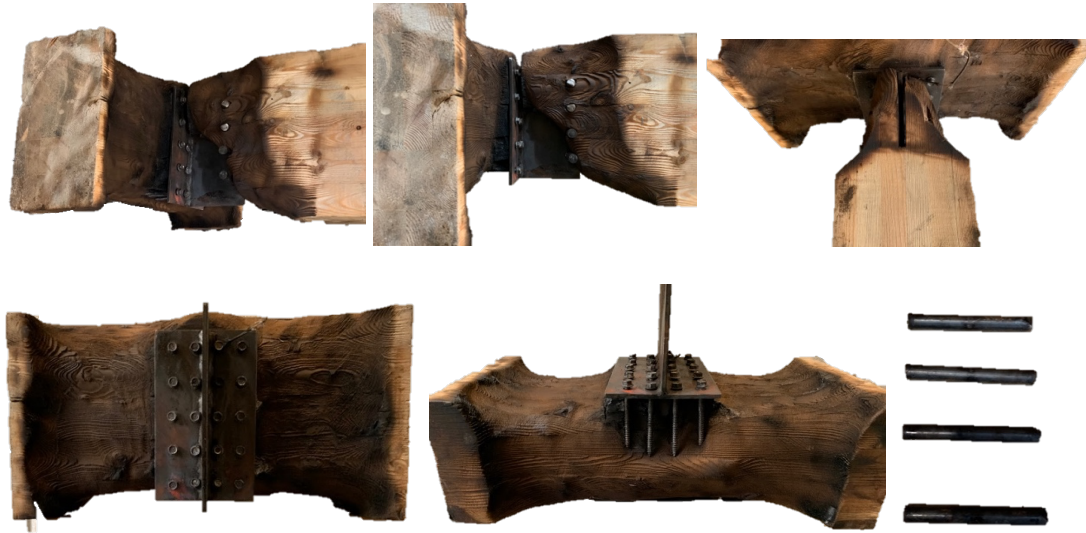
Figure 3.20 shows the residual section of the assembly after the FP test, and after the char layer was carefully removed. The post-fire investigation of the residual section showed significant charring of the girder, which impacted the anchorage of fasteners. Additional section loss in the connection region showed complete char through the Glulam laminations to the face of the connection, as well as charring to approximately mid-height of the connection, altering the heat distribution on the lower portion of the connection and on the two lower dowels. The maximum charring depth in the beam was 5.5-inch.

Figure 3.20. Residual Section of the Glulam Beam-to-Girder Assembly After the Fire-Performance Test

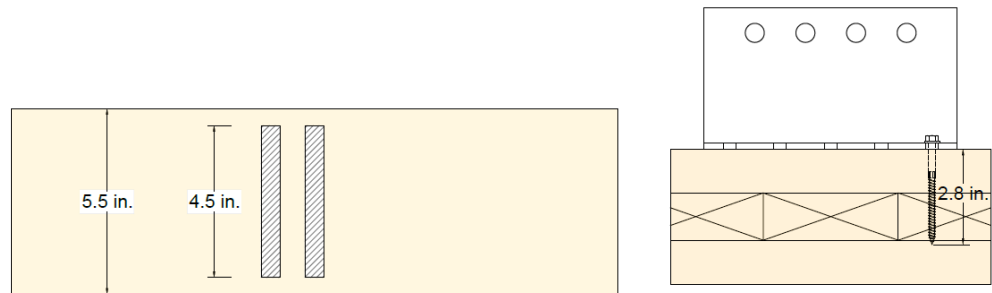
Figure 4.4 shows the steel dowels and screws in relation to the dimension of the CLT-Wall headers and the Glulam-beam. The 4.5 in. length dowels are cut from 1/2" structural steel rods (ASTM A572 Gr 50). The 1/4" diameter heavy-duty hexagonal connector screws with 3" length and 2" thread were manufactured from low-carbon steel wire, grade 1022. This fastener has 164,000 psi bending strength, 1,430 lbf allowable tensile strength, and 800 lbf allowable shear strength.

Figure 4.4. 3-Ply CLT-wall and Glulam-beam vs. hexagonal connector and steel dowels.

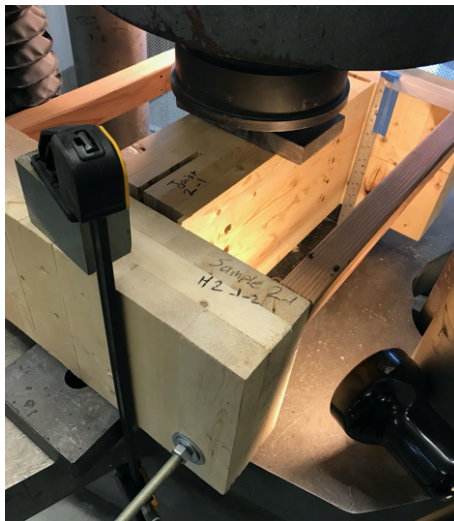
Figure 4.5, Figure 4.6, and Figure 4.7 show the experimental setup for the ambient, post fire, and fire performance tests performed on the Glulam-beam to CLT-wall connections. Additional details on the test setup can be found in Chapter 3. Ambient temperature experiments considered only mechanical load on the assembly, post-fire tests considered sequential (uncoupled) thermal and mechanical loading, and fire performance tests considered coupled thermal and mechanical loading. Post-fire performance tests were performed after 30 and 60 minutes of nonstandard fire loading. The only difference between the post-fire performance test performed on this assembly compare to the glulam beam to girder assembly was that the CLT-wall was only exposed on the connection side (1-side exposure) in this assembly. Fire performance tests were performed with a constant load applied, equivalent to 65% of the ambient temperature capacity of the assembly, along with a nonstandard fire exposure.

Figure 4.5. Test set-up and instrumentation utilized for testing at ambient temperature.

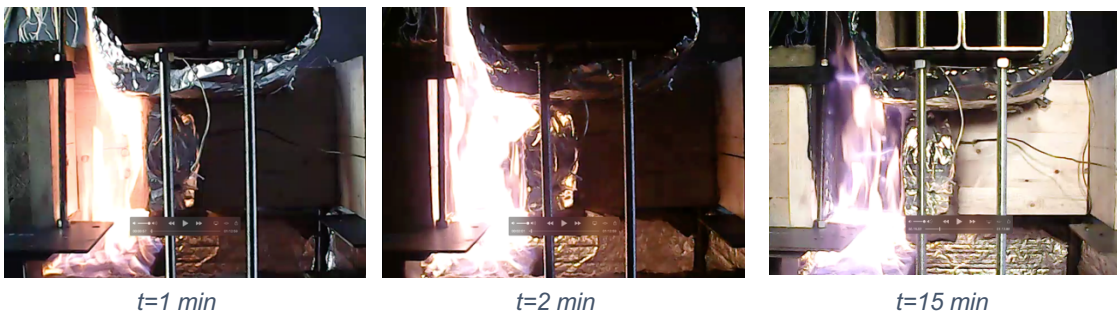
Figure 4.20. Fire-performance test video shots.

The entire fire-performance test was recorded by a fixed video camera. The recorded videos and captured pictures were used for further investigation on the fire-performance of the assembly. Figure 4.20 shows video captures of the fire-performance test at different times.

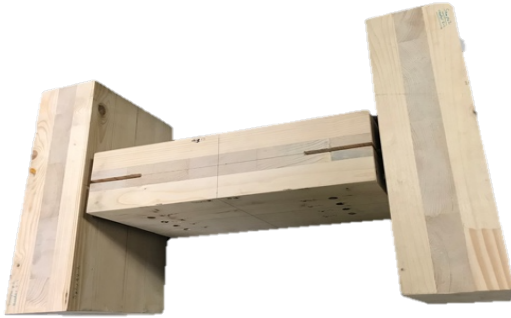
Figure 5.1. Assembly geometry: (a) test specimen, (b) top/ bottom view, (c) front view.

Experimental tests were conducted on symmetric, intermediate-size CLT beam-to-girder assemblies. Figure 5.1 illustrates the CLT beam-to-girder assembly and its geometry. Each assembly was comprised of two 3-ply CLT girders connected to a CLT beam with steel connections. Each steel connection included 4 full-length steel dowels to

the joist member and 20 Type 316 stainless steel screws to each girder. Table 5.1 provides more detailed information on the dimensions and material type of each component.

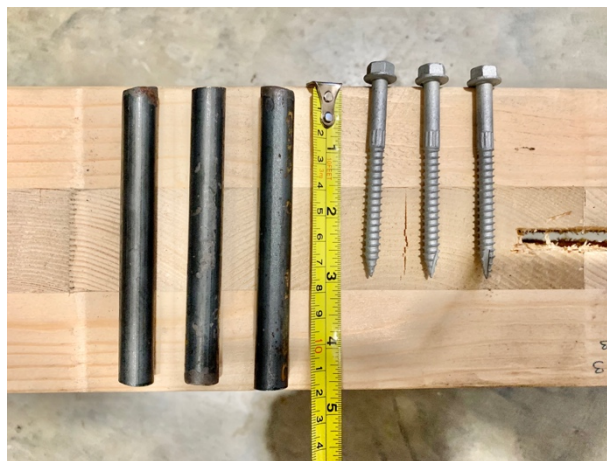
Figure 5.3. 3-Ply CLT beam, full-length steel dowels and heavy-duty screws.

The full-length dowels (4.72 in.) are cut from $\frac{1}{2}$ " steel rods with similar material property as the steel connection (ASTM A572 Gr 50). The $\frac{1}{4}$ " diameter heavy-duty hexagonal connector screws with 3" length and 2" thread are manufactured from low-carbon steel wire grade 1022. This fastener has 164,000 psi bending yield strength, 1,430 lbf allowable tensile strength and 800 lbf allowable shear strength. Figure 5.3 shows the steel dowels and screws placed on top of the CLT beam.

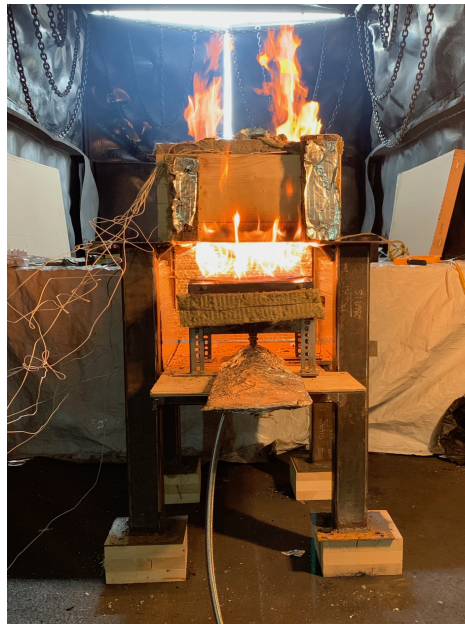
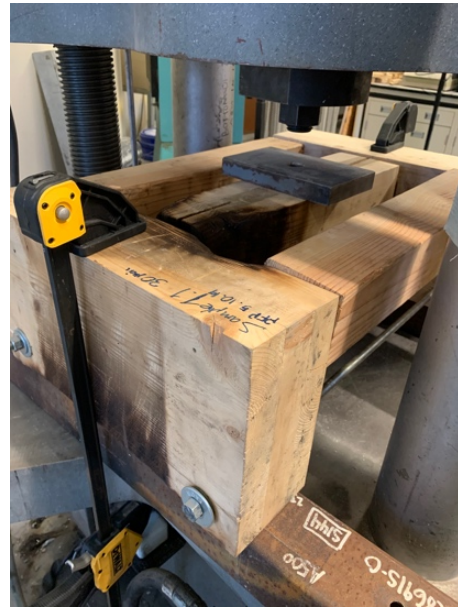
Figure 5.7. PFP30 test procedure: (a) non-standard fire test, (b) loading at ambient temperature.

Figure 5.7 shows a photo of the two-step post-fire test, including 30 minutes of nonstandard fire exposure of approximately 900 °F and subsequent cooling, followed by mechanical loading to failure. Figure 5.8 shows a photo of the fire performance test, including the application of constant mechanical load equivalent to 66% of the ambient temperature assembly capacity along with nonstandard fire exposure of approximately 900 °F until failure. Figure 5.9 and Figure 5.10 show the locations of the thermocouples used in the post fire and fire performance tests, respectively.

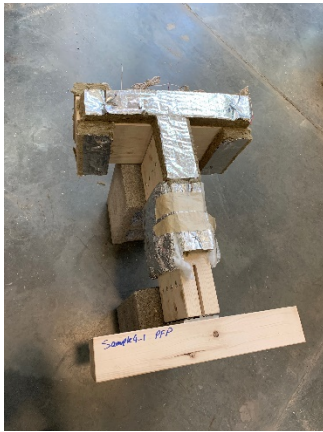
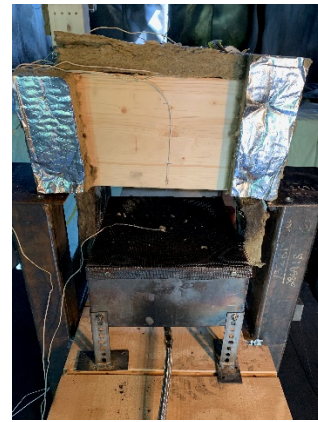
Prepared samples protected by insulation boards

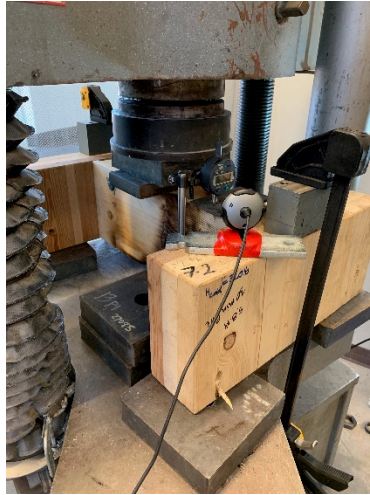
Loading burned sample under imposed downward load

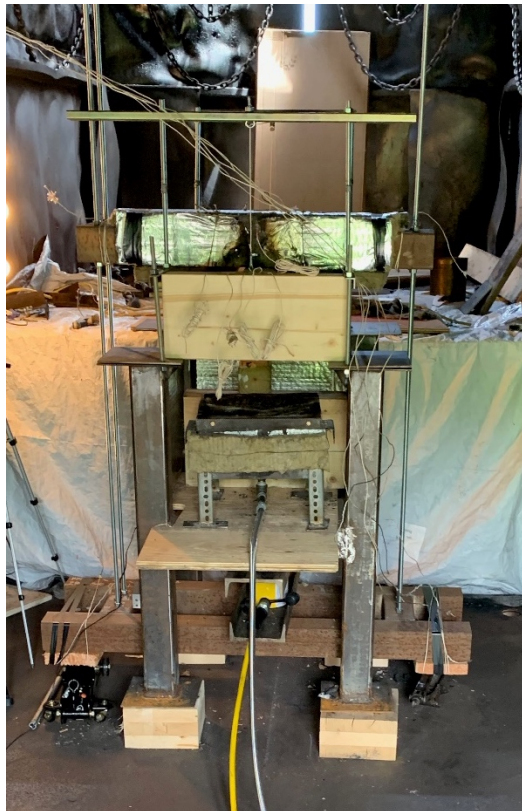
Fire performance test setup and loading system.

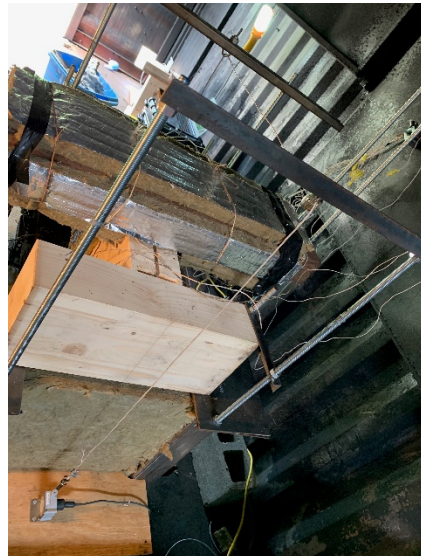
Strain pod measuring deflection

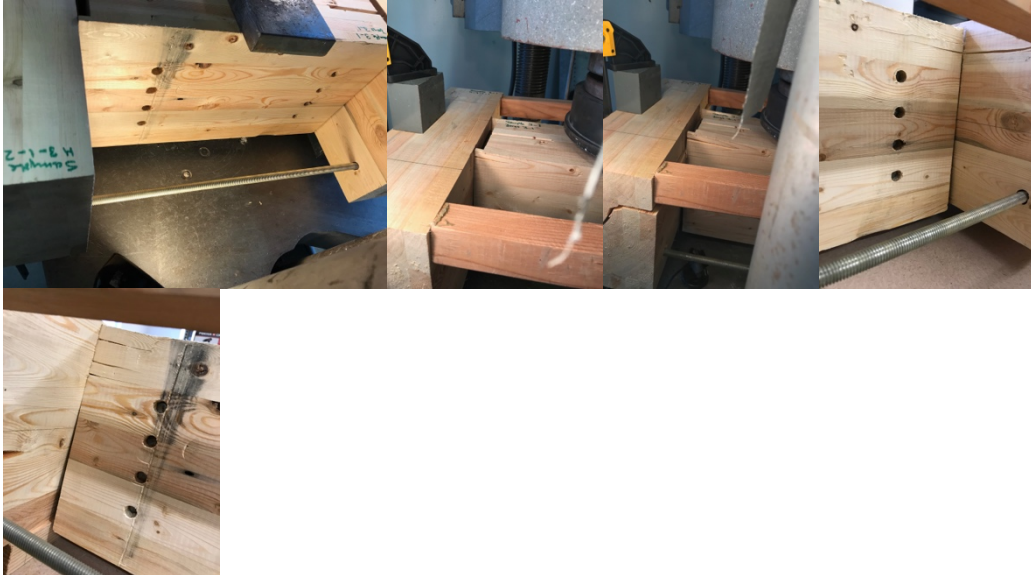
A3: Glulam beam-to-beam assembly
A3.1 AT

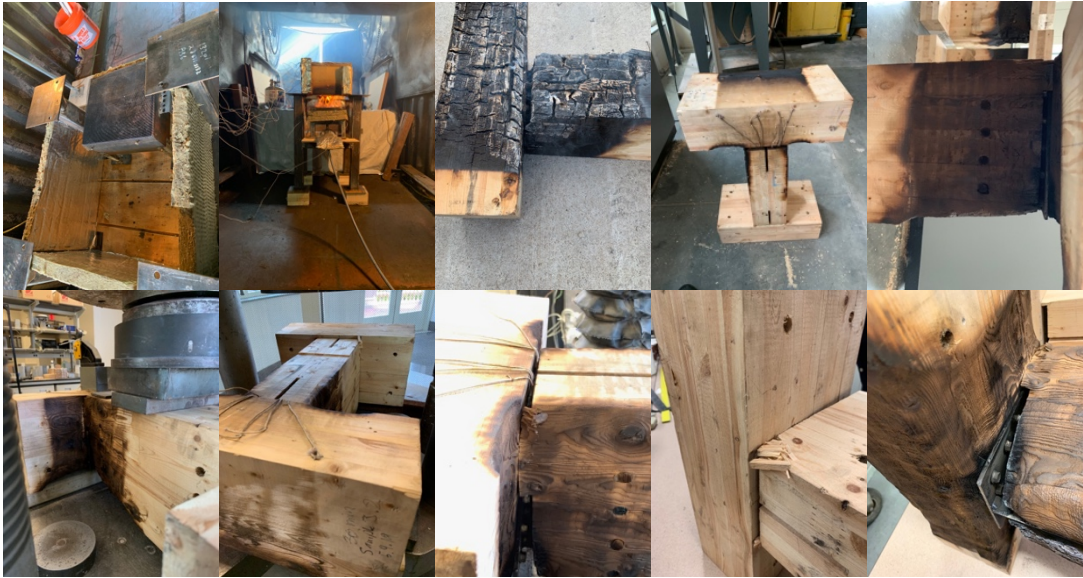
A3 PFP 30

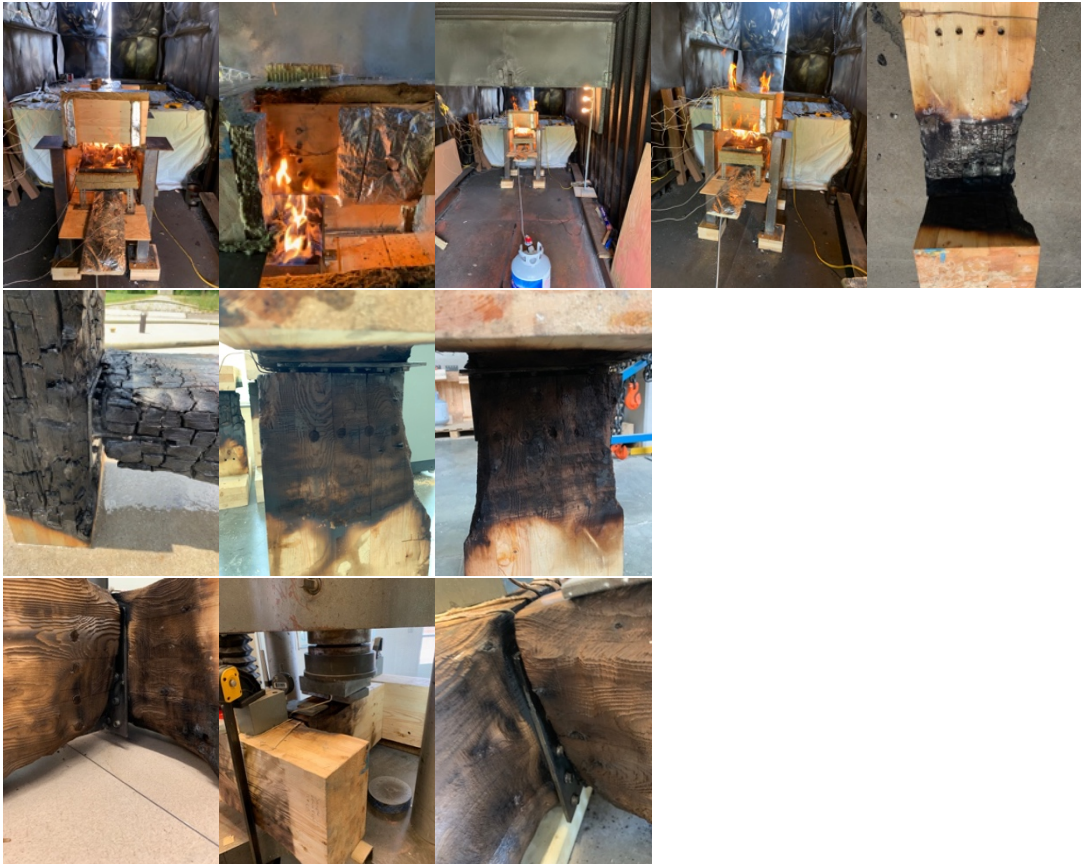
A3 PFP60

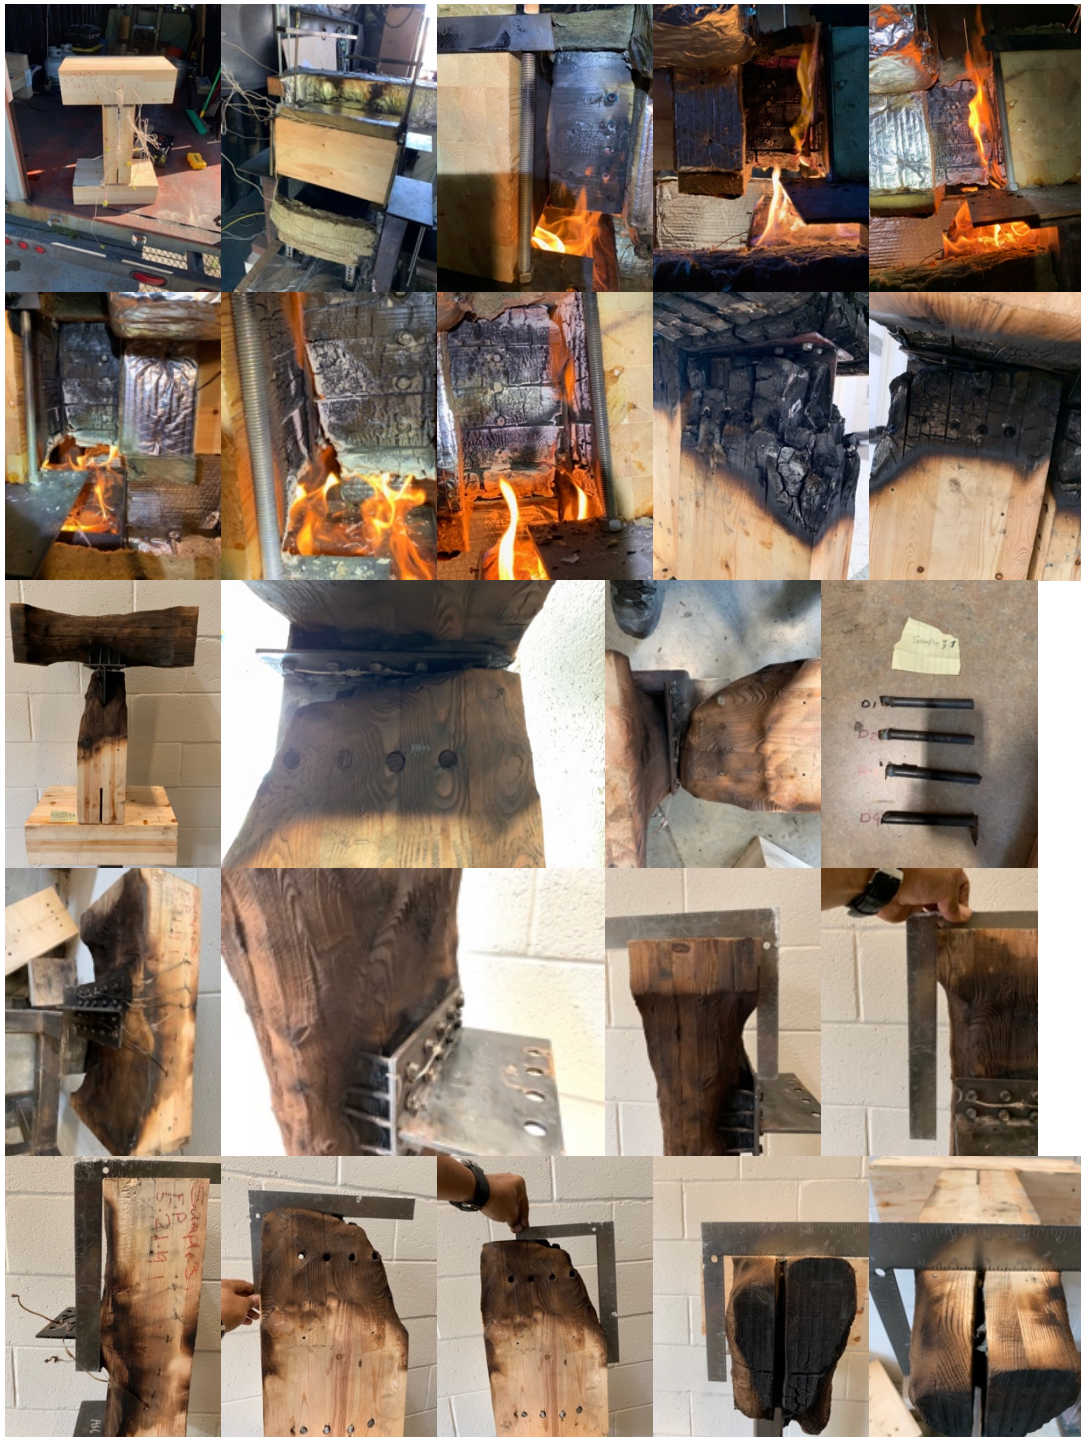
A3 FP1 (loading system failed)

Each one of Assemblies 2 and 3 tested twice under fire-performance condition. However, for each assembly one of the experiments failed as the loading jack stopped acting. The experimental results related to these failed tests provided in the following.

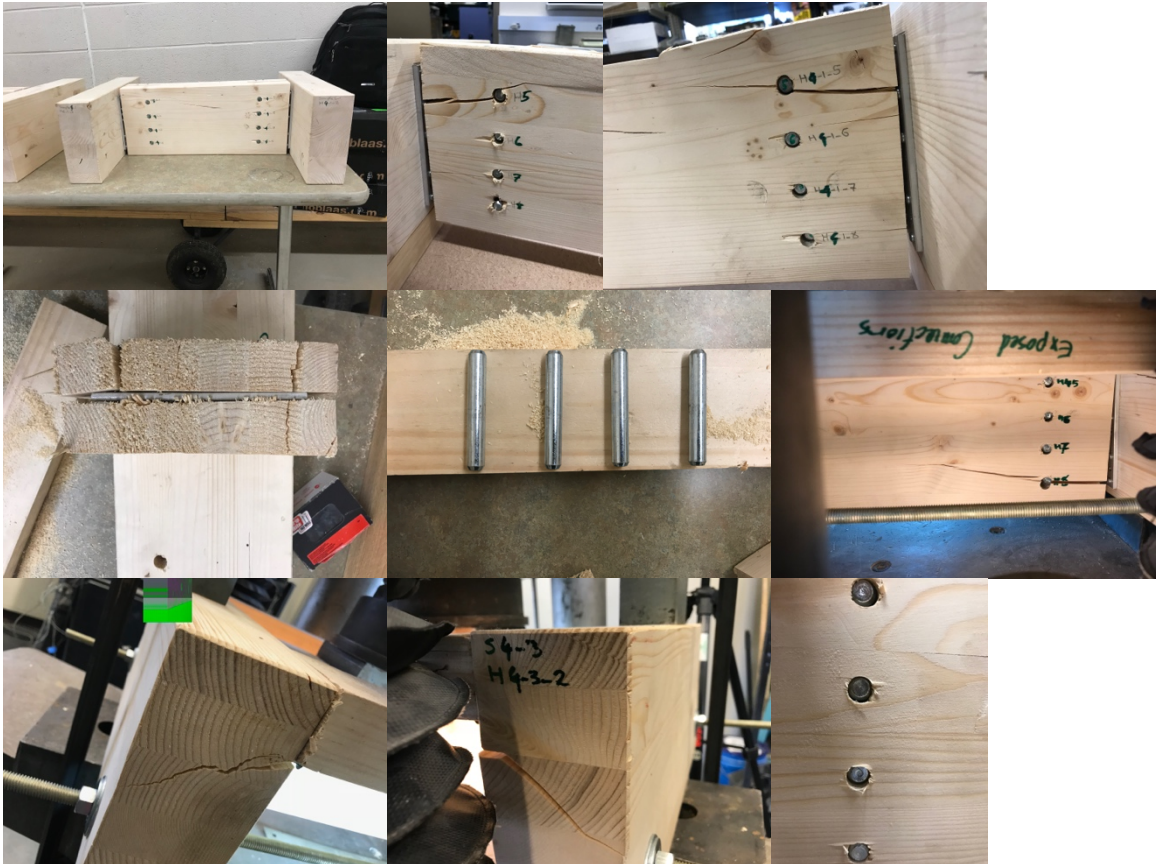
A4 (Glulam beam-to-beam exposed) AT

Assembly	Test #	Load Carrying Capacity of the System (lbf)	Relative Deflection (in.)	Failure Mode
A4	1	16372	0.61	Splitting
	2	15300	0.78	Splitting
	3	11861.98	0.85	Splitting
A5	1	19476.92	1.067	Splitting
	2	20607.937	1.15	Splitting
	3	20357	1.18	Splitting
A6	1	18155.35	0.7	Splitting
	2	15509.75	1.217	Splitting
	3	18146.38	0.81	Splitting
A7	1	21650	1.52	Splitting
	2	21956	1.537	Splitting
	3	21436.32	0.8335	Splitting

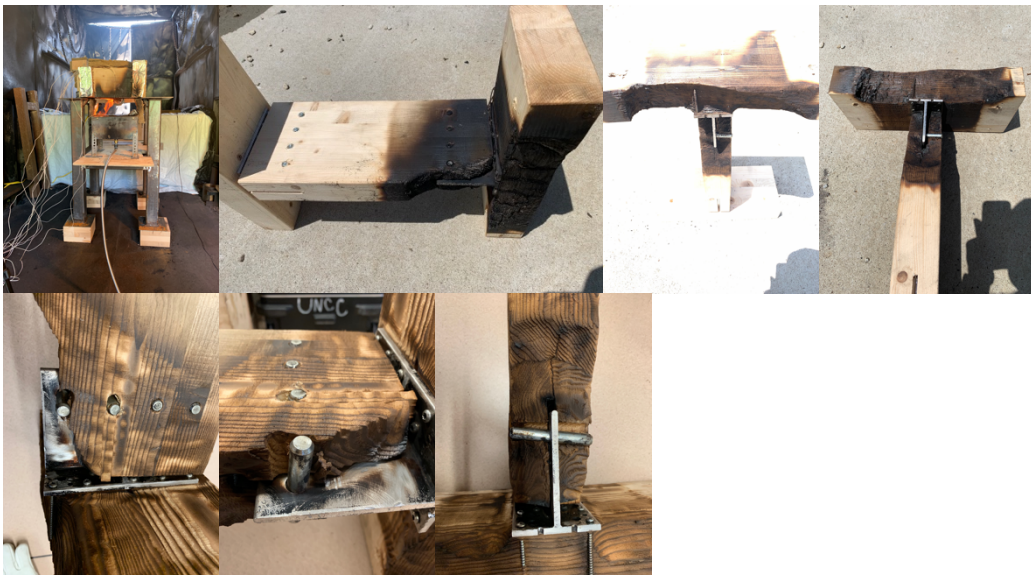
A4 PFP

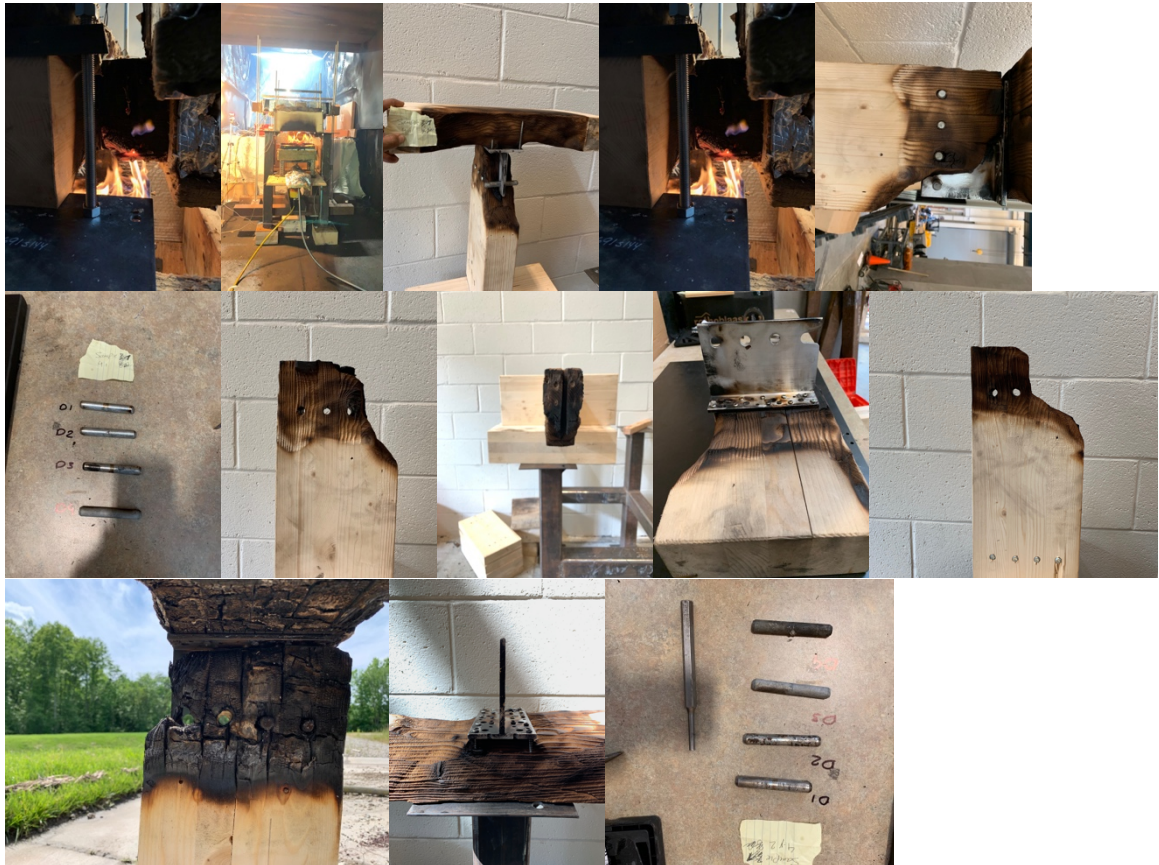
A4 FP (42 min and 32 min Fire exposure)

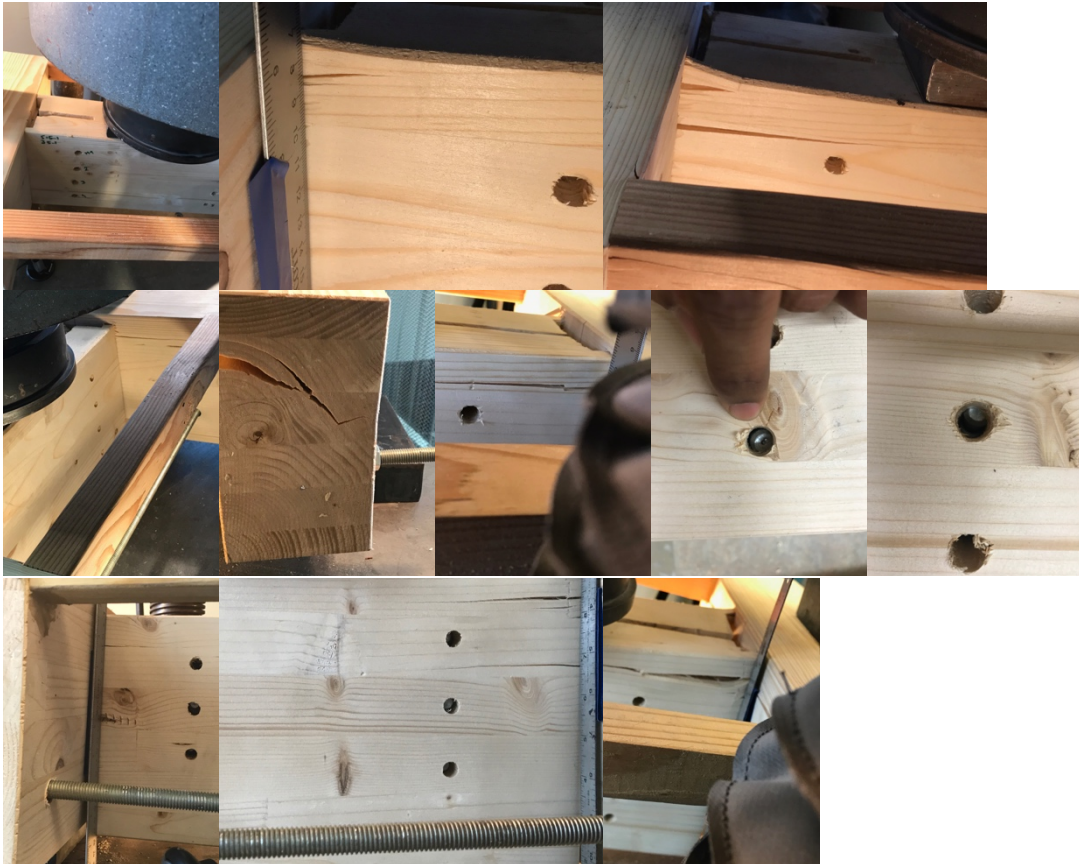
Assembly 5 (G1 beam-to-beam concealed) AT

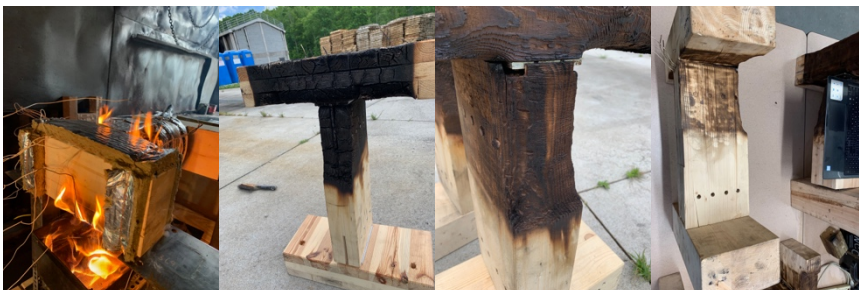
A5 PFP
