THERMO-MECHANICAL PERFORMANCE OF DOWELED CONNECTIONS IN
TALL TIMBER BUILDINGS

A dissertation submitted to the faculty of
The University of North Carolina at Charlotte
in partial fulfillment of the requirements
for the degree of Doctor of Philosophy in
Civil Engineering

MILAD SHABANIAN. Thermo-mechanical performance of doweled connections in tall timber buildings. (Under the direction of Dr. Nicole L. Braxtan)

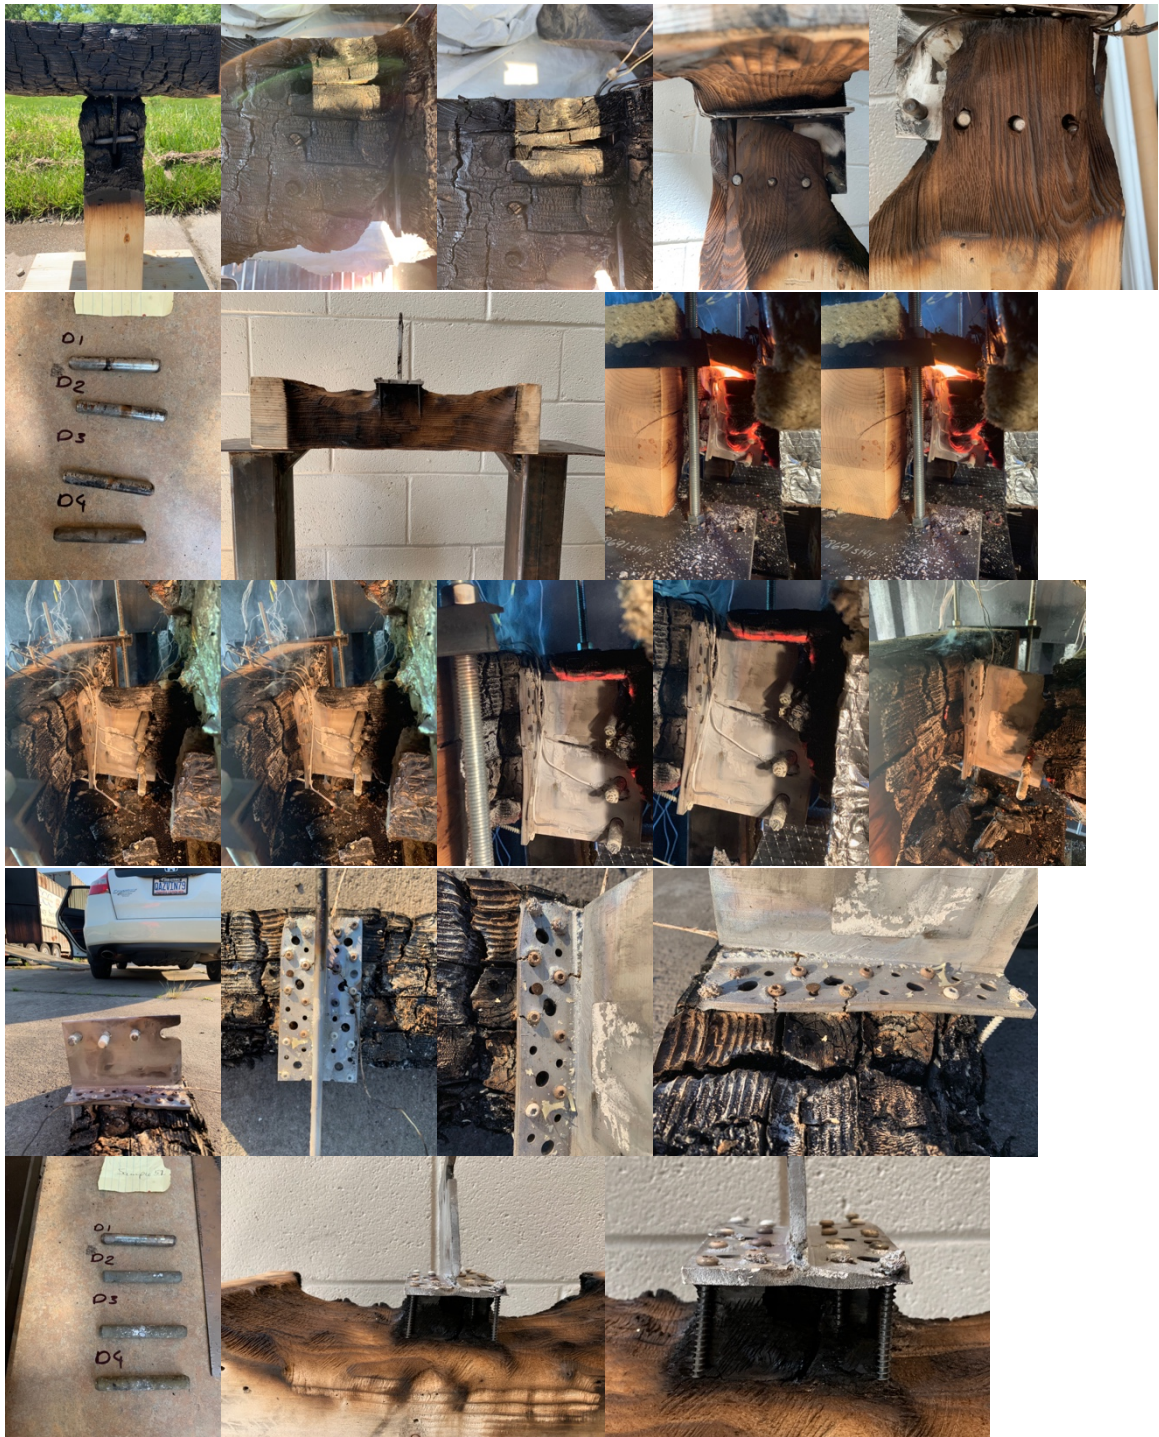
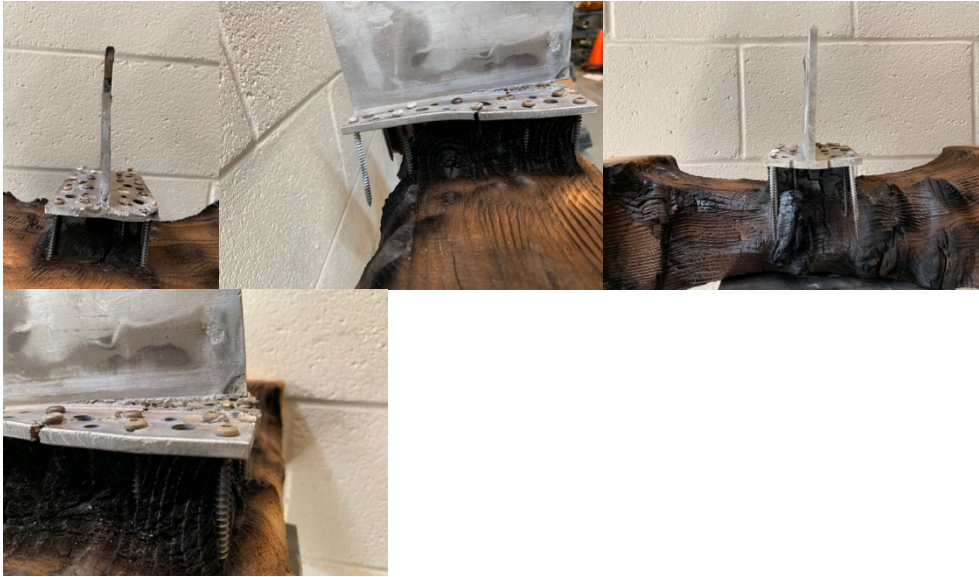
A5 FP (63 min and 110 min)

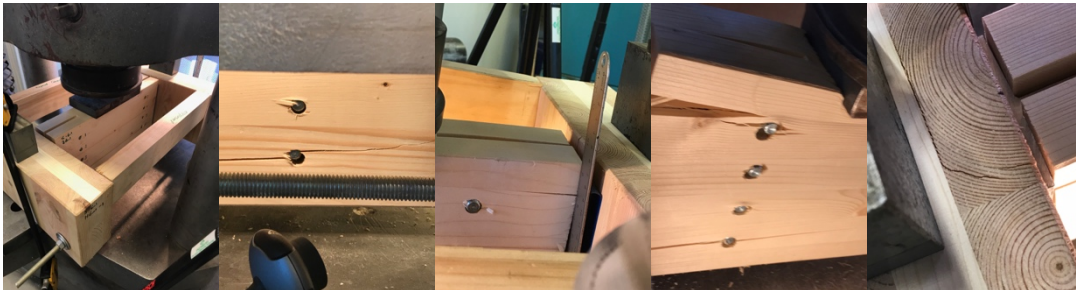
A6 (Glulam beam to CLT walls exposed) AT

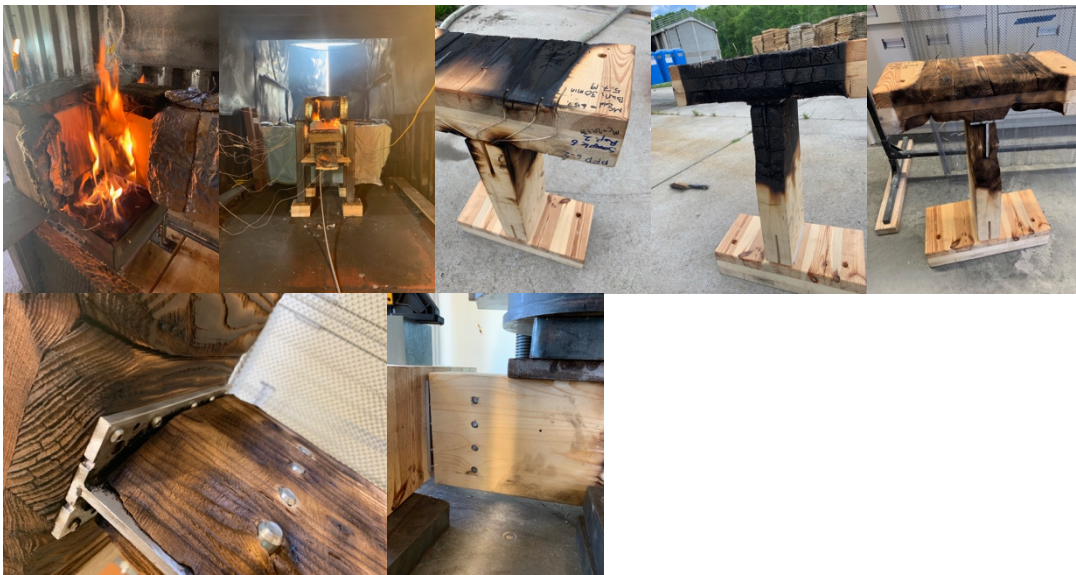
A6 PFP

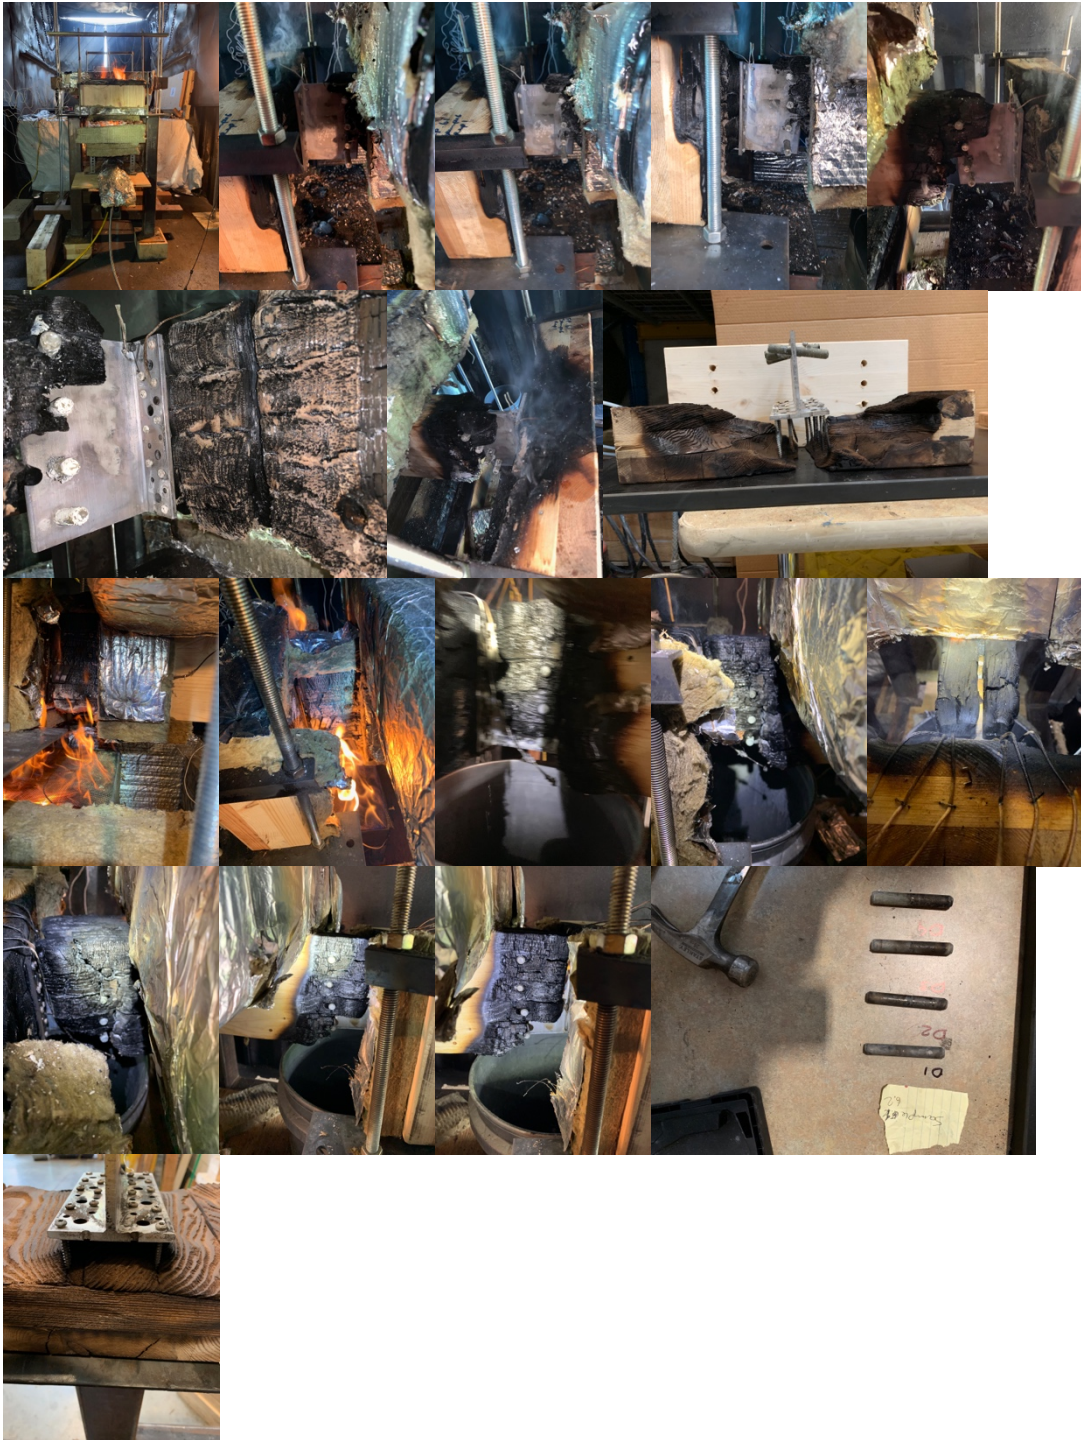
A6 FP (85 min and 45 min fire exposure)

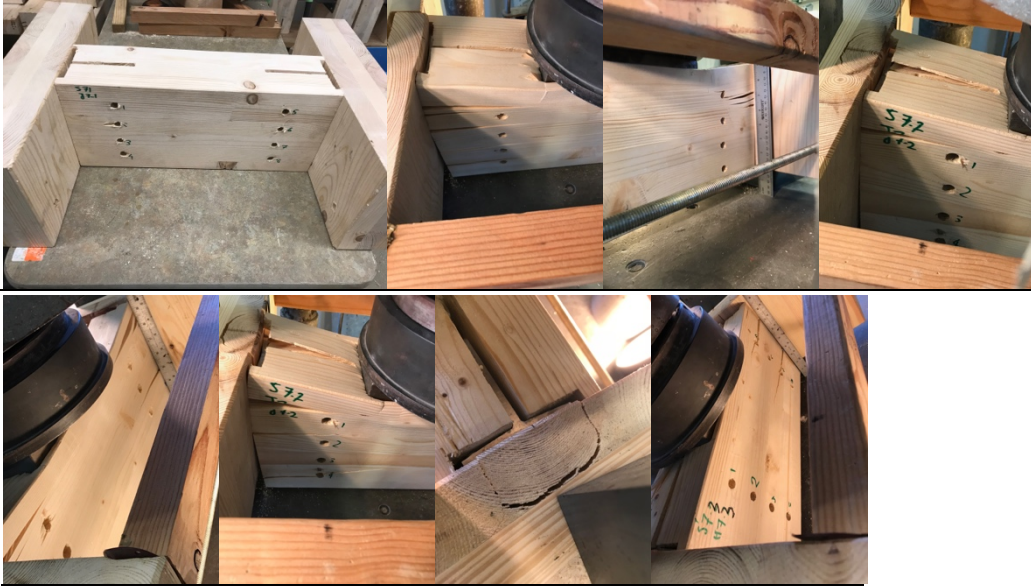
A7 (Glulam beam to CLT walls Concealed) AT

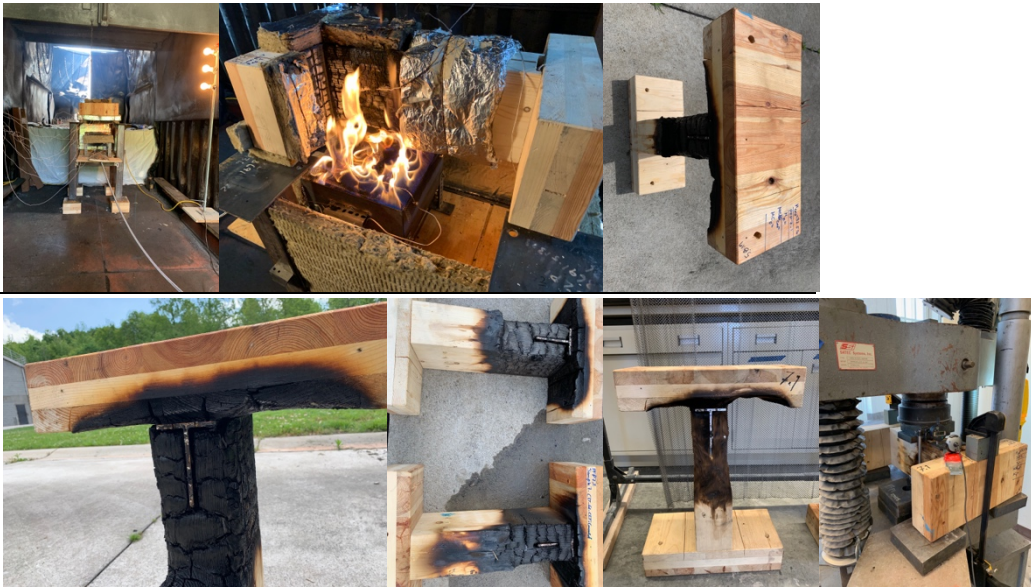
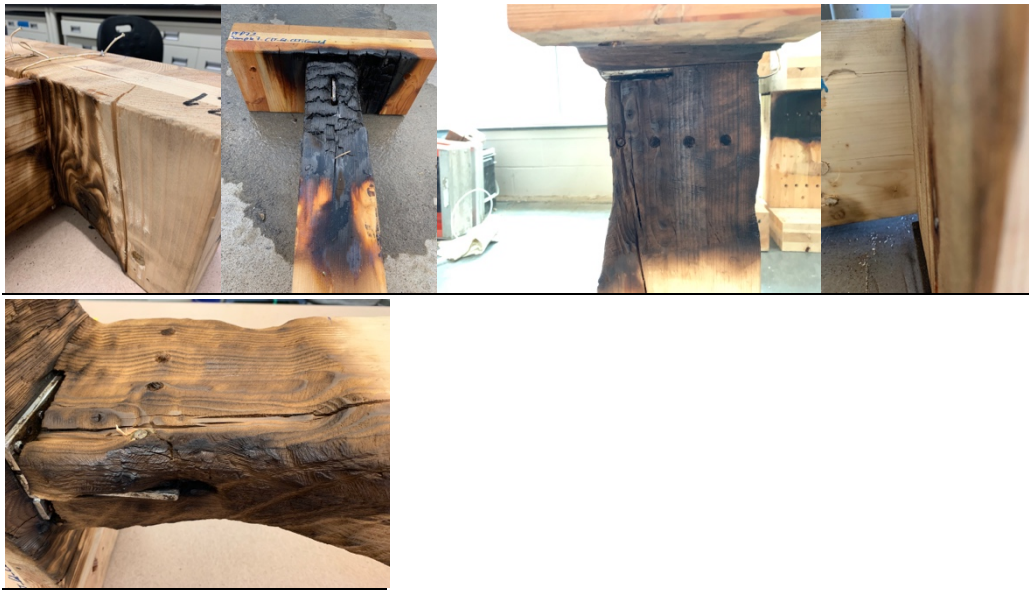
A7 PFP

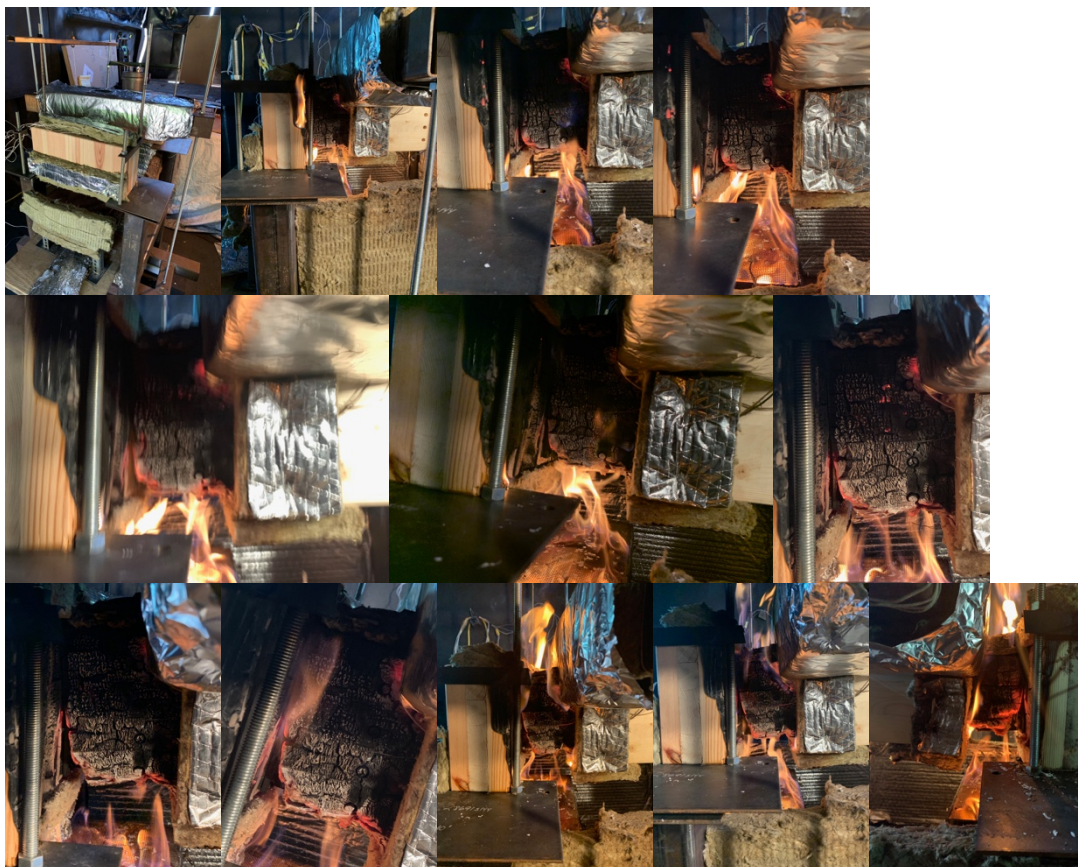
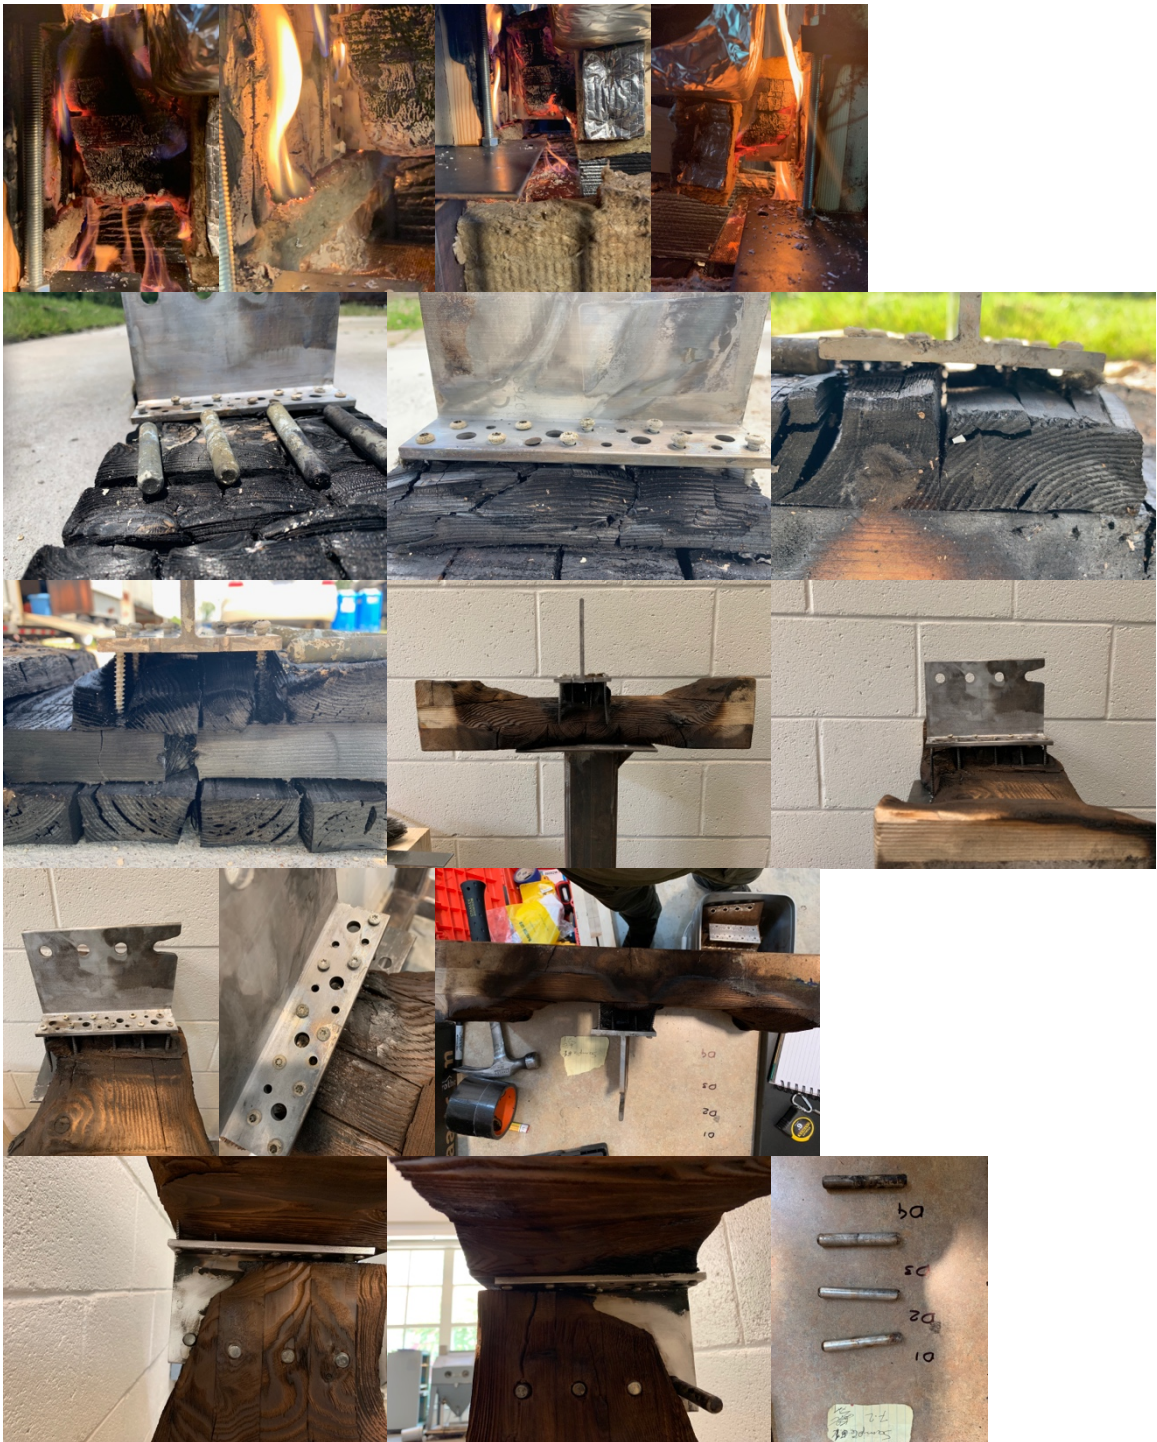
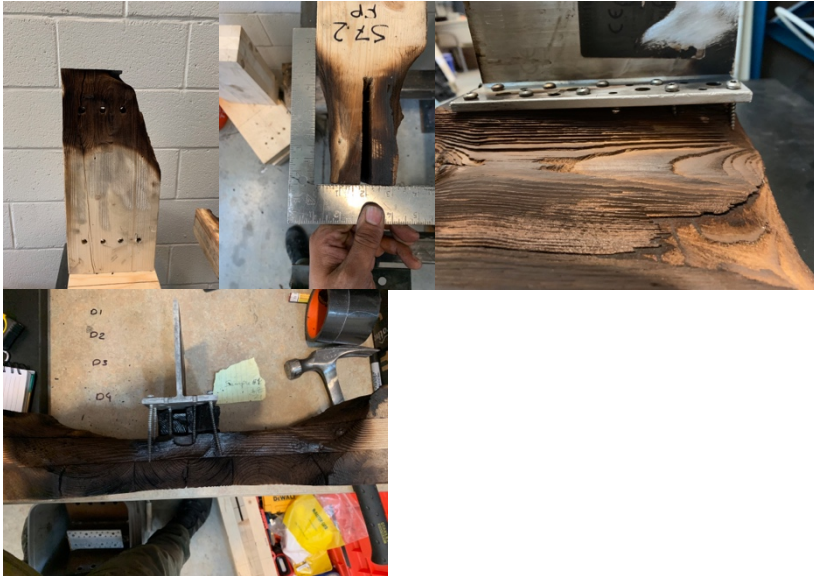
A7 FP (115 min and 60 min fire exposure)
